To Inspect Vehicle No: SKB 8383B Insured: \_\_\_\_\_

**FOR THE REPAIR OF VEHICLE NO. SKB 8383B .**

## VEHICLE DAMAGE INSPECTION REPORT

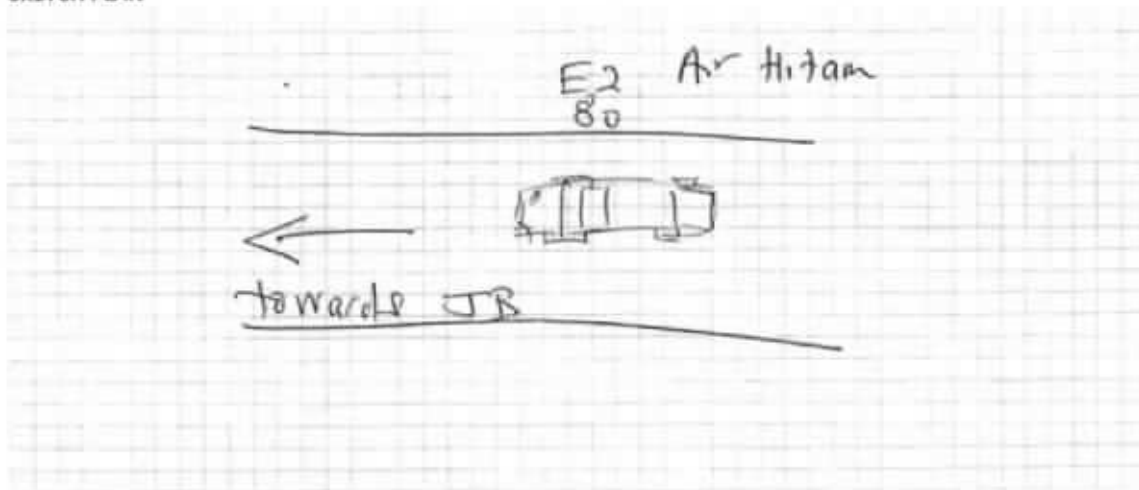
## SKETCH PLAN

I was travelling at 90 km/h towards Johore Bahru at the North-South Express Way. It started to rain heavily. Upon I tried to reduce speed. Upon brake applying, the car skidded & spin hitting the centre divider. No other cars or any people was involved in the accident.

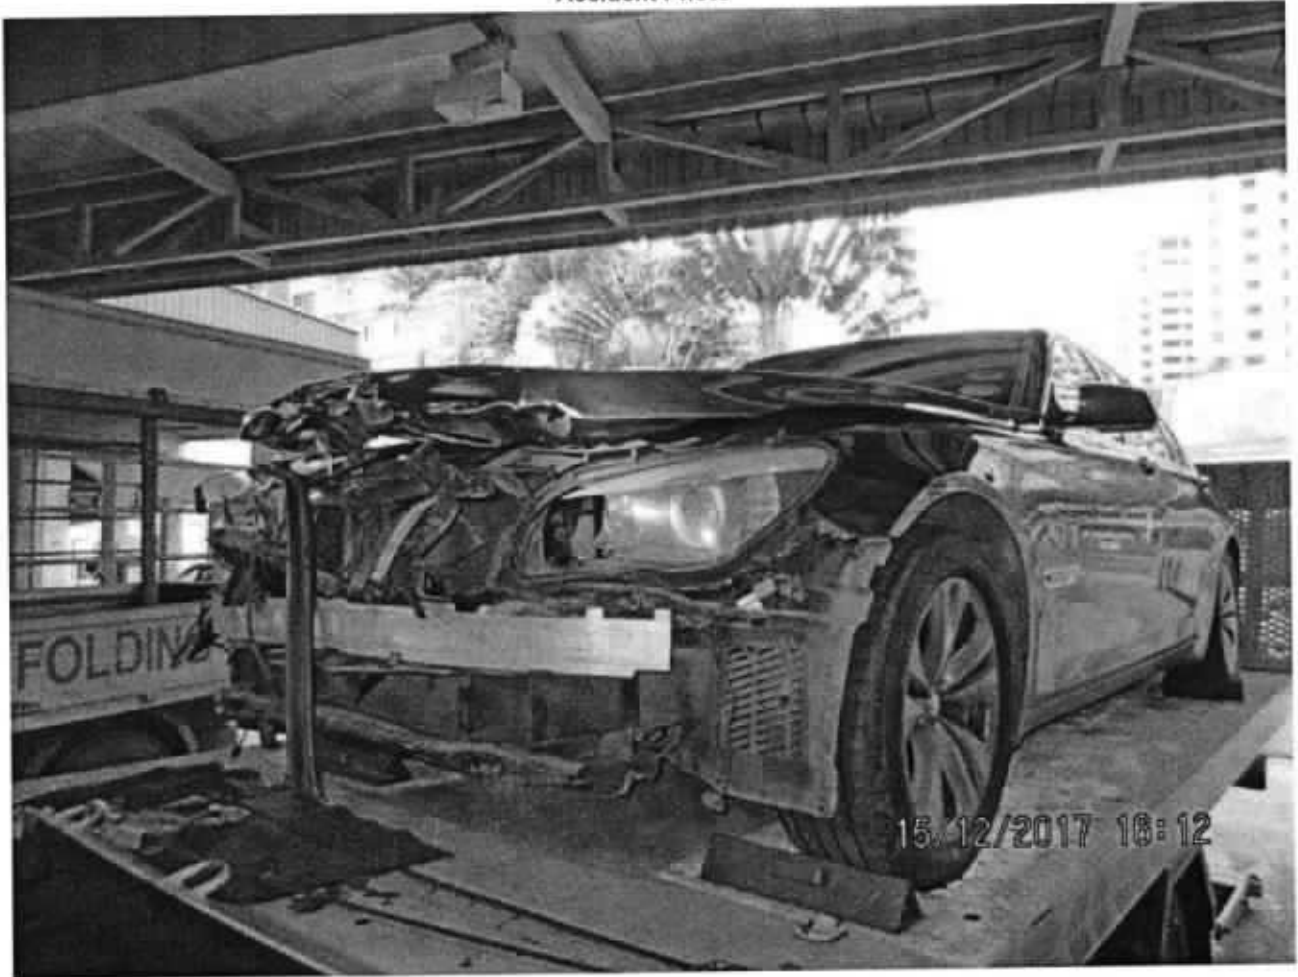
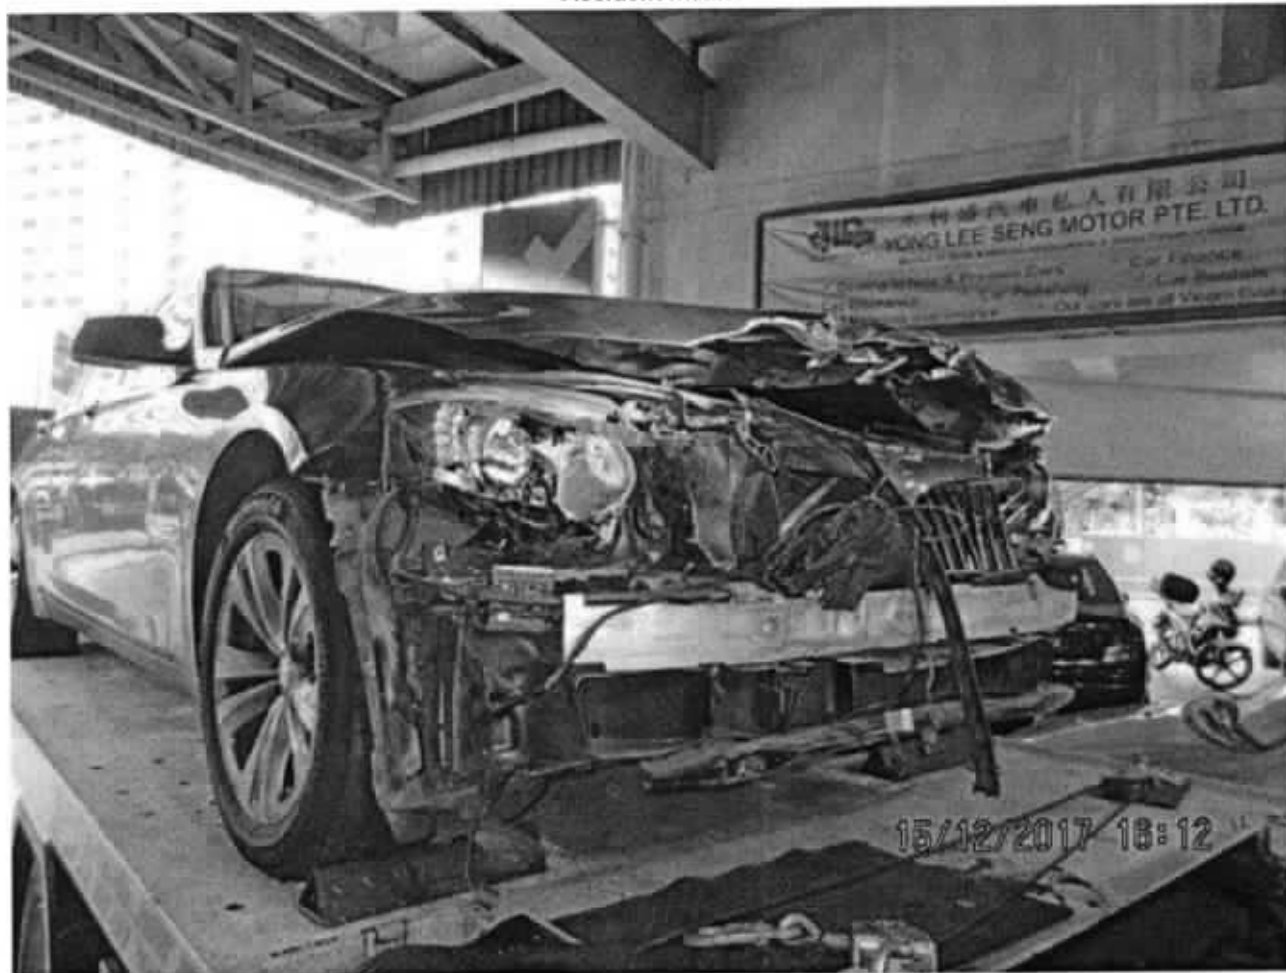
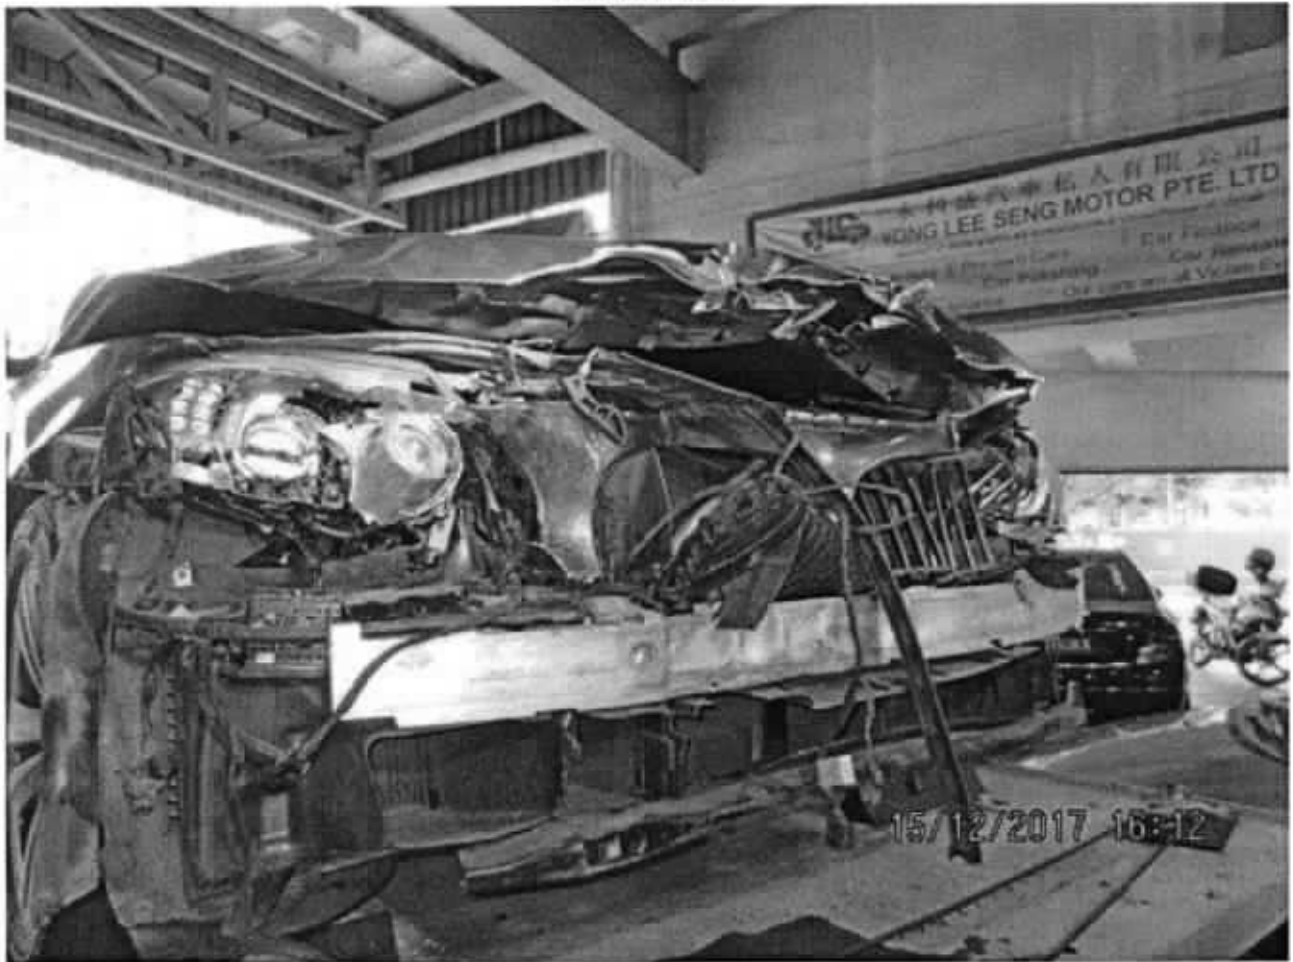
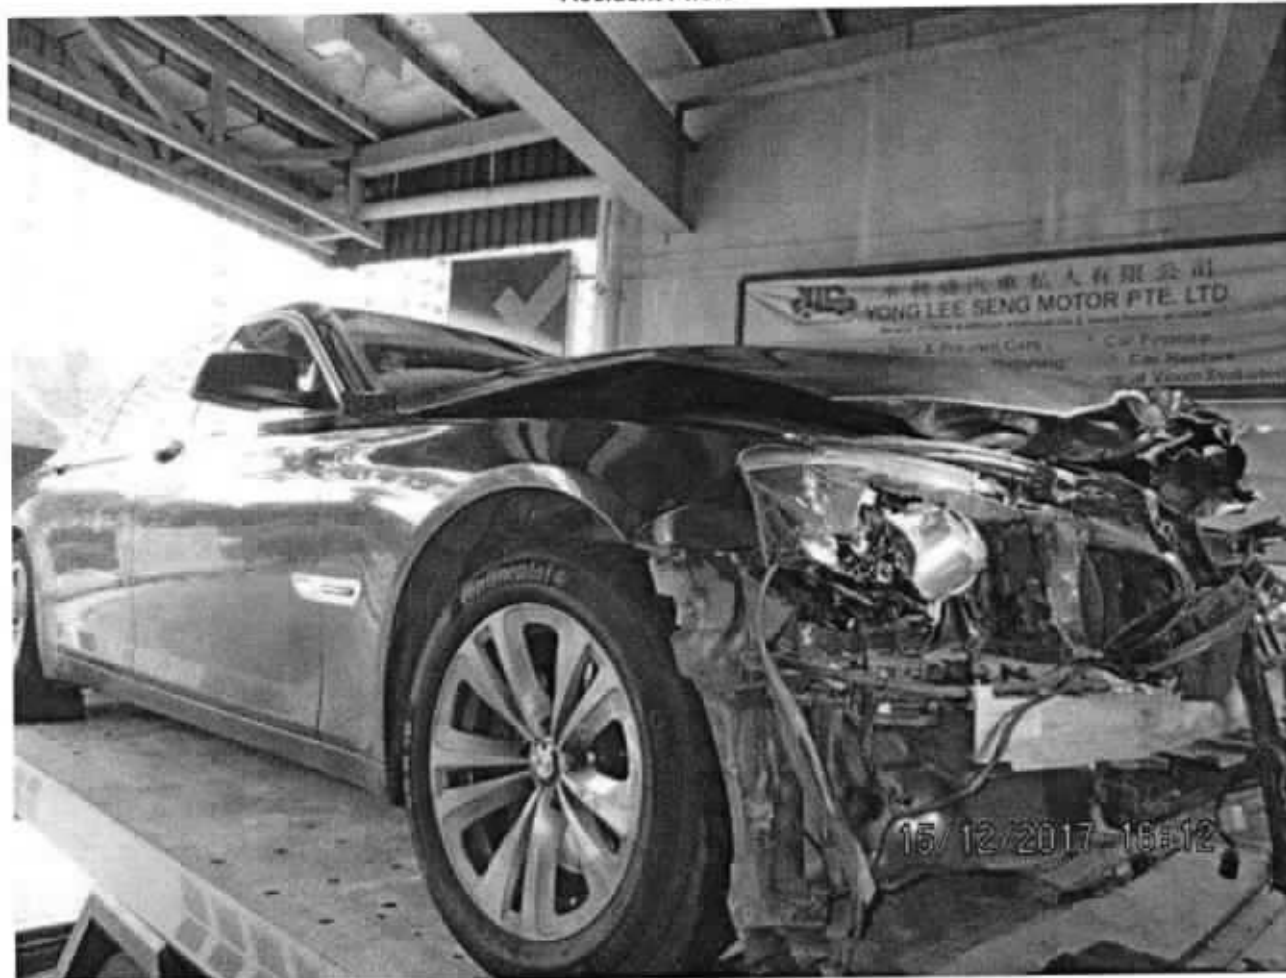
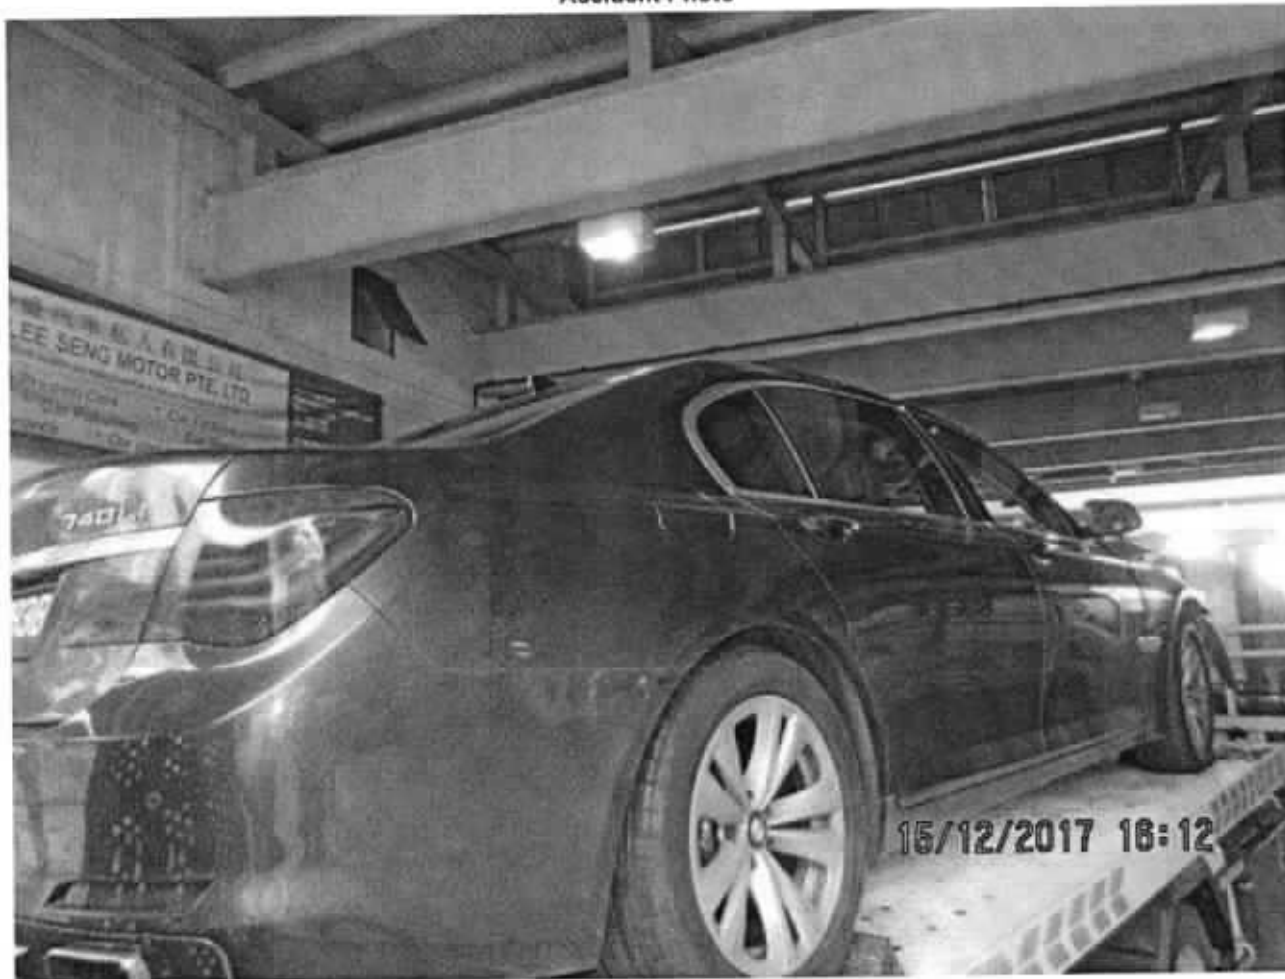
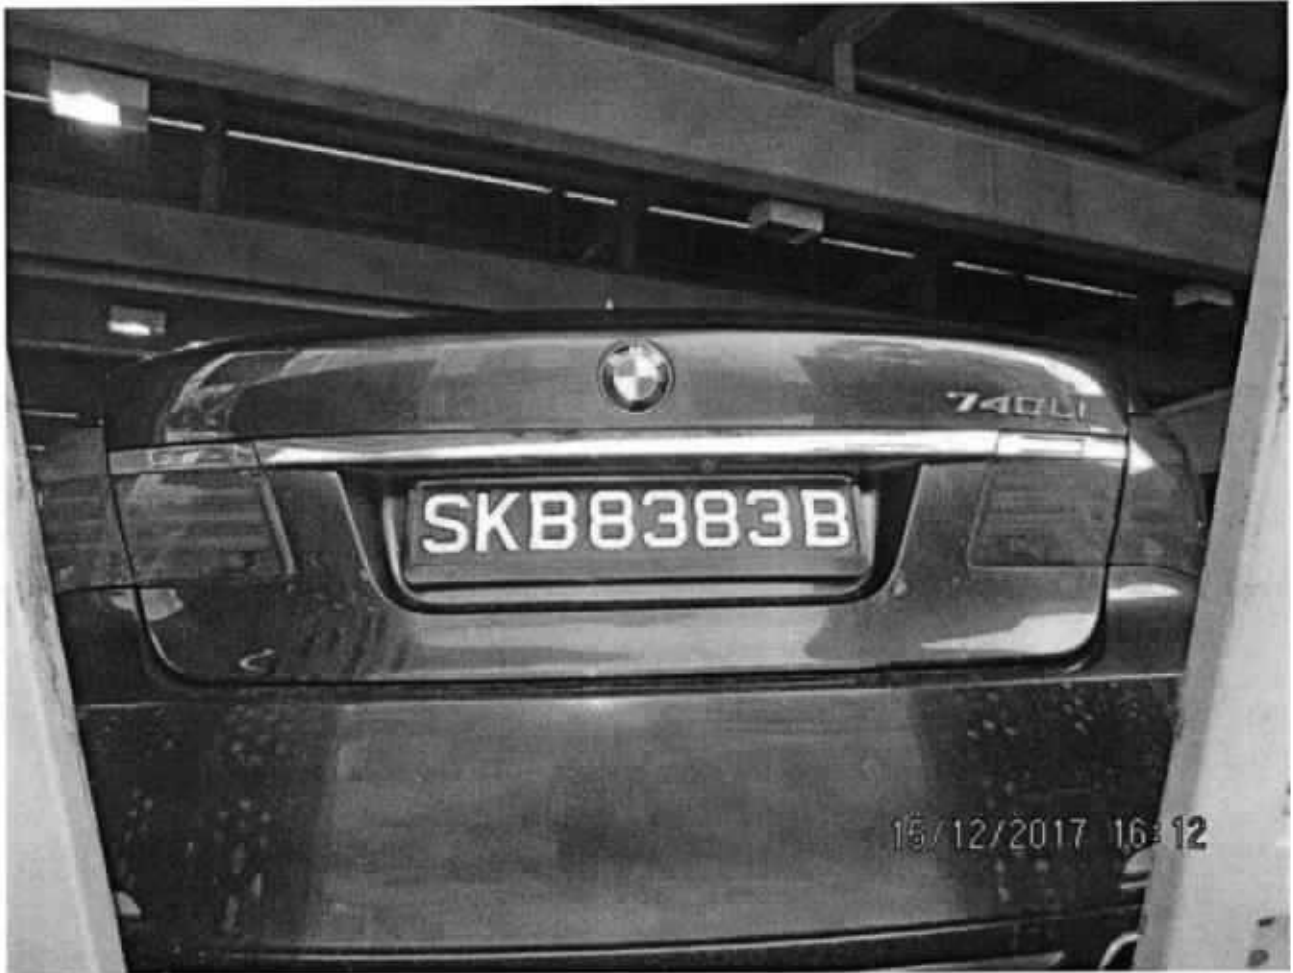
Accident Photo

The vehicle ~~sustained~~ badly damaged <sup>at the</sup> in front <sup>portion</sup>. Operational test to the braking sys. unable to be ~~contact~~ conducted. However, the static brake ~~do~~ test indicate ~~the~~ show that the brake sys. is in order. Tyre condition in serviceable condition with ~~damaged~~ ~~and the remaining~~ — am

The vehicle sustained impact / damages front portion and parts claimed are consistent to the accident.

As instructed by our client, please proceed to repair the insured vehicle SKB 8383B at repair cost not more than Lump Sum \$28,000.00 (excess \$600/-).
