Affiliated to Federation Internationale Des Experts En Automobile			
CHINA TAIPING INSURANCE (S) PTE LTD		Ref : CS/CTI17024226/Ktd3	
3 ANSON ROAD #16-00 SPRINGLEAF TOWERS SINGAPORE 079909		Date : 21-12-2017

ESTIMATE TO REPAIR HONDA VEZEL - SLE681R

VEHICLE DAMAGE INSPECTION REPORT

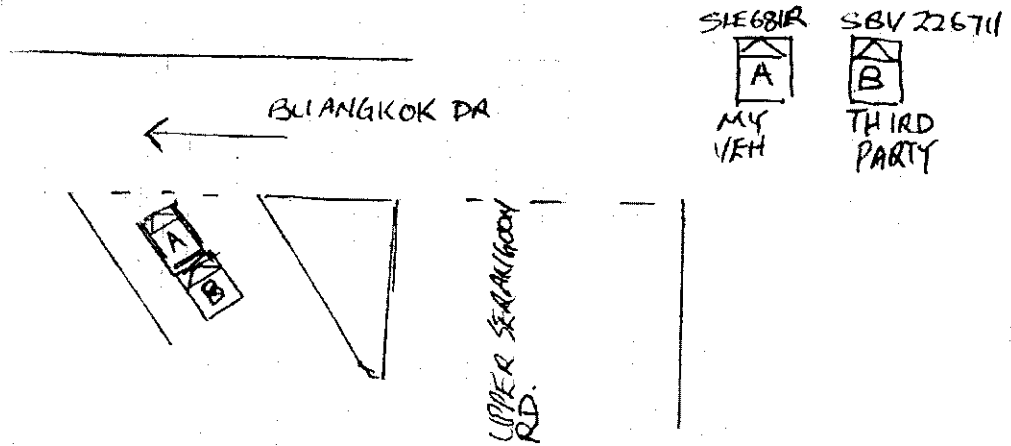
SKETCH PLAN

DESCRIBE CIRCUMSTANCES OF THE ACCIDENT

On 15th December 2017, I was driving my vehicle Reg. no. SLE 681R at around 2010 HR taking a left turn to Buangkok DR from upper Sarangpon Rd as I was hit by vehicle Reg no. SBV 226711.
