RE: Accident Involving SJT9191Z and SKP3760E on 21 December 2017

LKK Auto Consultants Pte Ltd

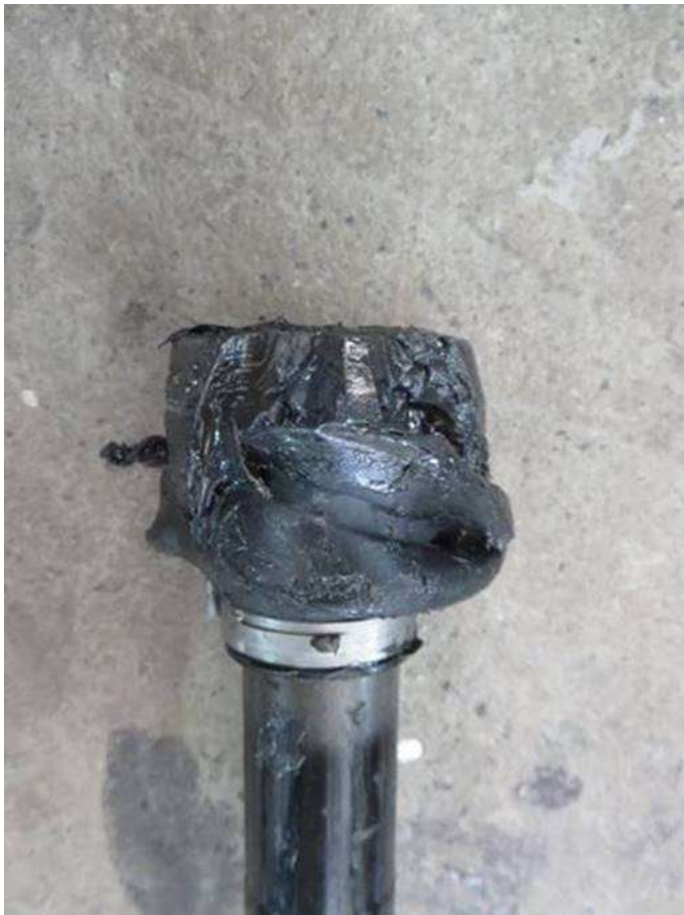
Subsequently, when the front right undercarriage parts were dismantled, physical damage was seen to almost all the parts like the lower arm, shock absorber etc. The damage to the drive shaft is shown in photo 128 and 129 in Merimen. The ball joint of the drive shaft was dislodged from its coupling at the output side of the gearbox.

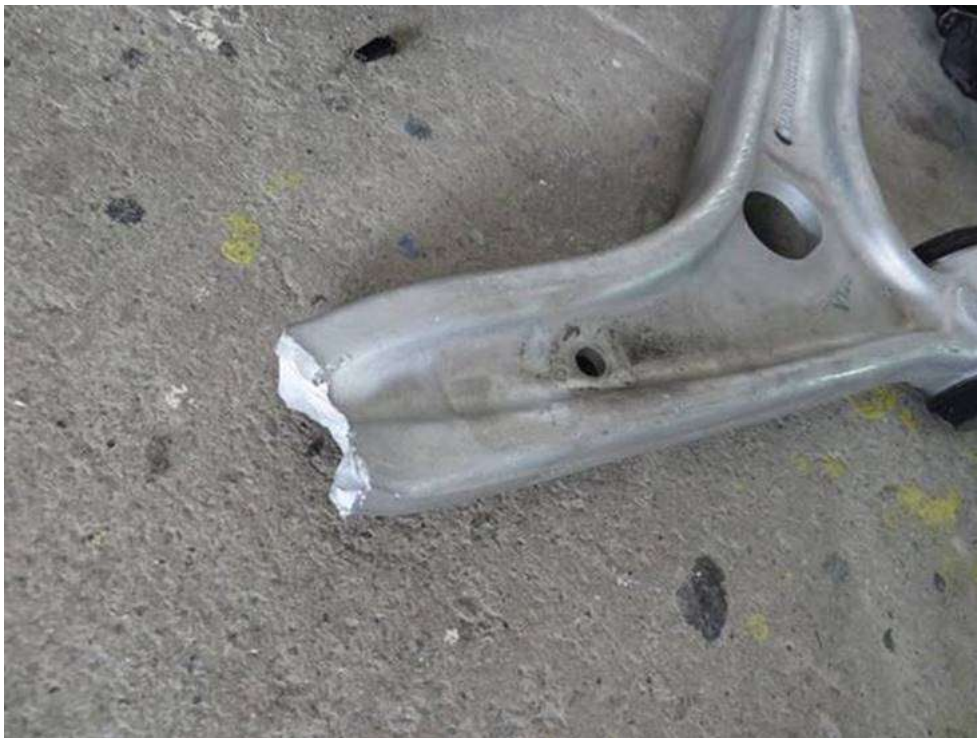
The lower arm is shown in 137 and 138 in Merimen. It was observed to be broken.
