Affiliated to Federation Internationale Des Experts En Automobile				
MSIG INSURANCE (SINGAPORE) PTE LTD			Ref : CS/MSG17024487/Gtb	
16 RAFFLES QUAY #24-01 HONG LEONG BLDG SINGAPORE 048581			Date : 27-12-2017	
			Code : MSG

1. Policy Particulars :- THIRD PARTY CLAIM				
Insured Veh.	FBF 9996L	Veh. Inspected	SLN 7510H	
Policy No.	MSD/VMT/17-358698	Coverage (\$)	0.00	
Claim No.	MSC/V/17-001973	Excess (\$)	0.00	
Assign From	MERIMEN (CATHERINE THIA)	Assign Date	22/12/2017

VEHICLE DAMAGE INSPECTION REPORT

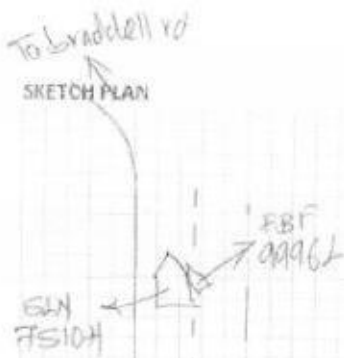
Accident Sketch Plan

As per police report
