Automobile Inspection Report

Registration No. : SJX 190P
Accident Date : 23/12/2017

Colour	: Black	Make & Model	: Honda Stream 1.8L
Engine Capacity	: 1799 cc	Pre-Accident Condition	: Good
Mileage (KM)	: 156317	Engine No.	: R18A13850561
Chassis No.	: JHMRN68809C200562	Steering	: In Order
Registration Date	: 07/05/2010	Brake	: In Order

VEHICLE DAMAGE INSPECTION REPORT

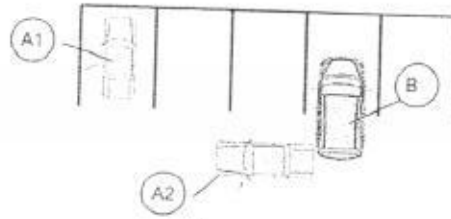
SKETCH PLAN

Blk 832 Sims Avenue Open Space Carpark

Vehicle A: SJX190P

Vehicle B: GZ3085R

I was reversing out from the carpark lot and as I need to exit at the exit nearby at the rear left, therefore I reversed along the driveway of the carpark. Suddenly, vehicle B reversed to exit the carpark lot. Unable to brake in time, my rear right area of my vehicle A hit into the rear left area of vehicle B.
