REF: CS/FCI17024672/Gad3

To Inspect Vehicle No: SLE1156J

**INITIAL INSPECTION REPORT OF VEHICLE NO. SLE 1156J.**

## ADJUSTMENT ON REPAIR COST FOR VEHICLE NO. SLE 1156J

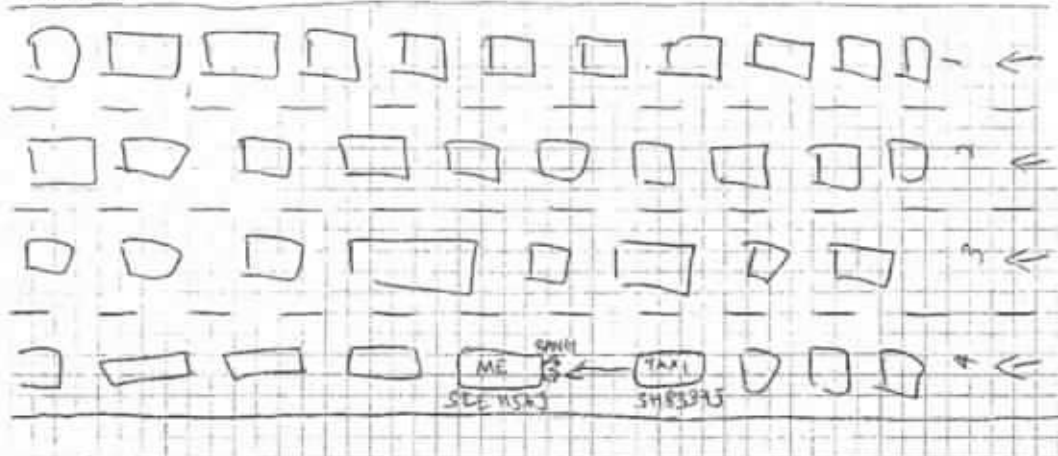
## SKETCH PLAN

PIE TOWARDS AIRPORT AFTER TGA PAYOH EXIT

On Friday, 22 Dec 2017, at around 10:30am, I was driving along PIE Towards Changi Airport. Traffic is congested moving at about 15km/h - 20km/h due to an accident up ahead. After Tan Payoh Exit, a blue Comfort Taxi SH8337J banged me from behind causing damage to the rear of my car. A video clip of the incident is available for reference. (Video is from my car SLE 1156J). A witness (Taxi Passenger) is willing to be my witness as she also thought that it's the taxi driver's fault for not paying attention while driving. The witness is a lady (Jesyka Tually tel: 8310 0149). Me and the Taxi driver exchanged particulars but he declined showing his ID but wrote down his Name, HP No and Vehicle No on a piece of paper instead. So I did the same. No police report were made. - PHOTOS and VIDEO is available for reference.
