1. Policy Particulars :- THIRD PARTY CLAIM

Insured Veh.	GY 1044C	Veh. Inspected	SJH 4286E
Policy No.	AVC1SB0079591702	Coverage (\$)	0.00
Claim No.		Excess (\$)	0.00
Assign From	TAN KAH LEONG	Assign Date	02/01/2018

Accident Date	12/12/2017	Inspection Date	02/01/2018
Survey held at	FAST TECH AUTO		
Repairer	FASTECH AUTO PTE LTD

ADJUSTMENT ON REPAIR COST FOR VEHICLE NO. SJH 4286E

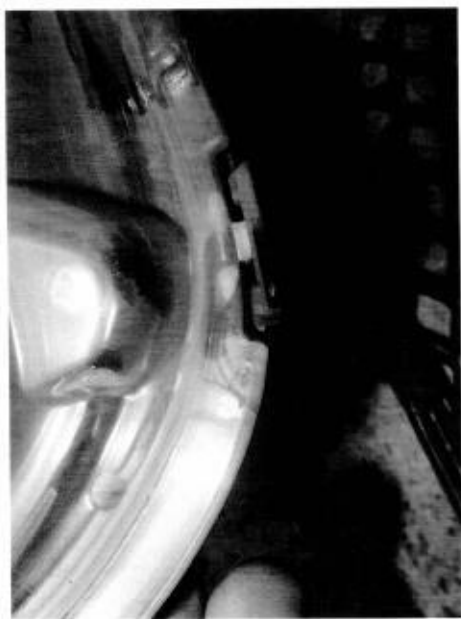
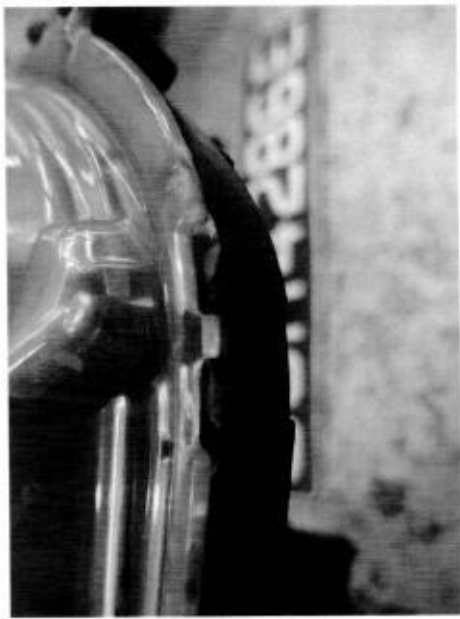
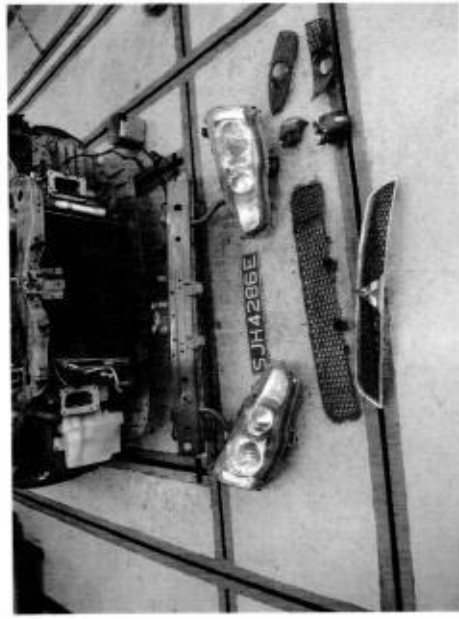
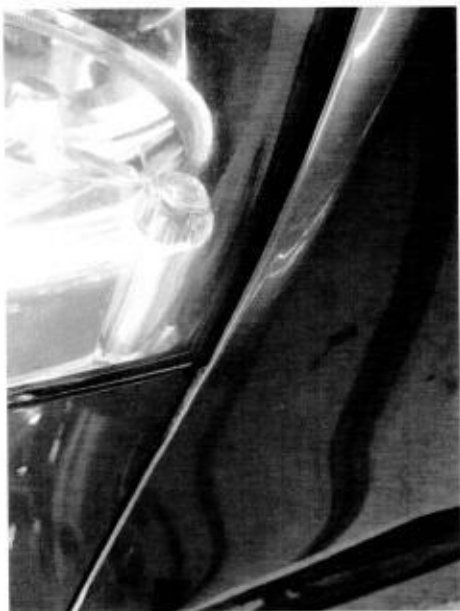
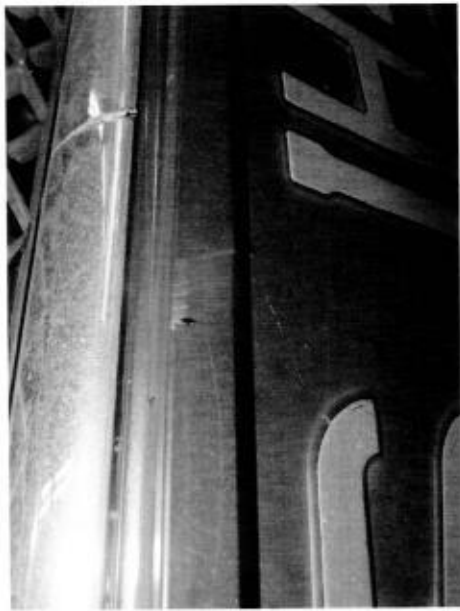
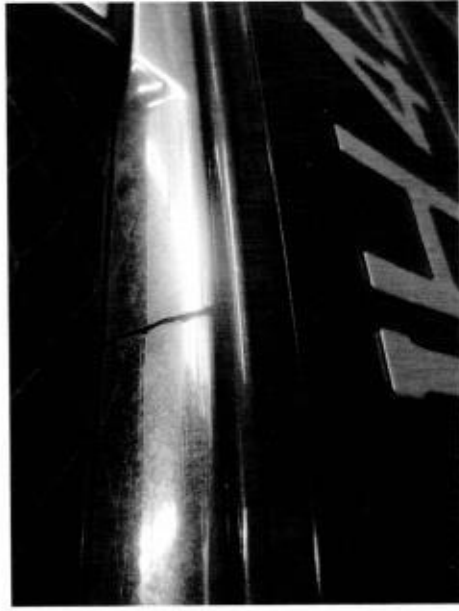
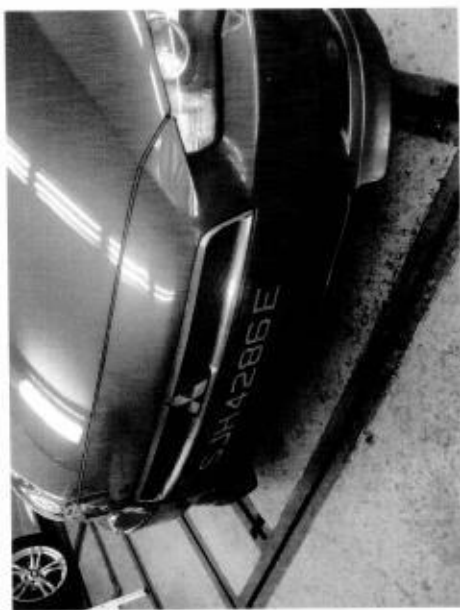
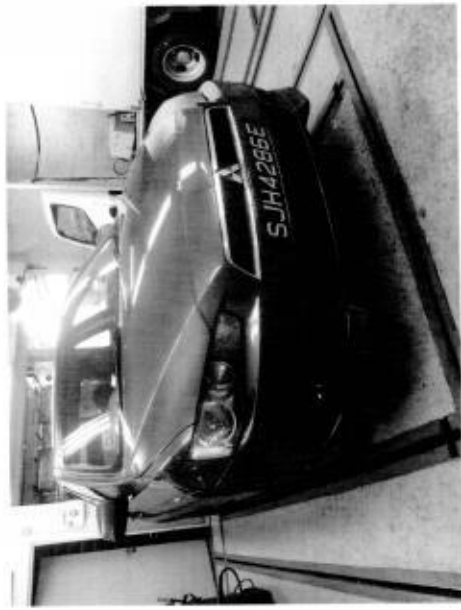
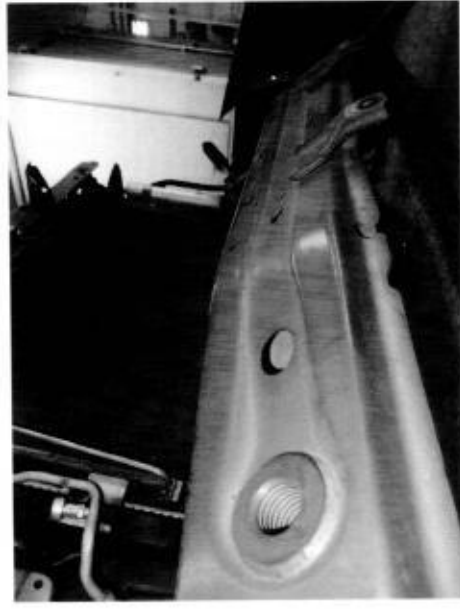
THE VEHICLE SUSTAINED DAMAGES AT THE FRONT PORTION. DAMAGES SEE DETAILS.

Qty	Description of Parts	Condition	Estimate By Workshop (\$)	Our Adjusted (\$)
<u>REPLACEMENT OF PARTS</u>				
1	FRONT BUMPER	DENTED / DEFORMED	897.00	897.00
2	FRONT BUMPER SIDE RETAINERS @\$32.00	BENT / NECESSARY	64.00	64.00
1	SET FRONT BUMPER CLIPS	NECESSARY	50.00	50.00
1	FRONT BUMPER LOWER CENTRE GRILLE	TWISTED	89.00	89.00
2	FRONT BUMPER FOG LAMPS @\$430.00	NOT NECESSARY	860.00	-
1	FRONT BUMPER REINFORCEMENT	BENT / DENTED	364.00	364.00
1	FRONT GRILLE	CRACKED	266.00	266.00
1	FRONT GRILLE LOGO	NECESSARY	42.00	42.00
2	HEADLAMPS @\$828.00	CRACKED	1,656.00	1,656.00
1	FRONT SUPPORT PANEL	TO REPAIR SEE LABOUR	380.00	-
1	AIR CON CONDENSER	NOT NECESSARY	1,100.00	-
	LESS 10% DISCOUNT		-	-342.80
			5,768.00	3,085.20
<u>SPECIAL NETT ITEMS</u>				
1	FRONT LICENCE PLATE W/HOLDER (SN)	BENT	80.00	40.00
1	BOL RADIATOR COOLANT (SN)	NOT NECESSARY	50.00	-

130.00	40.00
<u>LABOUR</u>				
	TO CHECK WIRING.		50.00	20.00
	TO SPRAY RUST PROOFING.	NOT NECESSARY	50.00	-
	TO REFILL AIR CON GAS.	NOT NECESSARY	120.00	-
	LABOUR FOR PANEL BEATING AND REPLACING PARTS.INCLUSIVE OF THE REPAIR OF FRONT SUPPORT PANEL.		600.00	300.00
	TO PUTTY AND SPRAY PAINTING.		680.00	450.00

RECOMMENDED COST OF LUMP SUM REPAIRS (TO ITS PRE-ACCIDENT CONDITION)			3,100.00
---	--	--	----------
