Insured Vehicle No	: SLR8585P		
TP Vehicle No	: GY1489C	Accident Date	: 28/12/2017
Make	: NISSAN URVAN	Assignment Date	: 02/01/2018
Date of Inspection	: 04/01/2018	Est. Duration of Repair	: 7.00
Inspection At	: AUTOBAY CAR SPRAY PAINTING CENTRE (HQ) 1 KAKI BUKIT AVENUE 6 #01-17, AUTOBAY @ KAKI BUKIT SINGAPORE 417883

The vehicle sustained impact / damages rear portion and parts claimed are consistent to the accident.

## VEHICLE DAMAGE INSPECTION REPORT

Our File No: CS/MSG18000087/AVBQ2

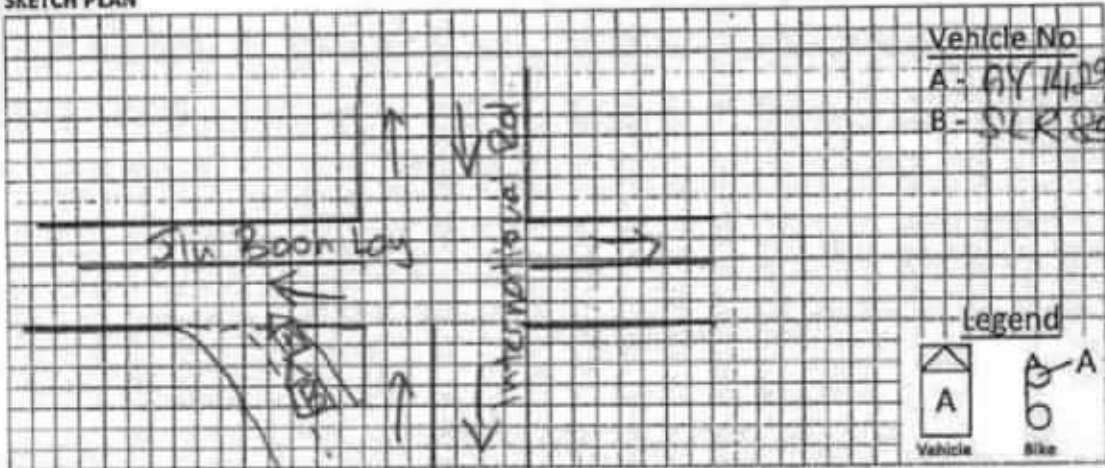
Sketch Plan #2

From International Rd turning left to Jln Boon Lay.  
 When I arrive at slip rd, before turning to Jln Boon Lay  
 I stop and check on coming vehicle suddenly the car  
 hit my car rear. Happen on 28.12.17 at 8:20 am.
