LKK Auto Consultants Pte Ltd

1. Policy Particulars :- THIRD PARTY CLAIM				
Insured Veh.	Veh. Inspected		SFL 325D	
Policy No.	Coverage (\$)		0.00	
Claim No.	Excess (\$)		0.00	
Assign From	Assign Date		02/01/2018

4. Description of Damages				
THE VEHICLE SUSTAINED DAMAGES AT THE REAR PORTION.				
DAMAGES SEE DETAILS.				
5. General Information				
Accident Date	27/12/2017	Inspection Date	02/01/2018	
Survey held at	FORTUNA MOTOR 40 UPPER EAST COAST ROAD SINGAPORE 455212			
5a. Remarks

ADJUSTMENT ON REPAIR COST FOR VEHICLE NO. SFL 325D

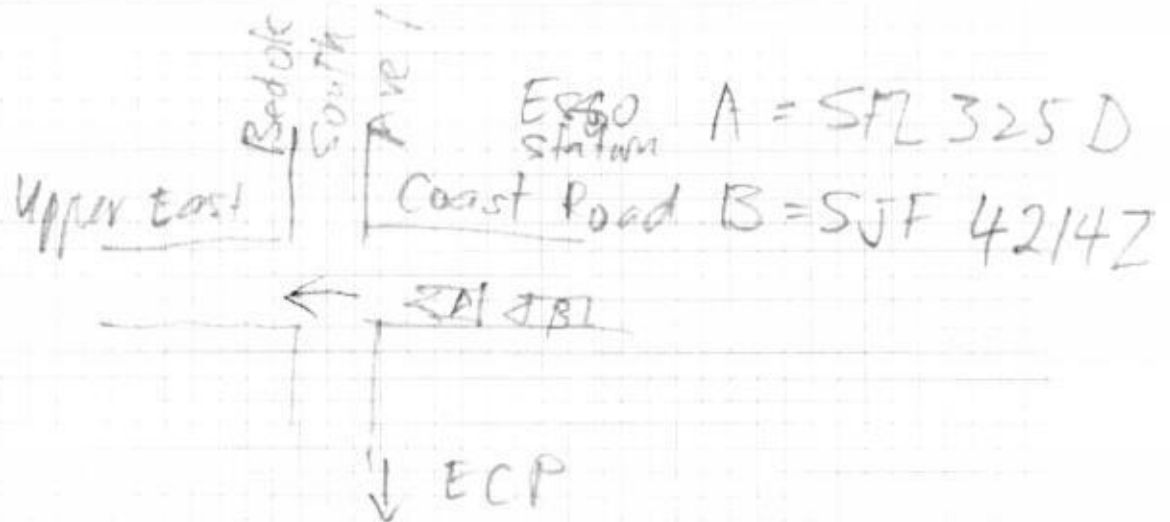
SKETCH PLAN

I was waiting at Junction of Upper East Coast Road and Bedok South Ave 1 to move West for traffic light to turn Green. My vehicle was stationary. The car at the back hit my back. Car number was SJF 4214Z. The date was 27 Dec 2017. Time about 1:30 pm.
