CS / TP18000180 / Aqbn2

Estimated repair cost for vehicle no: SKJ7136M TOYOTA ESTIMA AERAS 2.4 A '13

THE VEHICLE SUSTAINED DAMAGES AT THE FRONT N/S PORTION AND UNDERCARRIAGE.
DAMAGES SEE DETAILS.

ADJUSTMENT ON REPAIR COST FOR VEHICLE NO. SKJ 7136M

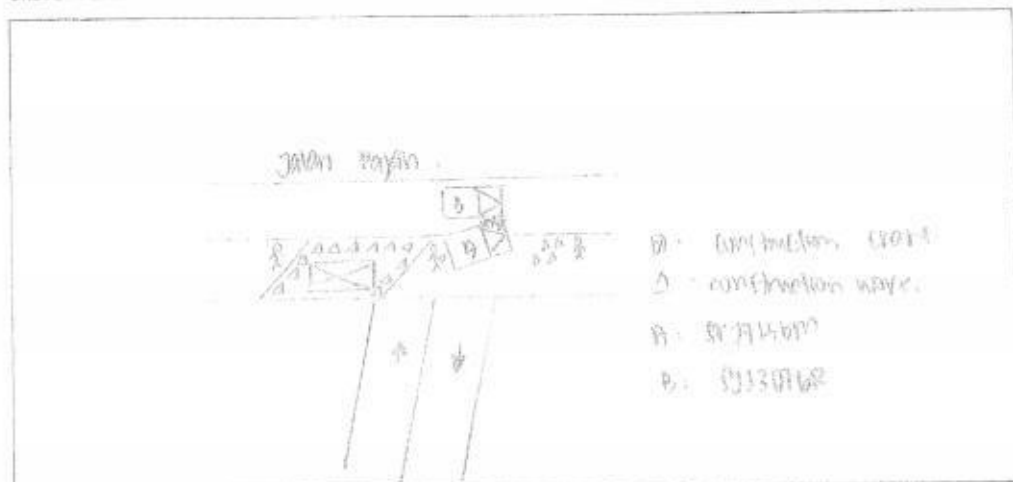
Sketch Plan #2 Pg. 1

I was exiting the carpark towards Jalan Rajah.
 There were construction work along Jalan Rajah with
 3 workers directing the traffic flow.
 One of the worker standing nearest to the carpark exit
 did not asked to stop thus I proceeded to turn towards
 Jalan Rajah.
 Suddenly, vehicle B came from my left and we collided.
 After the accident, driver B told me that it was a "Go"
 signage shown by the worker thus she did not stop.
