PRELIMINARY ADVICE OF VEHICLE NO. SLF 2119E

Pre-Repair Survey (PRS) Acknowledgement

ADJUSTMENT ON REPAIR COST FOR VEHICLE NO. SLF 2119E

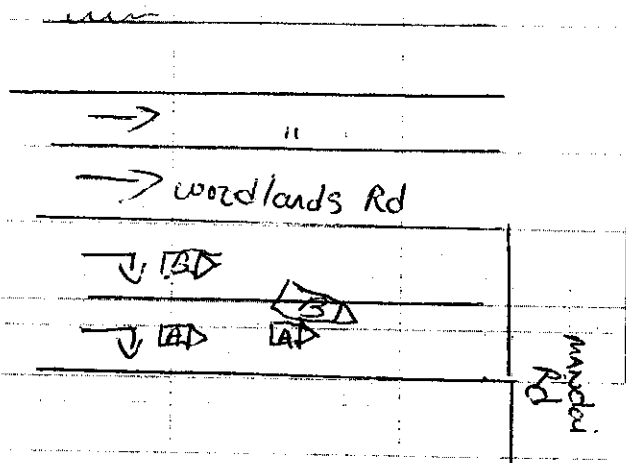
SKETCH PLAN

I was driving along woodlands Road towards Marsden Road. I was in the right turning lane and the lorry was in the left lane. Suddenly came into my lane and hit left side of my car.
