Estimated Cost: \_\_\_\_\_ Bill to: \_\_\_\_\_  
OD / TP / WS / TP RES / OD RES / EVA / EV / MV / CS  
To Inspect Vehicle No: SJD 5419D Insured: SJC 9883A  
at Workshop m/s: Loh Heng Tel: 6453 2737  
of 176 Sin Ming Drive #03-08  
Policy No: 28888306TMP Claim No: 545754  
Sum Insured: \_\_\_\_\_ Excess: \_\_\_\_\_  
Make of Veh: \_\_\_\_\_ D.O.A. 31.12.2017  
(Client's Record)  
CA / REV / REP. / REV 24 HRS 'wpi' H.O.D. Endorsement: \_\_\_\_\_  
Date/Time: 03012018 11:20am Person Contacted: Danny Vehicle: EXPLOUT  
Date/Time: \_\_\_\_\_ Action/Instruction (✓) Estimate: \_\_\_\_\_  
SJD 5419D x

## SINGAPORE ACCIDENT STATEMENT

## VEHICLE DAMAGE INSPECTION REPORT

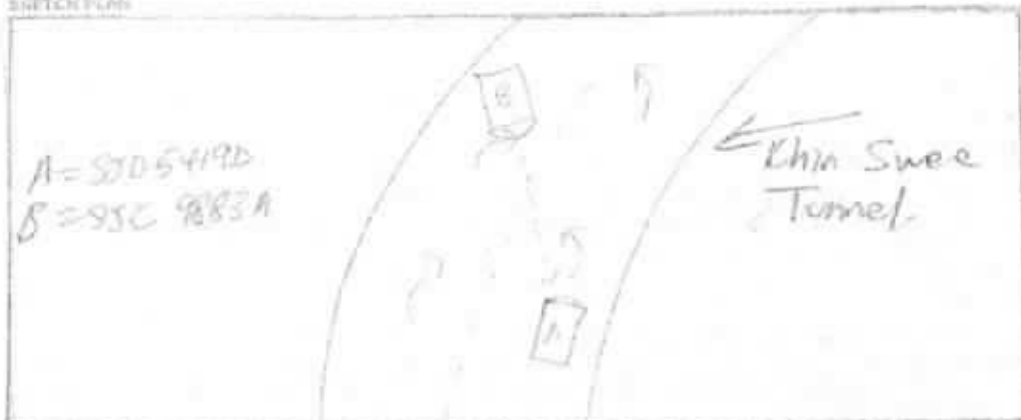
## SKETCH PLAN

DOA: 31/12/2017. 1.00p.m Chin Swee Tunnel (Bani) CTE tunnel  
bicycle SLE/TPR. Weather condition: Roads were wet but it  
was not raining.

I was driving into the tunnel behind the car that  
caused the accident when he overtook a truck instant  
at the back going into the tunnel. He was travelling out  
about 70-80km/h when he lost control and skidded.  
He hit the walls of the tunnel on both sides. The  
truck stopped in time and managed to move out of  
the way of the car. I came to a stop to see what  
the car would do but the truck blocked my view. The  
car went off their skid mark was facing the traffic but  
after the truck moved out of the way, the car accelerated  
and he smashed into the front left of my car.

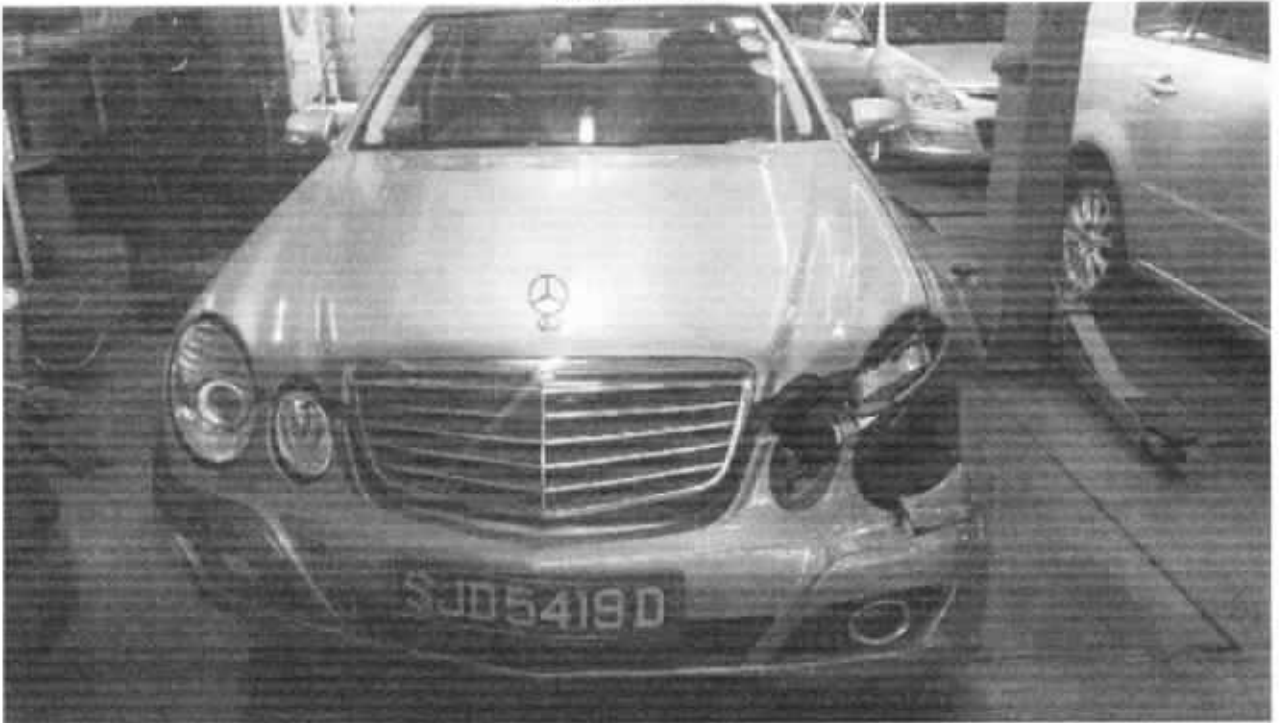
Accident Photo

The UIC / Chassis frame / Body Structure affected due to collision.

In view of the above, the vehicle is uneconomical to be repaired, you are advised to invite tender for the wreck.

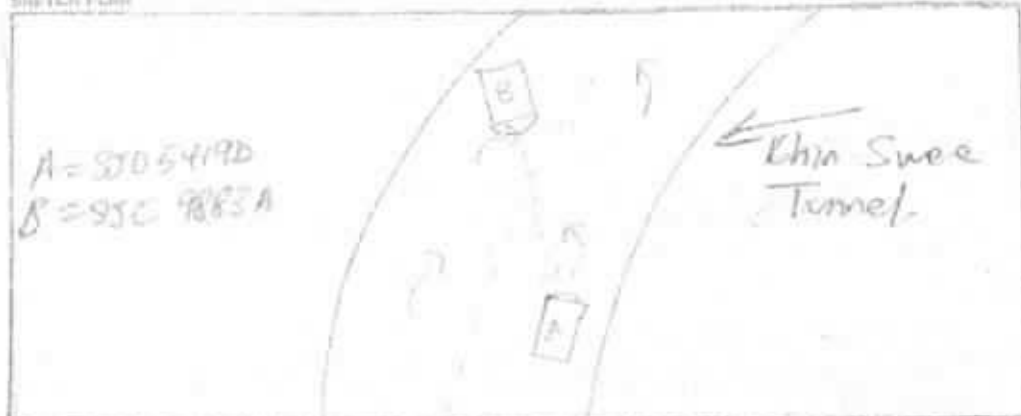
## SKETCH PLAN

DOA: 31/12/2017, 1:00 p.m. Collin Swee Tunnel 'Pinn'. CDE family  
towards SLE/TPR. Weather condition: Roads were wet but it  
was not raining.

I was driving into the tunnel behind the car that  
caused the accident when he overtook a truck instant  
at the head going into the tunnel. He was travelling at  
about 70-80 km/h when he lost control and skidded.  
He hit the walls of the tunnel on both sides. The  
truck stopped in time and managed to move out of  
the way of the car. I came to a stop to see what  
the car would do but the truck blocked my view. The  
car was if that skid back was facing the truck but  
after the truck moved out of the way, the car accelerated  
and he smashed into the front left of my car.
