# LKK Auto Consultants Pte Ltd

Ref : CC6/III18000331/Ahs3

## 1. Policy Particulars :- THIRD PARTY CLAIM

## VEHICLE DAMAGE INSPECTION REPORT

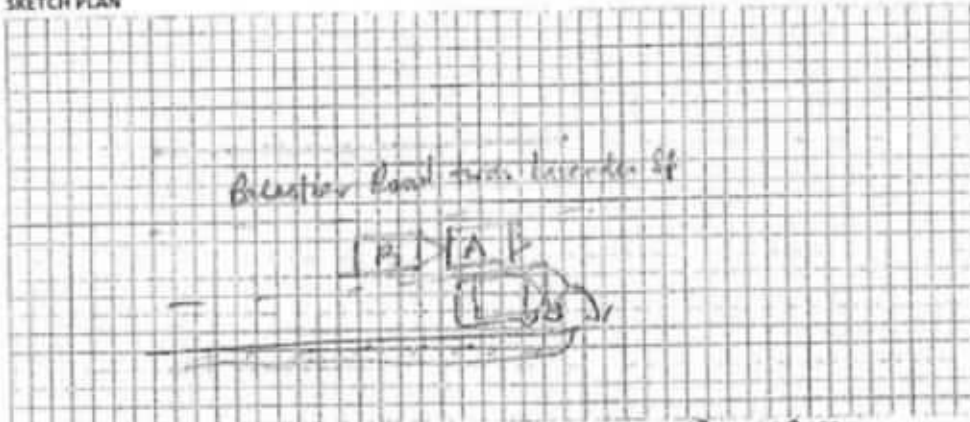
## SKETCH PLAN

DESCRIBE CIRCUMSTANCES OF THE ACCIDENT A) SHB4335C B) SJS80A

As I was driving from Balestier Road towards Lander Street direction a car SJS 5830A hit my cab from the rear driven by Mr Tan. I hit my cab from the rear. There was 2 passengers in my cab during this time. There was no visible injury but they requested me to drive them to Tan Tock Seng Hospital for a check up.

It was observed that Insured vehicle had slowed down and stopped with signal lights on to make a right turn from the middle lane as there was another vehicle that would like to make a right turn at the left most lane when rear-ended by TP vehicle.

We are of the opinion that TP failed to maintain safety distance and proper lookout to the vehicles in front.
