To inspect Vehicle No: EC 60 B

Affiliated to Federation Internationale Des Experts En Automobile				
MSG INSURANCE (SINGAPORE) PTE LTD			Ref : CS/MSG18000564/Ktd3	
16 RAFFLES QUAY #24-01 HONG LEONG BLDG SINGAPORE 048581			Date : 09-01-2018	 
Code : MSG

ESTIMATE FOR VEHICLE NO. : EC60B

VEHICLE DAMAGE INSPECTION REPORT

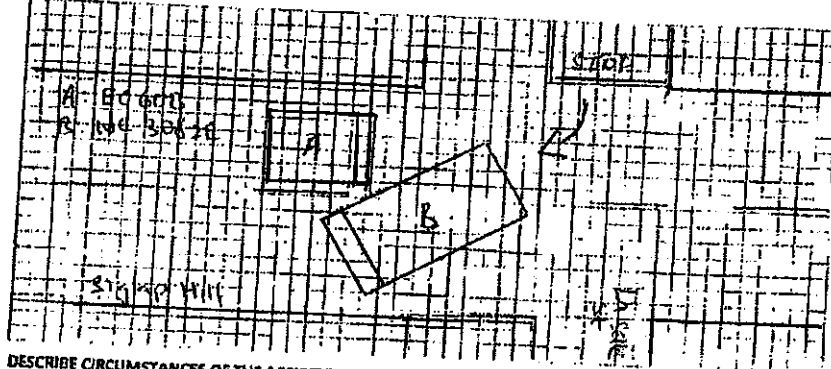
SKETCH PLAN

DESCRIBE CIRCUMSTANCES OF THE ACCIDENT

On 6/1/18 at 14.43h, I was driving along Singapore Hill. Weather was sunny and clear. As I approached the junction of LaSalle Street and Singapore Hill, I noticed a cement mixer coming down the LaSalle Street. It was moving and did not stop at the stop line.

I applied emergency brake and sounded the horn continuously immediately (Refer to audio audio/video clip). The cement mixer MC 3082E driven by Mr. Paragaran continued to move and turn right. The truck failed to stop until it collided against the front right end of my vehicle, which was stationary.
