ASSIGNMENT

1. Policy Particulars - THIRD PARTY CLAIM				
Insured Veh.	GT 4929G	Veh. Inspected	SHC 4740K	
Policy No.	5038126247-08	Coverage (\$)	0.00	
Claim No.		Excess (\$)	0.00	
Assign From		Assign Date	09/01/2018

4. Description of Damages				
THE VEHICLE SUSTAINED DAMAGES AT THE O/S BODY. DAMAGES SEE DETAILS.				
5. General Information				
Accident Date	08/01/2018	Inspection Date	09/01/2018	
Survey held at	SMRT AUTOMOTIVE SERVICES PTE LTD 60 WOODLANDS INDUSTRIAL PARK E4 SINGAPORE 757705			
5a. Remarks				
A)THE INSPECTION WAS CONDUCTED ON A"WITHOUT PREJUDICE" BASIS. B)IN ACCORDANCE TO YOUR INSTRUCTIONS, WE HAVE NOT AUTHORISED REPAIRS.				
5b. Estimate Days of Repair				
ESTIMATED NORMAL PERIOD FOR REPAIR:		5 Working Days

ADJUSTMENT ON REPAIR COST FOR VEHICLE NO. SHC 4740K

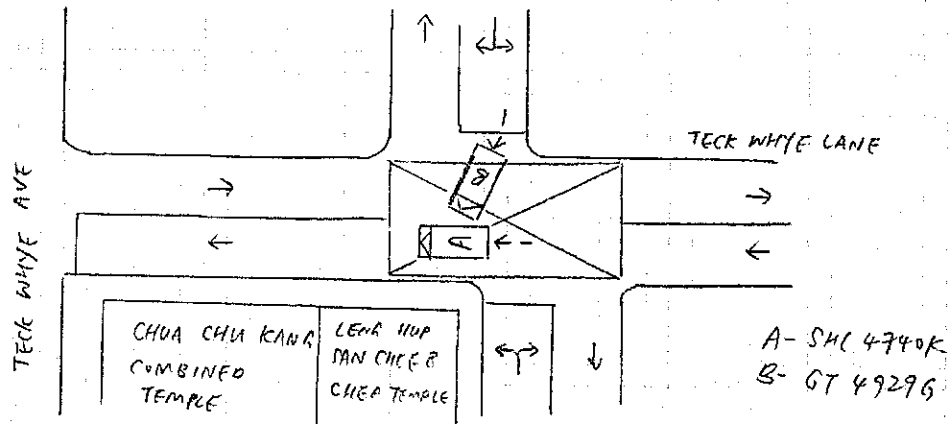
SKETCH PLAN

I WAS TRAVELLING STRAIGHT ALONG TECK WHYE LANE WITH A PASSENGER ON BOARD WHEN THE VEHICLE GT4929G SUDDENLY DASHED OUT OF THE CAR PARK EXIT AND COLLIDED ONTO THE RIGHT PORTION OF MY TAXI.

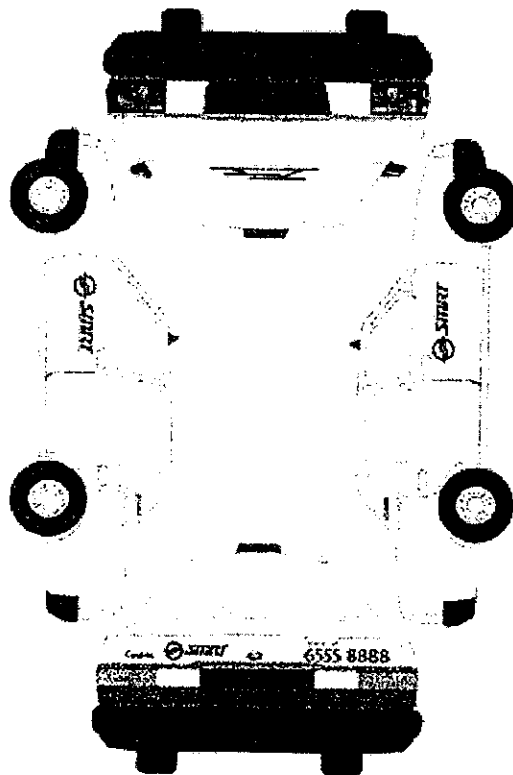
Reg. No : SHC4740K
Ref. No : TAX/01/18/2041
Reg. Date : 22/01/2016
Vehicle Type : TAXI
Make : TOYOTA PRIUS
Model : PRIUS
Name of Driver : NG WEI TECK COLLIN
Type of Accident : HEAD TO SIDE
Date / Time of Accident : 08/01/2018 10:30:00 AM
Accident Reported Date / Time : 08/01/2018 12:00:00 AM
Surveyor is Required? : Yes
Survey by : Sebastian
Vehicle is Towed Back? : No
Towed Back Date/Time :
Replacement Vehicle issued? : No
Accident Repair Job Card No : 000024093979
Special Instruction to ARC, if any :
GT4929G NTUC P/P
Prepared Date : 08/01/2018 02:01:39 PM

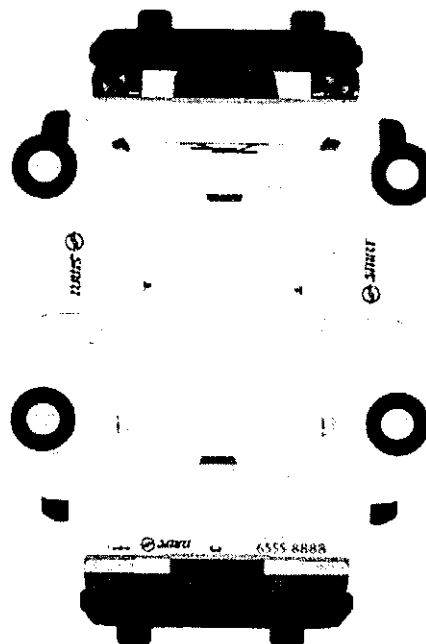
- Part by part repair.
- Question Mark Item Photo
- Photo Before Paint

- To resurvey before/after spray painting
- To display damaged part(s) during resurvey
- Parts prices are subject to confirmation
- Third party survey is on a "Without Prejudice" basis
- No illegal modification(s) is allowed
- Supplementary item(s) must be resurveyed and is subject to final approval from Insurance Company
