SLH 430H

SJE 3769B

### **ACCIDENT INVOLVING SLH 430H(AIG) & SJE 3769B ON 04/01/2018**

## VEHICLE DAMAGE INSPECTION REPORT

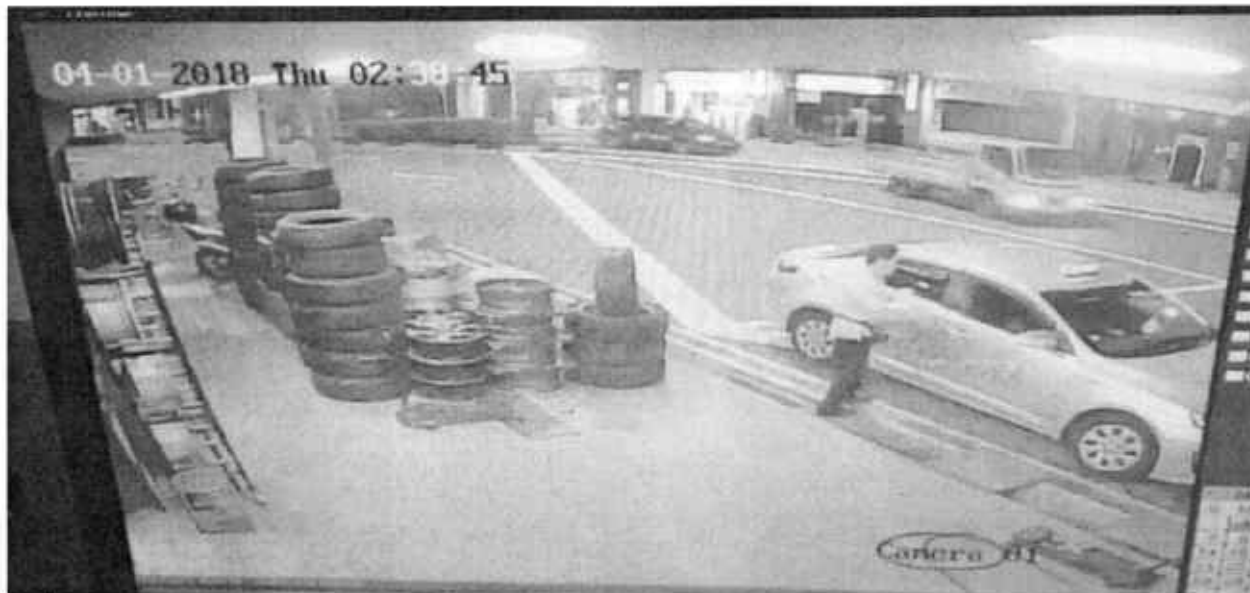
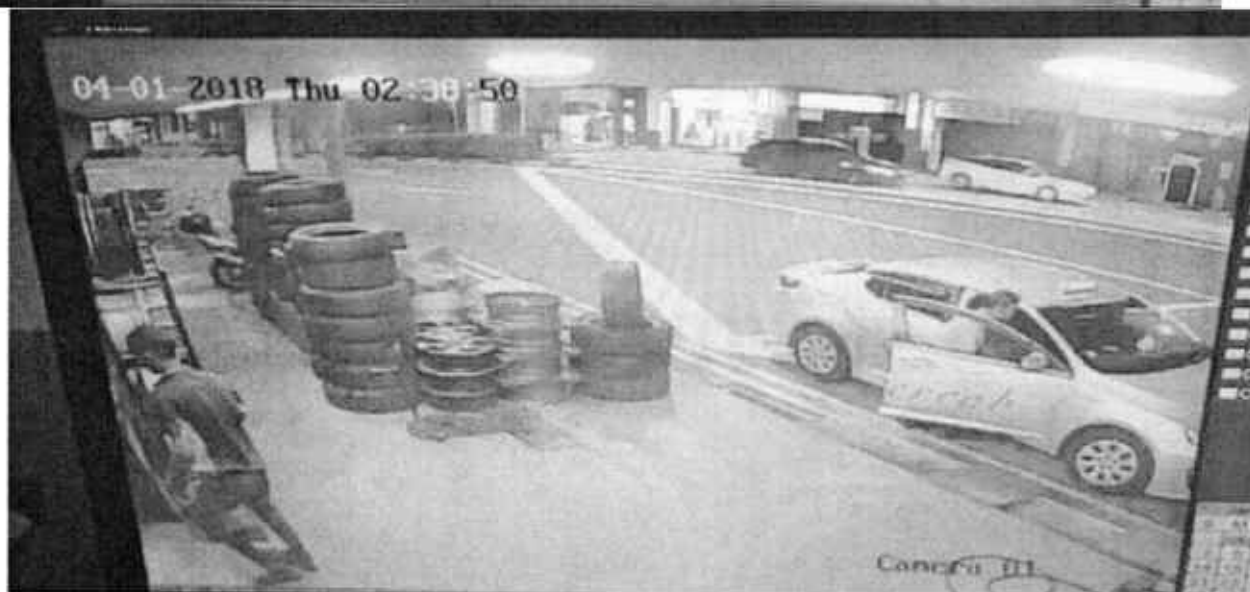
We append herewith two snapshots for comparison: (Left) a vehicle which was travelling along lane meant for right turning only and (Right) your client's vehicle (in black) at all material time.

Judging from the distance between both vehicles and the center white line, it was clear that your client was travelling along the lane meant for right turning only, and not along the lane meant for going straight and right turning as she alleged, at all material time. Also, in your client's accident report, she stated that she has stopped her vehicle at the traffic junction and suddenly our insured's vehicle side-swiped her vehicle, which was again, inconsistent with what the video footage has shown.

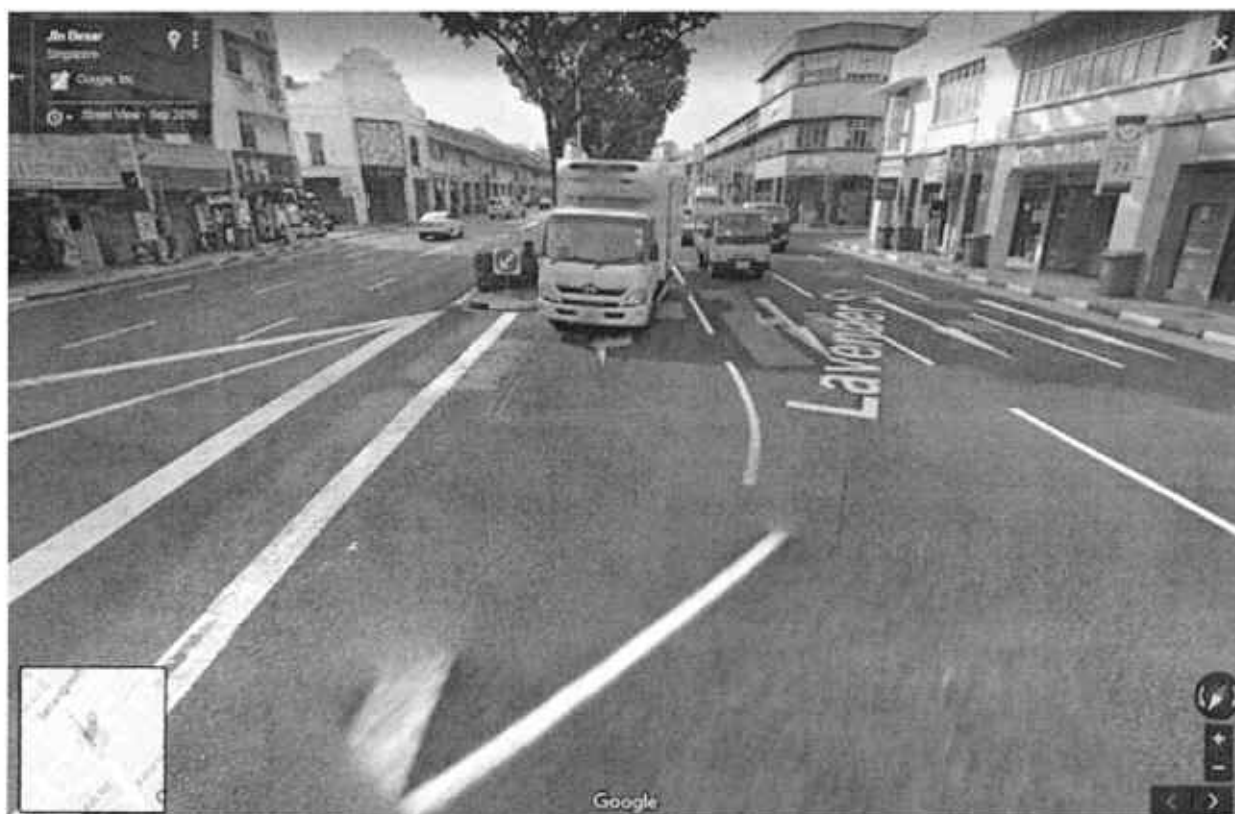
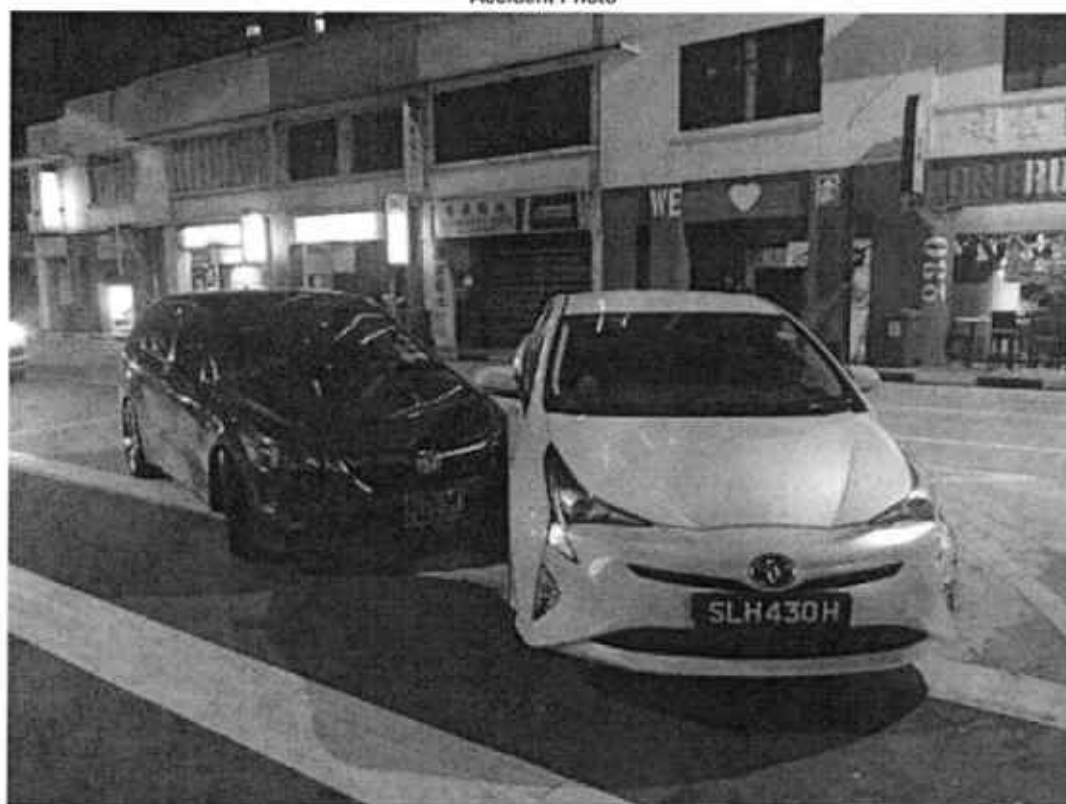
Accident Photo

We append herewith the photo of the accident site (on the left) and photograph taken right after the accident (on the right). As you can see from the photo of the accident site, the travelling lane in which our insured's vehicle was travelling within was meant for going straight as well as turning right, while the photo taken right after the accident clearly showed that our insured's vehicle was travelling within his travelling lane.

In view of the above, your client, who had encroached into our insured's travelling path at all material time, was the proximate cause of the said accident, and thus we are unable to consider her injury claim.
