Front O/S

Affiliated to Federation Internationale Des Experts En Automobile			
TOKIO MARINE INSURANCE SINGAPORE LTD		Ref : CS/TMI18000833/K1qb	
20 MCCALLUM STREET #09-01 TOKIO MARINE CENTRESINGAPORE 069046		Date : 15-01-2018	
		Code : TMI

1. Policy Particulars :- THIRD PARTY CLAIM			
Insured Veh.	SKU 6621C	Veh. Inspected	SHC 8223K
Policy No.	MW007197	Coverage (\$)	0.00
Claim No.	M1800253	Excess (\$)	0.00
Assign From	MERIMEN (FIONA GAN)	Assign Date	15/01/2018

VEHICLE DAMAGE INSPECTION REPORT

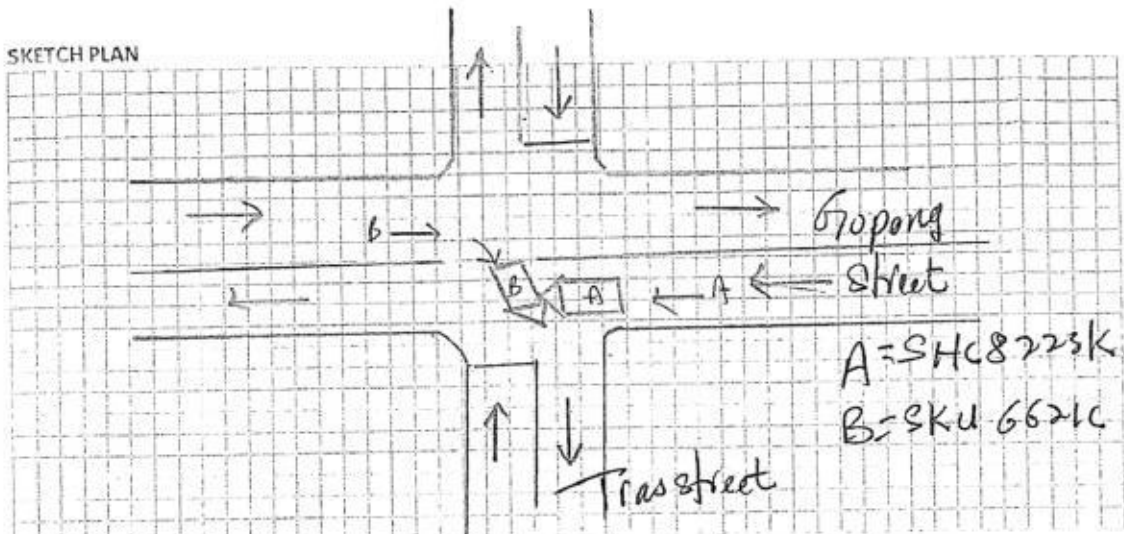
SKETCH PLAN

Type Of Accident	COLLISION - HEAD TO REAR
Weather Conditions	DRIZZLING
Road Surface	WET

I was driving straight on gopeng street. Suddenly the other party car on a two way traffic make a sudden right turn into tras street. I apply brake but unable to stop in time and collided onto the car.
video evidence available

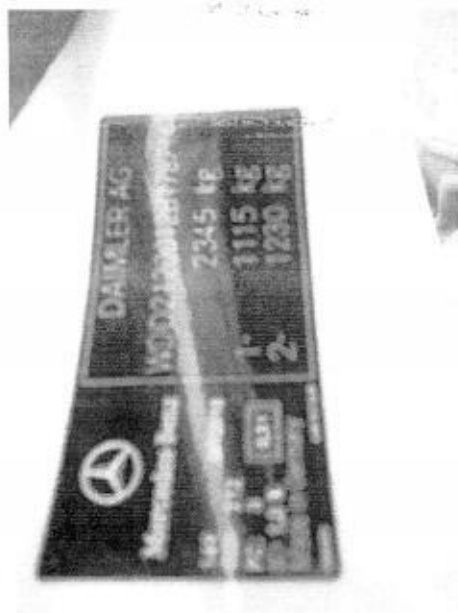
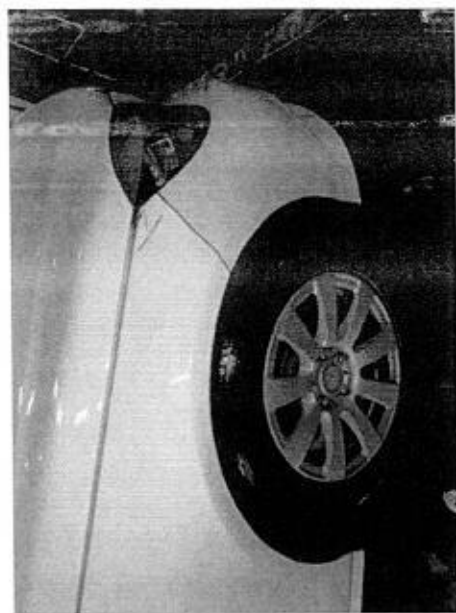
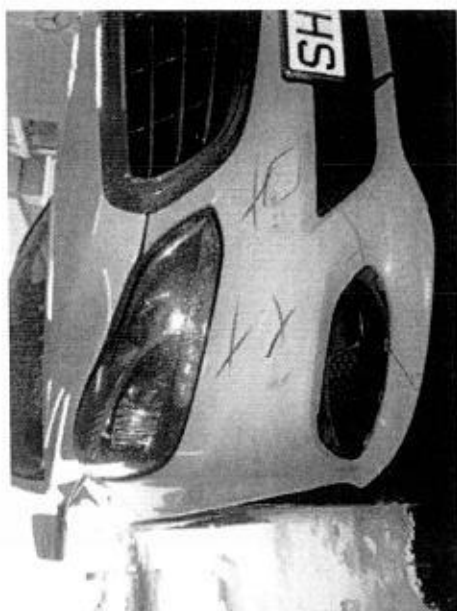
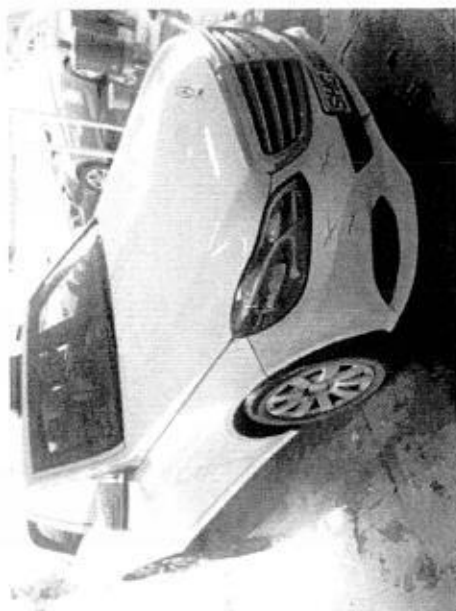
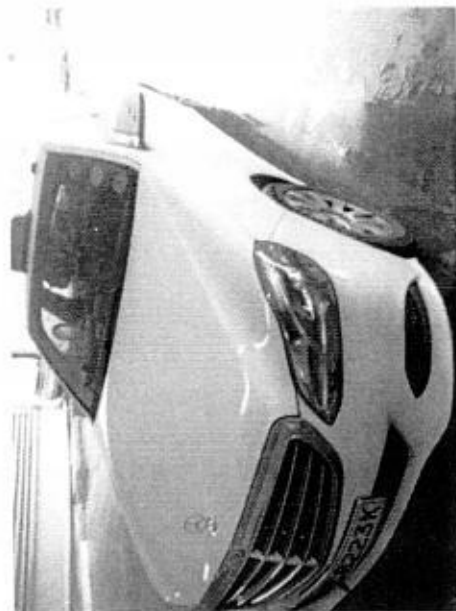
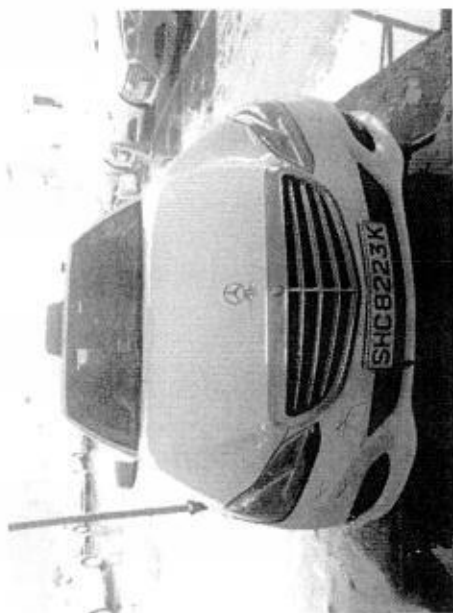
The U/C / Chassis frame / Body Structure affected due to collision

No.	Qty	Part No.	Particulars	Condition	Repairer's	Amount
1	1		*FRONT BUUMPER	Deformed	1,890.50 FL	*1,890.50 FL
2	1		*FRONT BUUMPER REINFORCEMENT	Serviceable	1,158.00 FL	*- FL
3	1		*FRONT BUUMPER BRACKET - RH	Serviceable	95.00 FL	*- FL
4	1		*FRONT BUUMPER ABSORBER	Serviceable	207.00 FL	*- FL
5	1		*FRONT BUUMPER SIDE BEAM - RH	Serviceable	26.90 FL	*- FL
6	1		*FRONT BUUMPER SPONGE - RH	Serviceable	250.00 FL	*- FL
7	1		*FRONT BUUMPER TOWING COVER	Repair	62.50 FL	*- FL
8	1		*HEADLAMP - RH	Cracked	2,380.00 FL	*2,380.00 FL
9	1		*HEADLAMP BRACKET - RH	Serviceable	300.00 FL	*- FL
10	1		*HEADLAMP PANEL - RH	Repair	480.00 FL	*- FL
11	1		*FRONT BUMPER GRILLE - RH	Bent	290.50 FL	*290.50 FL
Supplementary #1						
12	1		*Radiator Grille	Cracked	1,220.00 FL	*1,220.00 FL

No	Particulars	Lab.Type	Repairer's	Amount
<u>Labour Items</u>				
1	PANEL BEATING	New	400.00	200.00
2	SPRAY PAINTING	New	300.00	200.00
3	WIRING CHARGE	New	50.00	20.00
Gross Labour Cost (\$\$)			750.00	420.00
