CS/TMU8000958/KVbe2

SHD 6928T

Affiliated to Federation Internationale Des Experts En Automobile				
TOKIO MARINE INSURANCE SINGAPORE LTD			Ref : CS/TMI18000958/K1vb	
20 MCCALLUM STREET #09-01 TOKIO MARINE CENTRESINGAPORE 069046			Date : 16-01-2018

## VEHICLE DAMAGE INSPECTION REPORT

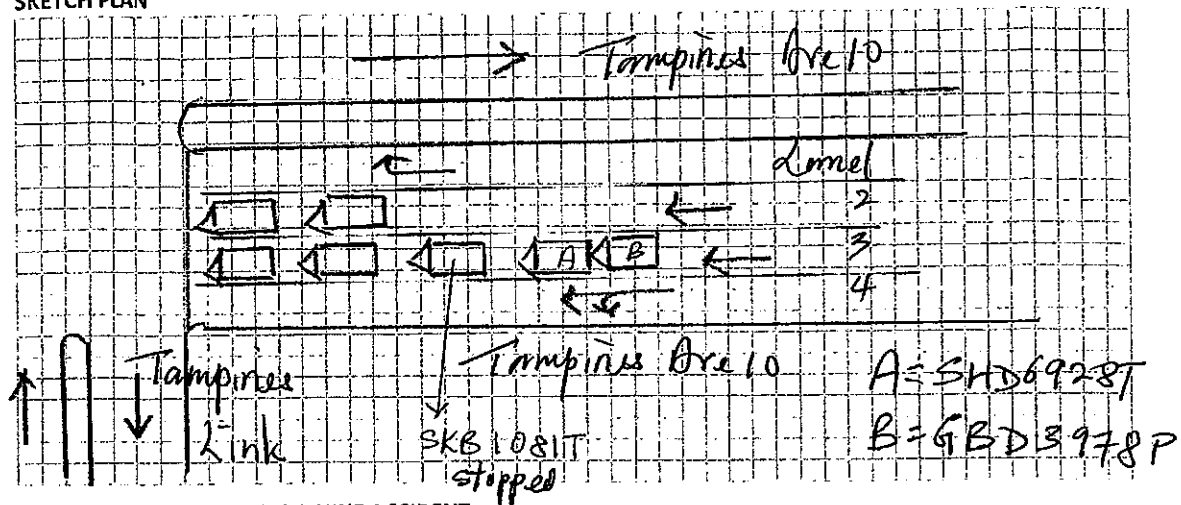
## SKETCH PLAN

As seen in the video footage, while I stopped behind a private car on Tampines Ave 10 as it was already red light ahead at Tampines Link junction, I felt a sudden impact when it was vehicle B (GBD 3978P) behind that hit into the rear of my taxi. I took photos at the scene following the accident. The impact caused damage to my taxi. Vehicle B was a van and its front sustained dents. No passengers in my taxi at the time of accident.
