REF: CS/CTI18001120/Gvd3n2

Vehicle No	: GBF1158S	Accident Date	: 15/01/2018
Make	: NISSAN NV350	Policy No.	: DMCVSN1642021701
Assignment Date	: 17/01/2018	Excess	: S\$500.00
Date of Inspection	: 22/01/2018	Est. Duration of Repair	: 7.00
Inspection At	: MCWELL VENTURES PTE LTD (HQ) 51 UBI AVE 1, #01-05 PAYA UBI INDUSTRIAL PARK SINGAPORE 408933

ESTIMATE COST OF REPAIRS TO VEHICLE GBF1158S.

## VEHICLE DAMAGE INSPECTION REPORT

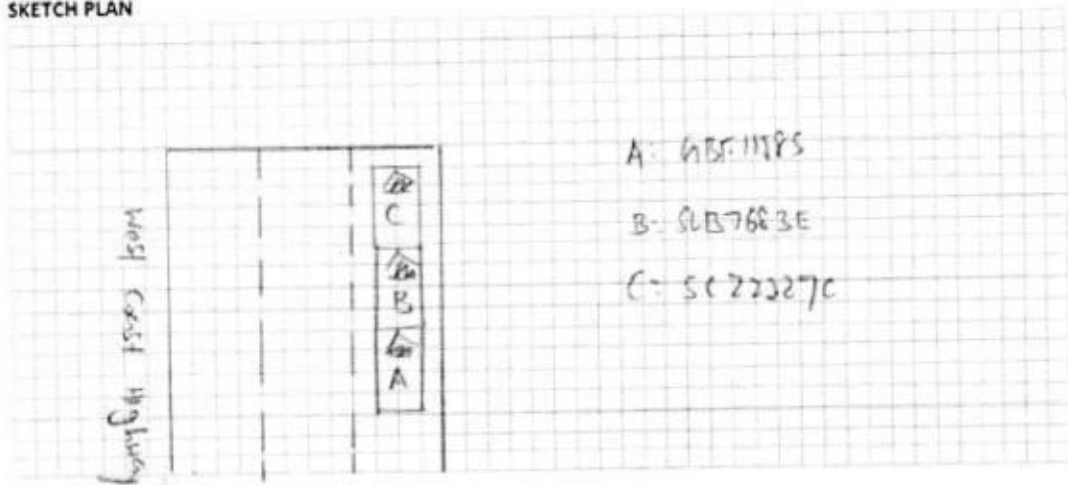
## SKETCH PLAN

On 15/12 17:45 I was travelling along W coast Highway towards Harbourfront. Suddenly vehicle C step on the break of his vehicle. In a result, vehicle B couldn't break in time and hit onto vehicle C rear portion. In a same way, I couldn't break my vehicle and hit onto vehicle B rear portion.

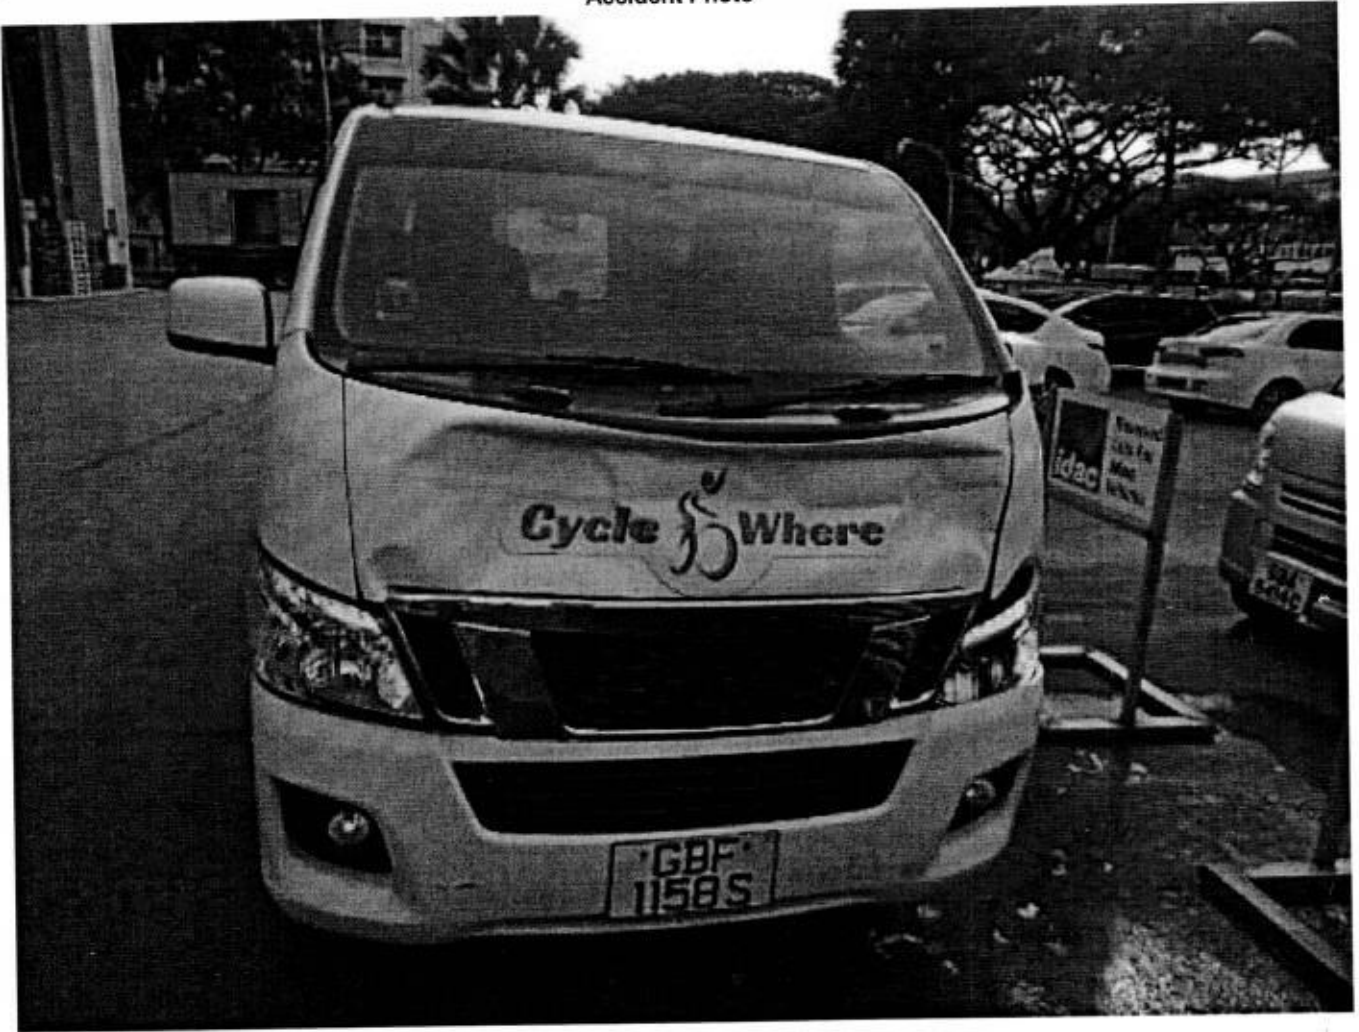
Accident Photo

The vehicle sustained impact / damages front portion and parts claimed are consistent to the accident.
