REF CS/MSIG/18001181/Kvd3c2

The vehicle sustained impact / damages n/s front portion and undercarriage and parts claimed are consistent to the accident.

## VEHICLE DAMAGE INSPECTION REPORT

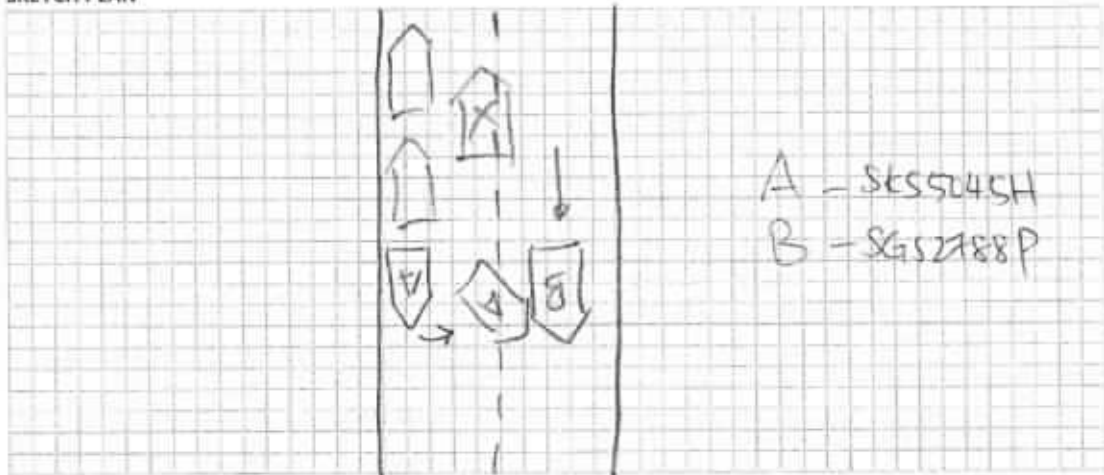
SKETCH PLAN

I was parked along the single white line two lane road outside VIC Centre, perpendicular to Union Street. As I was driving out, and turning left, a car driving straight bang into me. There was a van parked illegally that block both car views, creating a blind spot.

The vehicle that bang into me (SG52788P) came out of the car, citing that he was distracted looking for his grab passenger as the road in front of VIC building cannot be found in google map, thus, he has to physically check out the building premise while driving. This was heard and witness by building security guard ~~Lee~~ Grand (tel: 93736349). He also stated that the van was blocking his view.
