**Preliminary Advice**

Vehicle No	: SKQ5196R	Accident Date	: 09/01/2018
Make	: PEUGEOT 308	Policy No.	: DMPCSN1737761700
Assignment Date	: 18/01/2018	Excess	: S\$500.00
Date of Inspection	: 19/01/2018	Est. Duration of Repair	: 0.00
Inspection At	: CHENG AUTO BODYWORKS (HQ) 5 SOON LEE STREET #01-62 PIONEER POINT SINGAPORE 627607

## VEHICLE DAMAGE INSPECTION REPORT

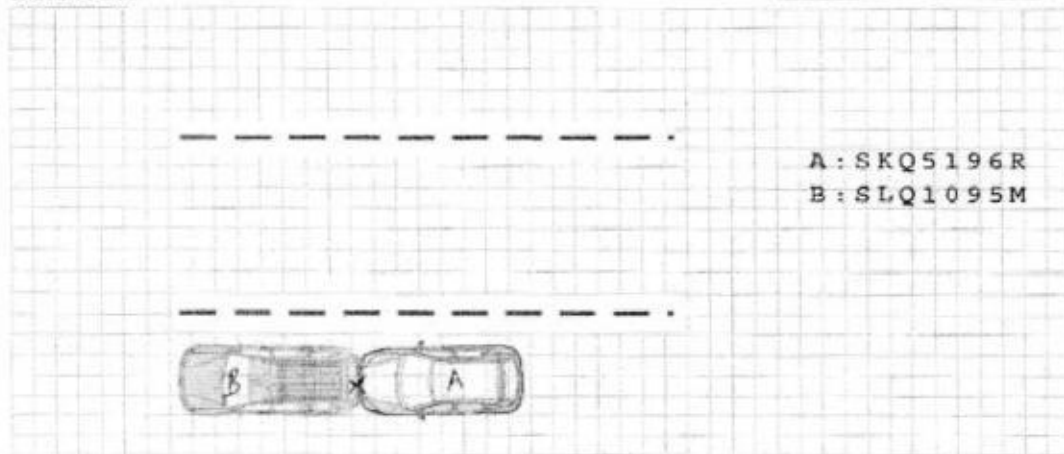
## SKETCH PLAN

Please refer to police report T/20180110/2066.

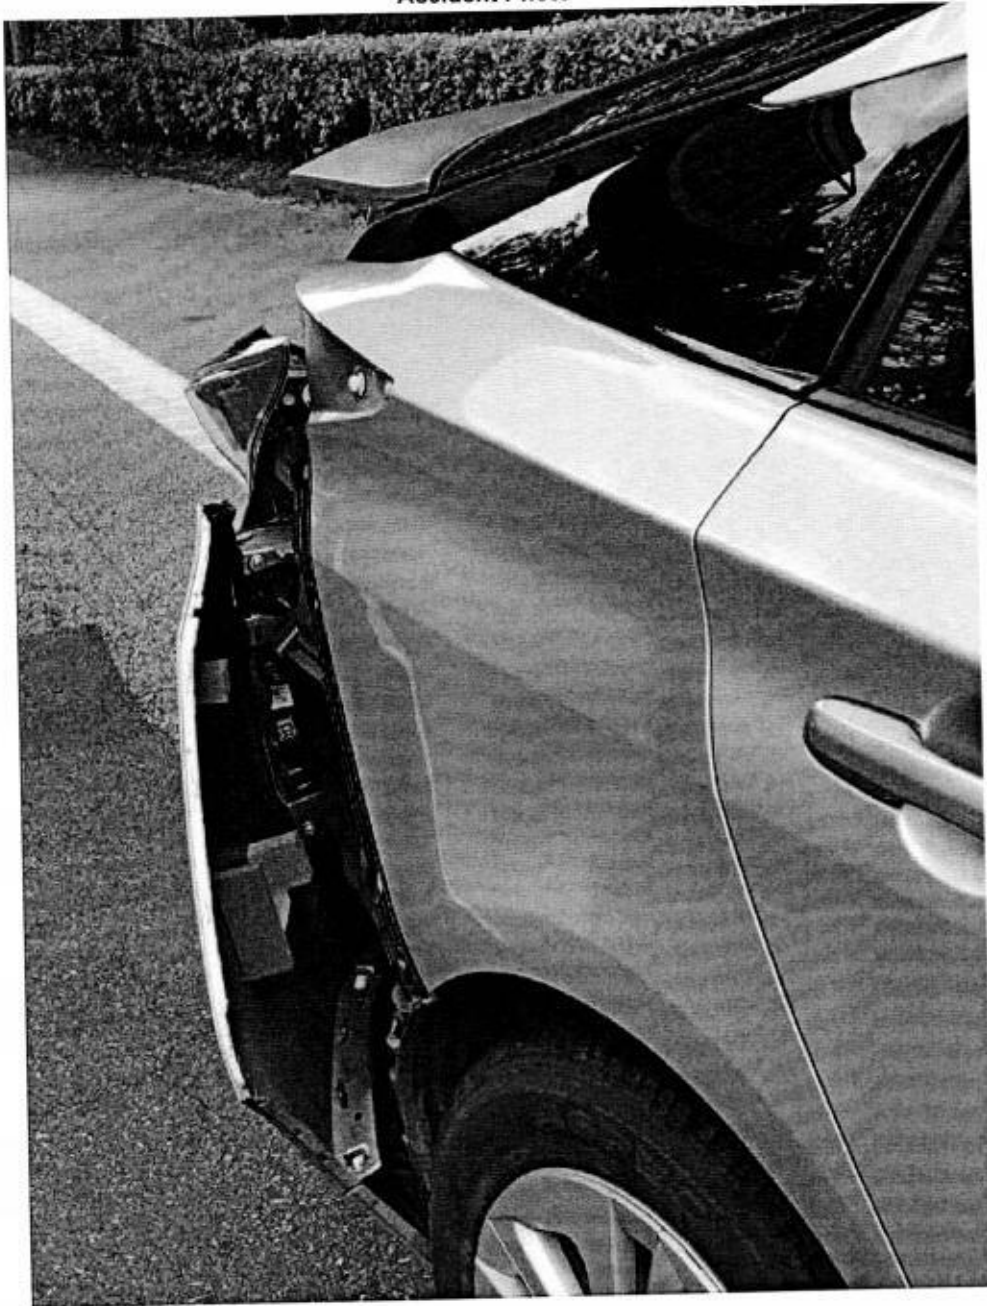
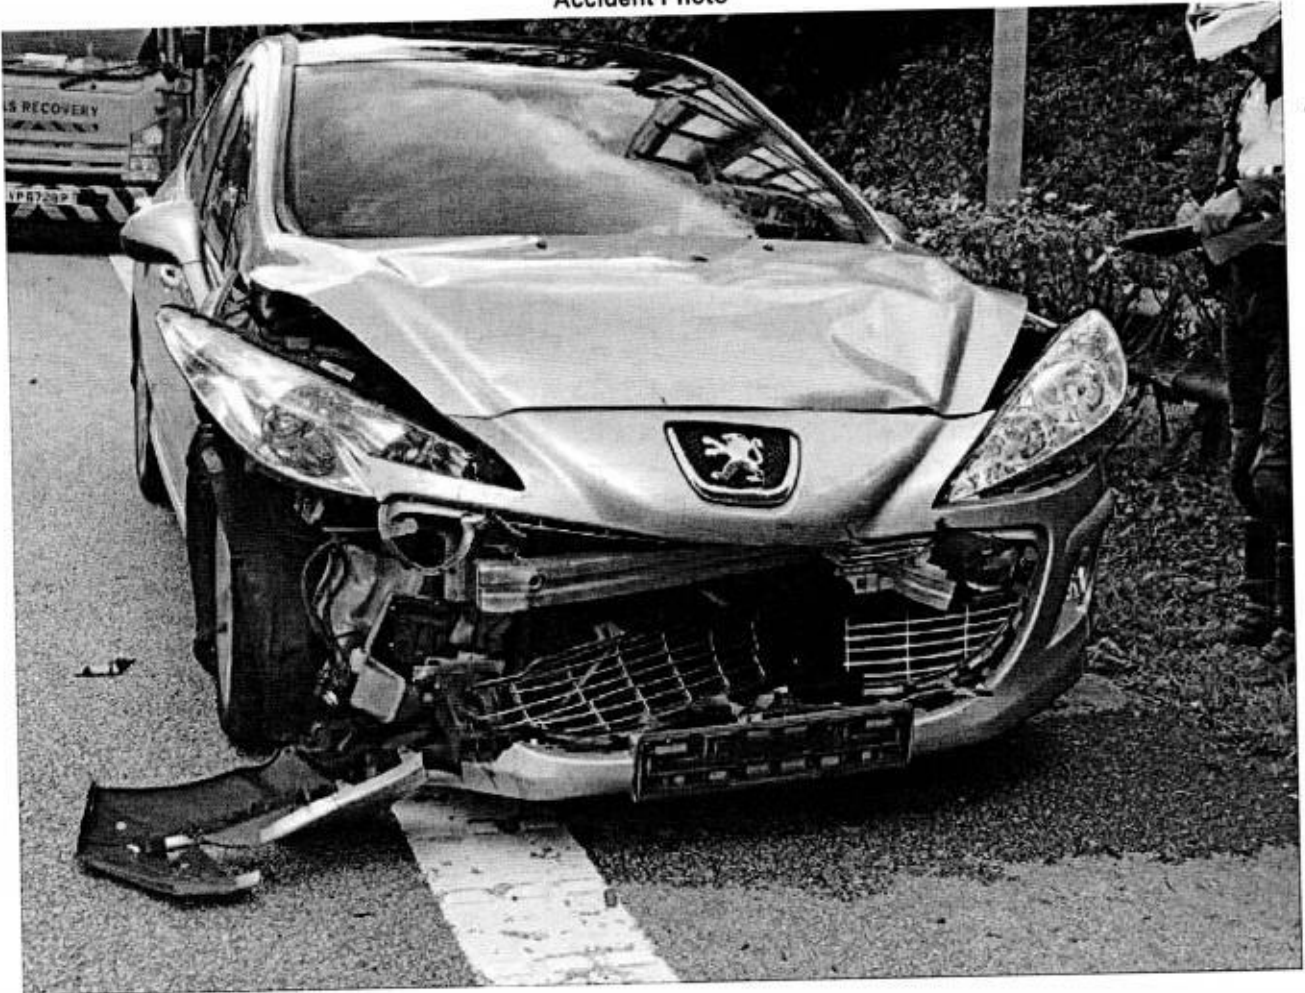
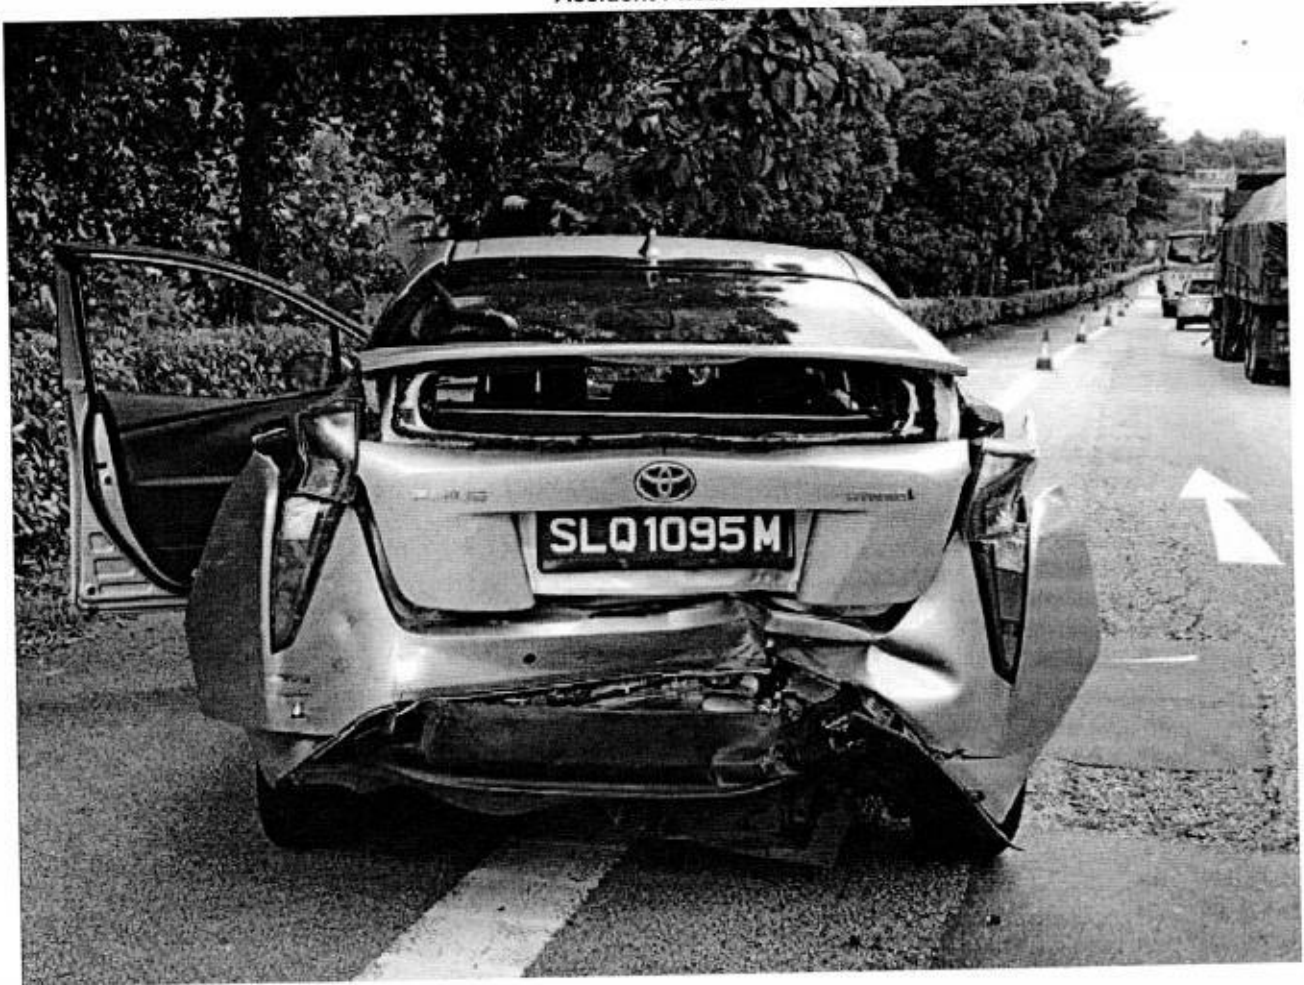
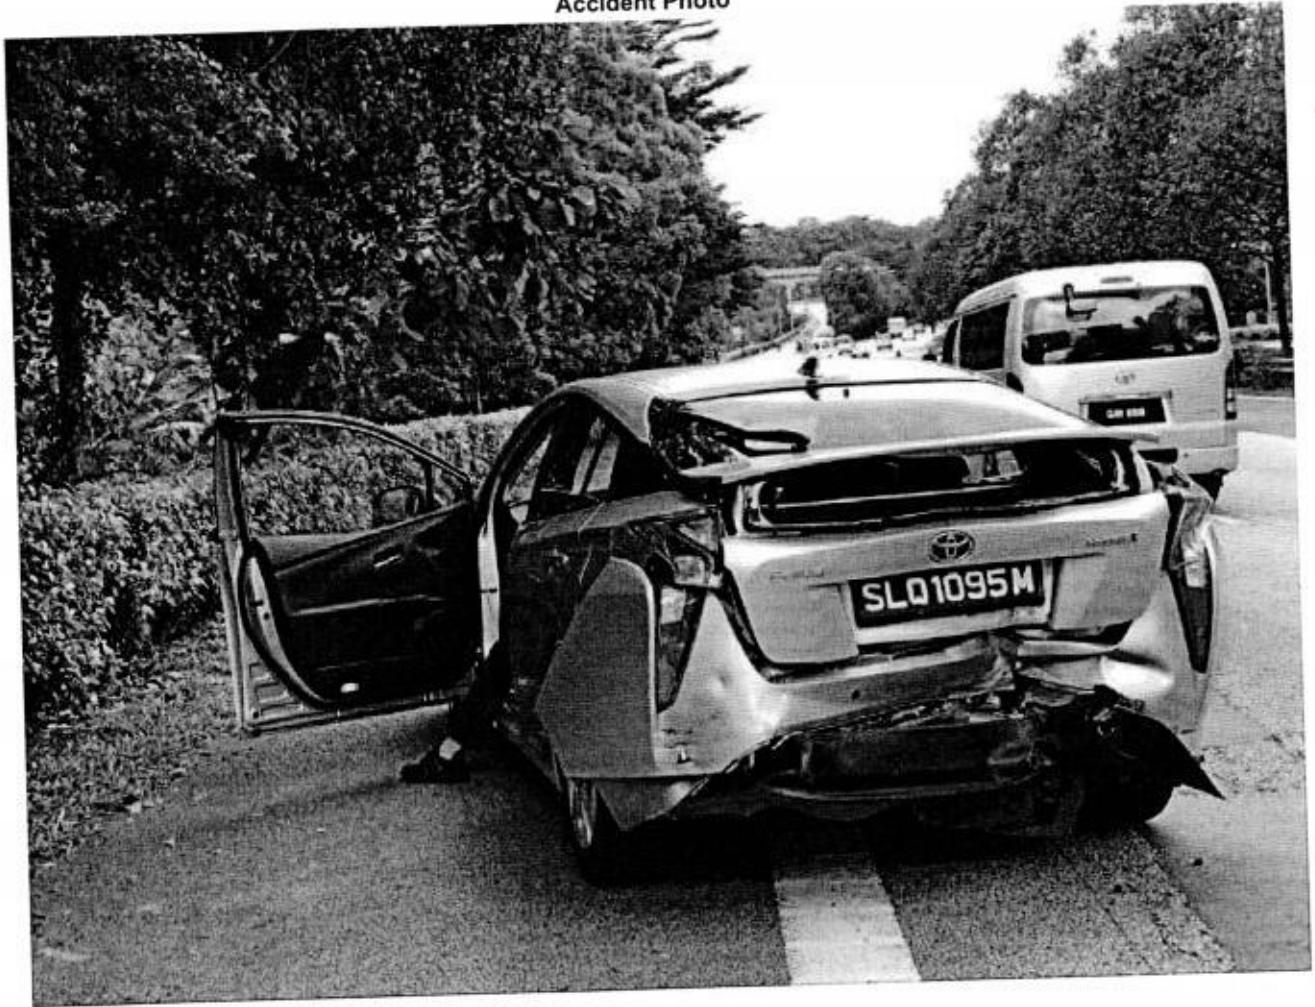
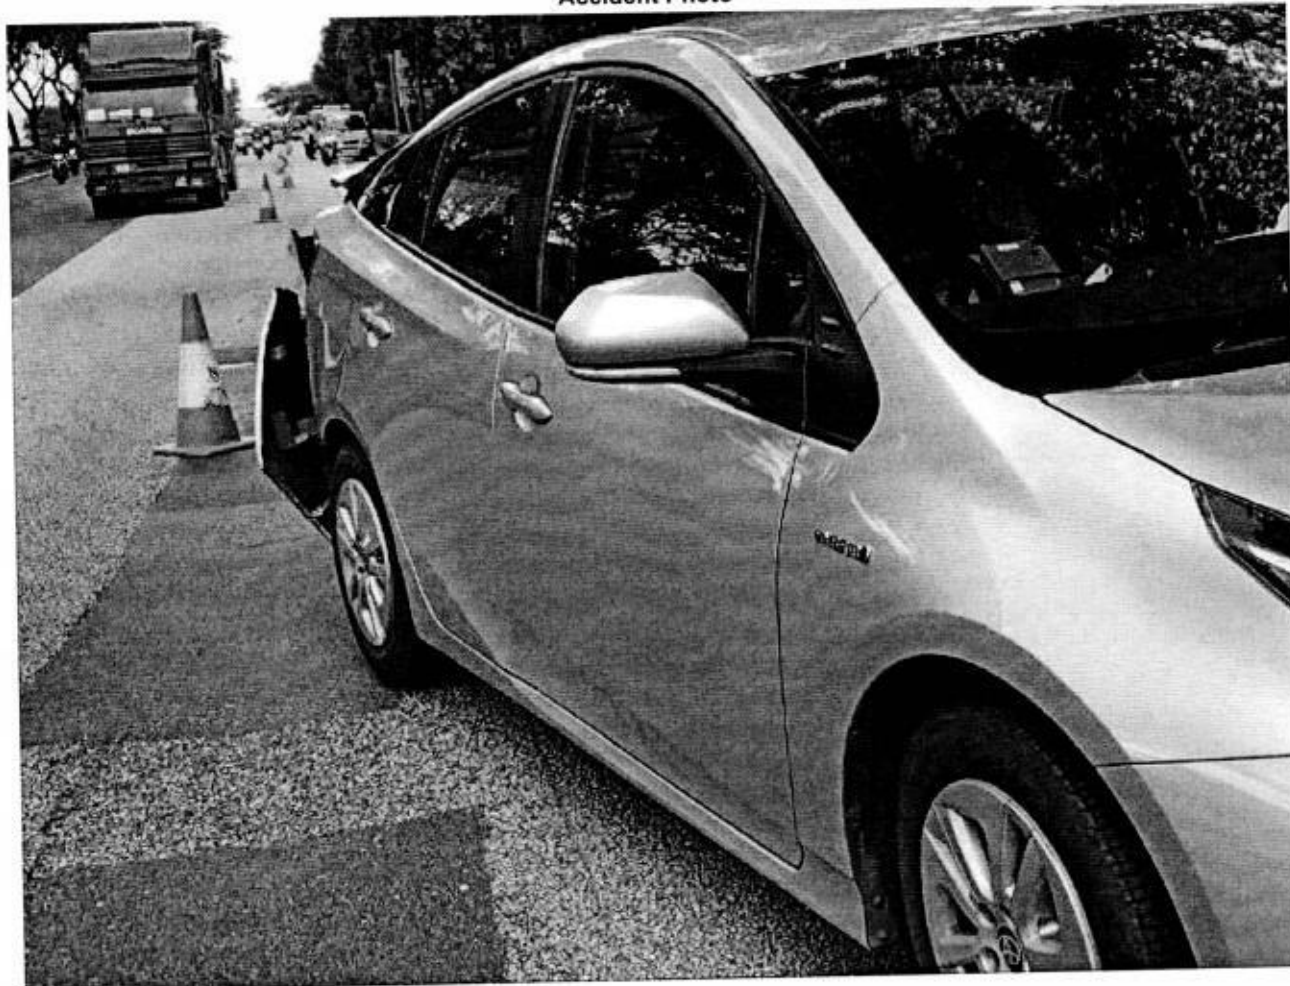
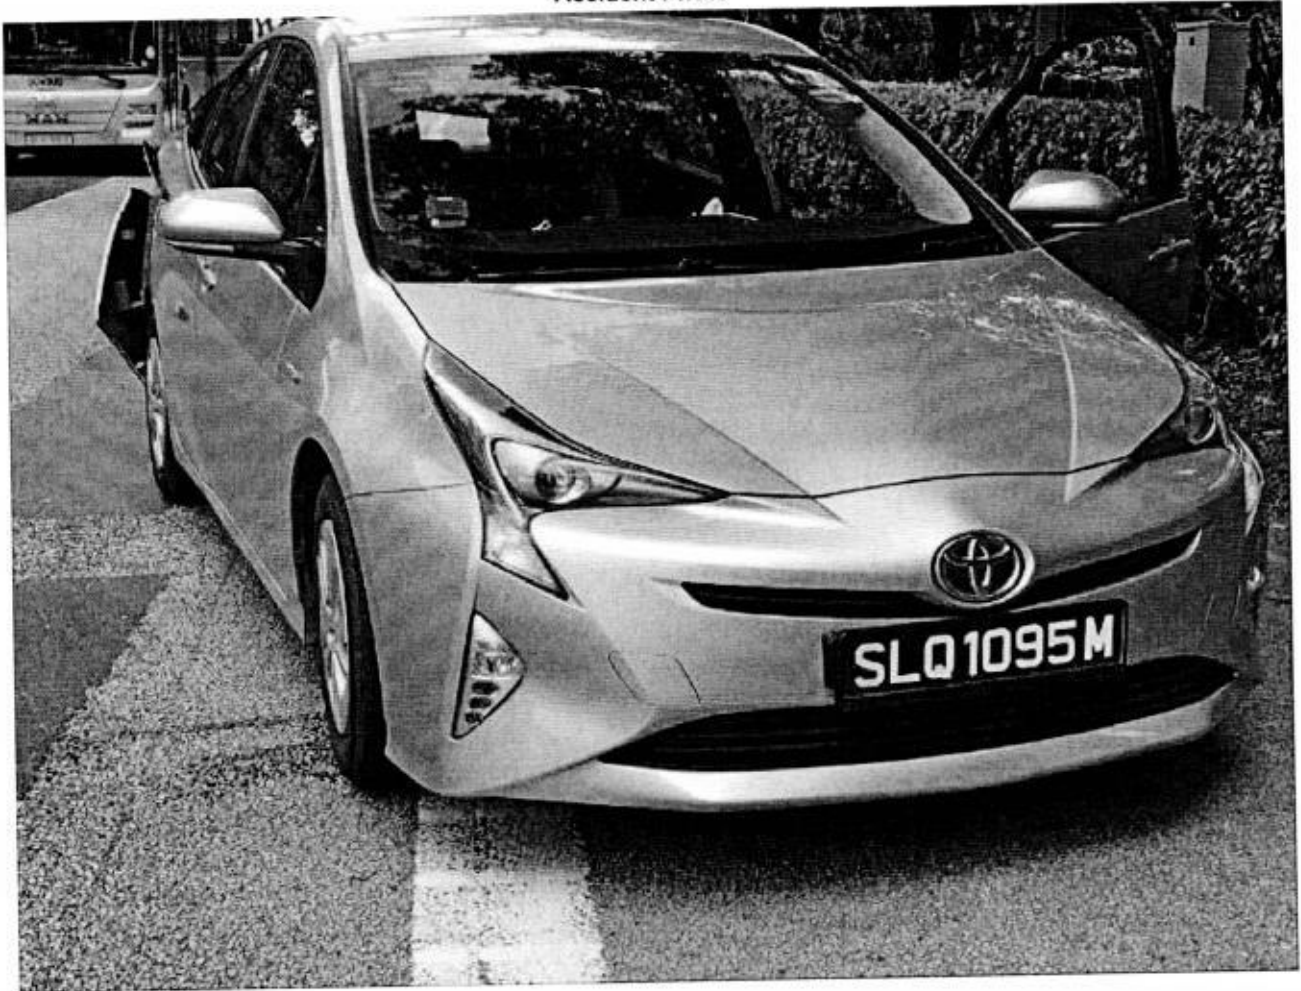
Accident Photo

The U/C / Chassis frame / Body Structure affected due to collision

The vehicle sustained impact / damages front portion and parts claimed are consistent to the accident.

In view of the above, the vehicle is uneconomical to be repaired, you are advised to invite tender for the wreck.
