Preliminary Advice

Vehicle No	: SKP1124E	Accident Date	: 19/01/2018
Make	: VOLKSWAGEN JETTA	Policy No.	: S27936551SMF
Assignment Date	: 22/01/2018	Excess	: S\$3,000.00
Date of Inspection	: 23/01/2018	Est. Duration of Repair	: 10.00
Inspection At	: VOLKSWAGEN CENTRE SINGAPORE - TUAS (HQ) 17 TUAS AVE 9 SINGAPORE 639197

Point of Impact / General Description of Damages

VEHICLE DAMAGE INSPECTION REPORT

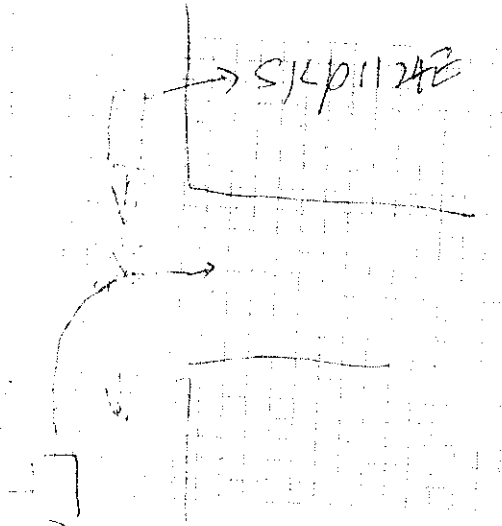
SKETCH PLAN

DESCRIBE CIRCUMSTANCES OF THE ACCIDENT

I was driving straight on Woodlands
 road, when the green light.
 Car SGH 9552P
 was right in front of me, when there
 was green light.

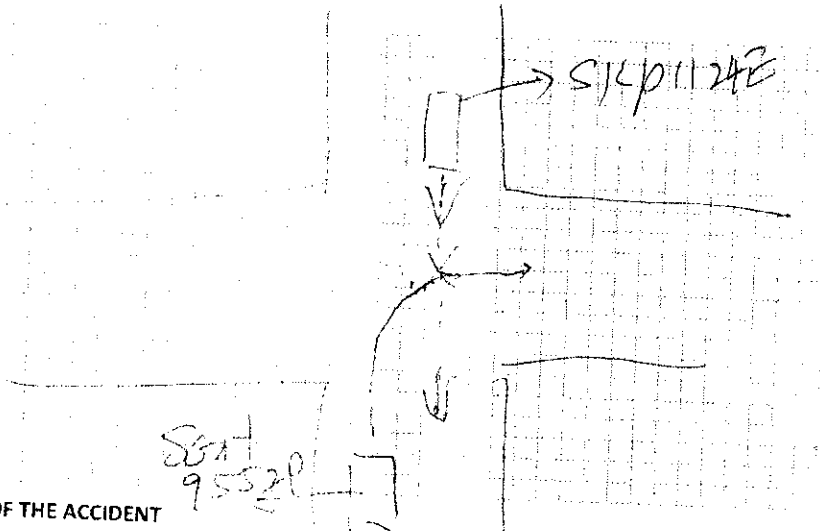
SKETCH PLAN

DESCRIBE CIRCUMSTANCES OF THE ACCIDENT

At 2:00 am, SGP 1124E driving straight on Woodlands Ave 2, During the Green light. Car SGT 9552P turned right from Ave 2 to Ave 9, when there was ^{not} a green arrow.
