Ref : CC3/AIG18001487/Aqb

**From:** Shiau Chan (LKKAuto)  
**Sent:** Tuesday, 27 March 2018 12:08 PM  
**To:** 'Boo seng yak'; SUR; Carrine Leong; Nora Khai  
**Subject:** RE: FINAL REVISION SKH183H - OD AIG - SURVEYED 25 JAN 18

### VEHICLE DAMAGE INSPECTION REPORT

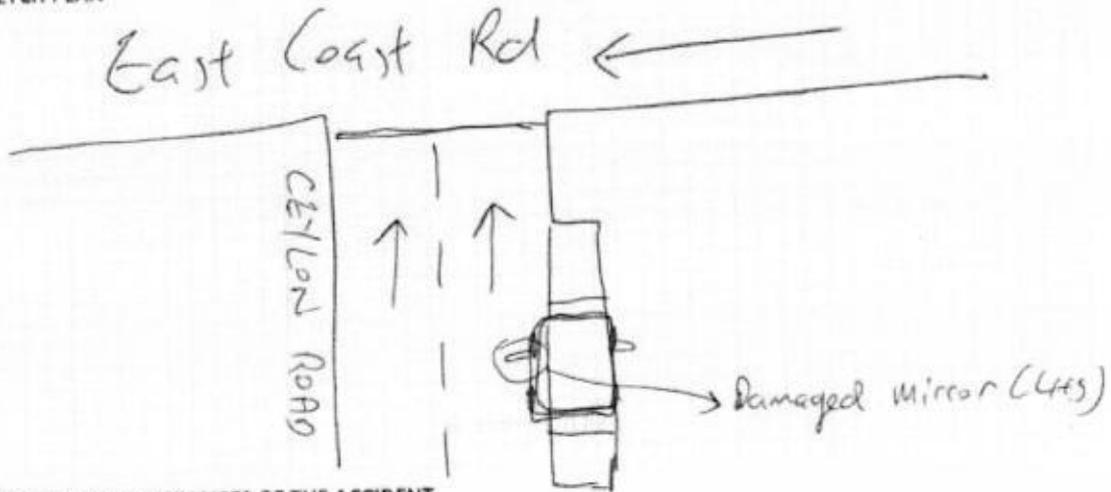
Sketch Plan #2

On the morning of 22/01/2018, I parked my car along Ceylon Road, in the parallel parking lot found along said road, at about 8 a.m.

Upon my return at around to my car at 09:30 hrs I noticed the damage to my Left Side Wing Mirror. There had been no signs for me to be able to identify the cause of the damage, as I was away from my car.
