# LKK Auto Consultants Pte Ltd

## VEHICLE DAMAGE INSPECTION REPORT

Our File No: CC3/MSG18001558/ATBN2

| Claimant Vehicle No : | SH4880H | Insured Vehicle No : | SJR1791E |

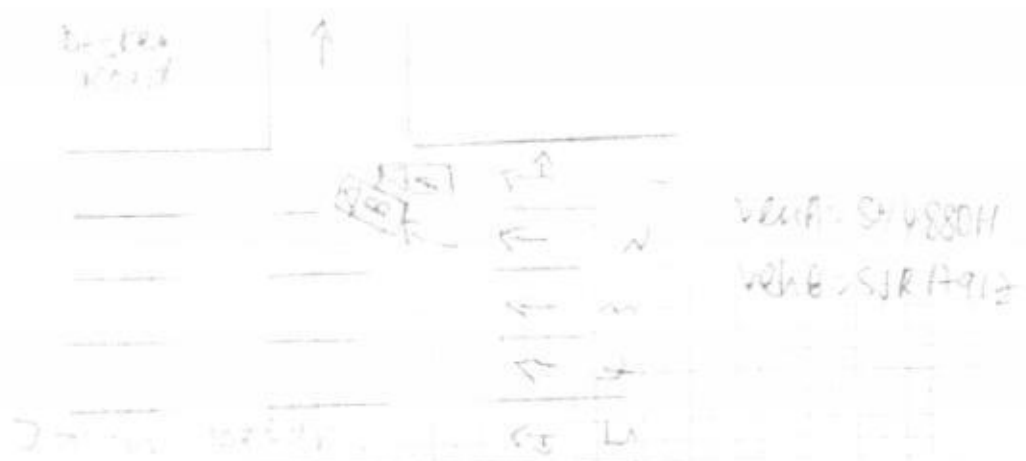
# Accident Sketch Plan

I was driving straight along in lane 1 of Jalan Besar on 20.01.2018 @ 11:00hrs. I was stationary at lane 1 for pick up passenger. When I start to move, suddenly I heard a bang sound and felt an impact from my left. Vehicle B from lane 2 suddenly turn right and collided onto left side of my vehicle.
