LKK Auto Consultants Pte Ltd

Affiliated to Federation Internationale Des Experts En Automobile			
QBE INSURANCE (SINGAPORE) PTE LTD		Ref : CS/QBE18001645/Avd3e2	
1 RAFFLES QUAY #29-10 SOUTH TOWERSINGAPORE 048583		Date : 01-11-2018

1. Policy Particulars :- THIRD PARTY CLAIM			
Insured Veh.	YP 1094S	Veh. Inspected	GR 4128L
Policy No.		Coverage (\$)	0.00
Claim No.	V0012333	Excess (\$)	0.00
Assign From	JOYCE FOO	Assign Date	25/01/2018

ADJUSTMENT ON REPAIR COST FOR VEHICLE NO. GR 4128L

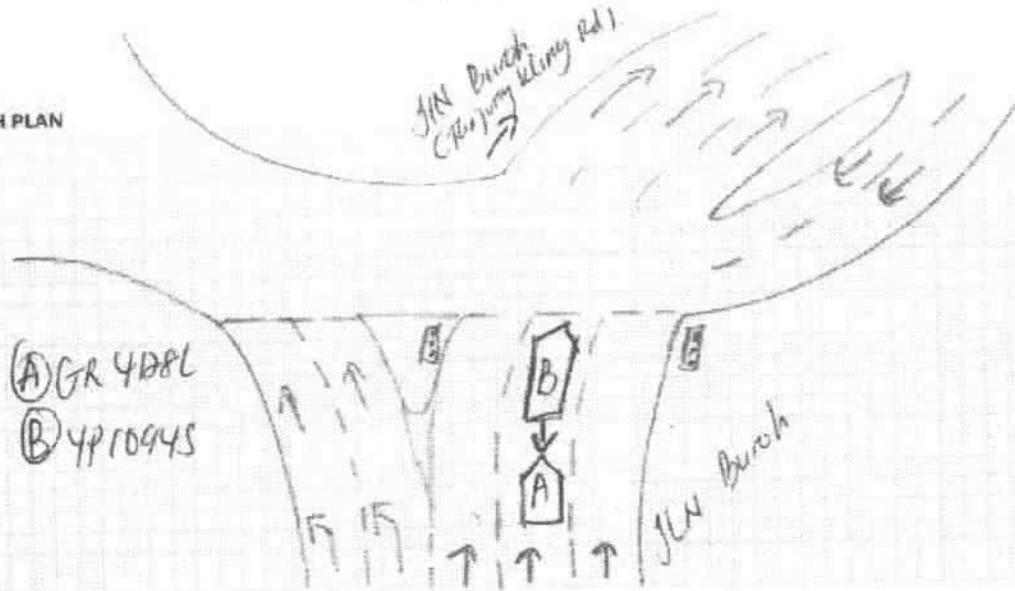
SKETCH PLAN

My vehicle was stationary at the traffic light. I honned when I saw veh B reversing but veh B still hit my veh front. When traffic light turned green, veh B drove off and I followed him back to his company at chin Bee Ave. I informed him what happened and he said he wanted to do private settlement. Later on veh B driver told me to file a report and claim against his veh insurance.
