| Affiliated to Federation Internationale Des Experts En Automobile | | | |
|---|---|---|---|
| MSIG INSURANCE (SINGAPORE) PTE LTD | | Ref : CS/MSG18001948/M1qd3 | |
| Insured Veh. | SKU 5623D | Veh. Inspected | SDM 2002R |

**Preliminary Advice**

## VEHICLE DAMAGE INSPECTION REPORT

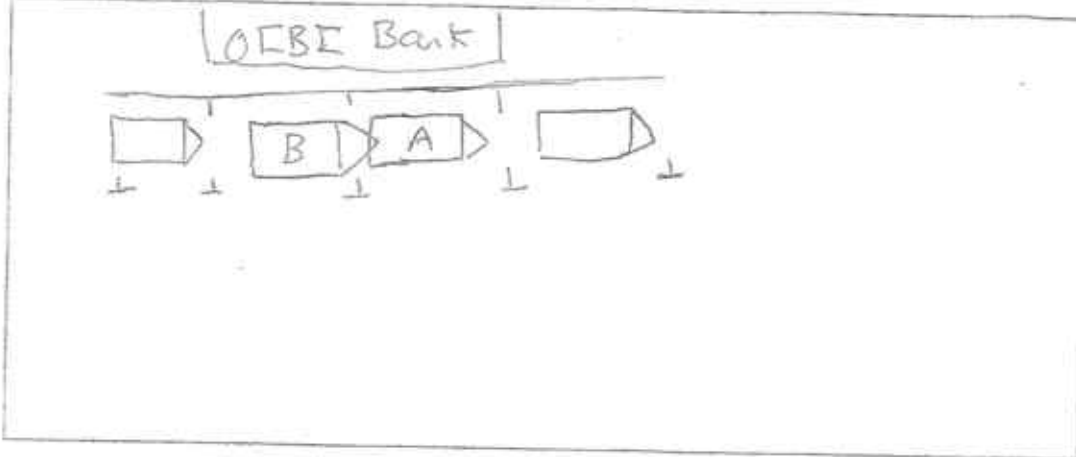
Date of accident: 24.1.18 Time: 3:50pm Location: Outside Serangoon garden OCBC  
 My Vehicle A: SDM2002R Vehicle B: SKL5623D Vehicle C: \_\_\_\_\_  
 SKETCH PLAN

DESCRIBE CIRCUMSTANCES OF THE ACCIDENT

on the 24.1.18 at about 3:50pm, vehicle SDM2002R was parked stationary in the carpark lot outside OCBC bank at serangoon garden. I was standing and waiting outside the bank beside my car. I saw vehicle SKL5623D trying to park in the empty lot behind my car. While trying to park his car, vehicle SKL5623D hit onto my stationary park car SDM2002R in the rear portion, causing damages to my car. There were no passengers in my car at the time of the accident.
