Vehicle No	: SLJ729L	Accident Date	: 27/01/2018
Make	: PORSCHE PANAMERA	Policy No.	: B28973937MPQ
Assignment Date	: 31/01/2018	Excess	: S\$10,000.00
Date of Inspection	: 01/02/2018	Est. Duration of Repair	: 6.00
Inspection At	: STUTTGART AUTO PTE LTD (HQ) 12 SUNGEI KADUT AVE SINGAPORE 729648

The vehicle sustained impact / damages o/s front portion and parts claimed are consistent to the accident.

VEHICLE DAMAGE INSPECTION REPORT

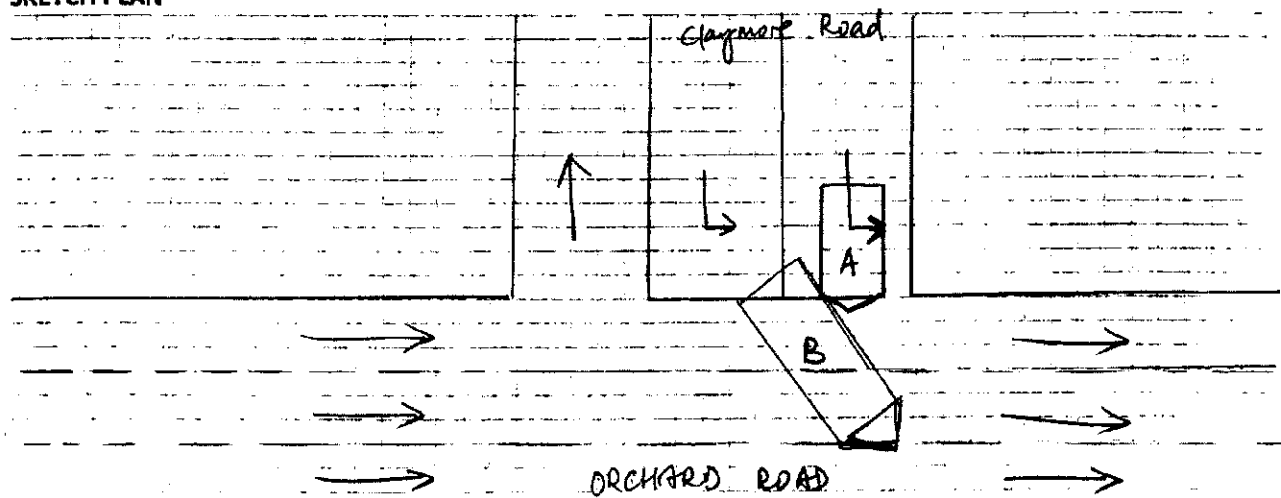
SKETCH PLAN

On 27 Jan 2018, at about 3:30 pm, I was stationary on Claymore Road waiting to turn on to Orchard Road. I was on the inner turning only lane (Vehicle A). There was a lorry (vehicle B) on my right. We were both waiting for traffic to clear so as to turn onto Orchard Road. My view of the traffic on Orchard Road was completely blocked by ~~the~~ vehicle B, so I remained stationary the whole time, even as the vehicle B turned out. As vehicle B turned left, his angle was too sharp, coming very close to my car. As I realised that he was eating into my lane I tried to steer left to avoid him, but he came in too deep and fast, and hit onto the right front of my car.
