**PRELIMINARY ADVICE OF VEHICLE NO. XD 7032G.**

QUOTATION FOR REPAIRS OF VEHICLE NO. XD 7032 G

## ADJUSTMENT ON REPAIR COST FOR VEHICLE NO. XD 7032G

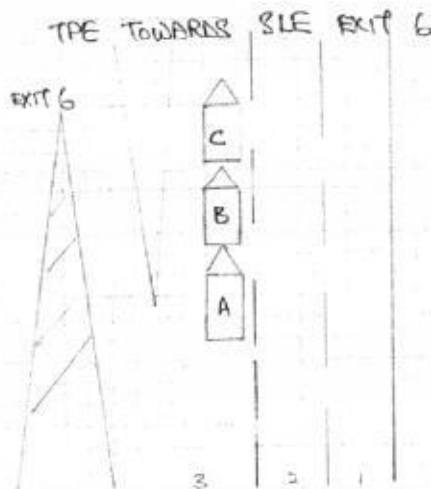
### SKETCH PLAN

3) XB 7908R

c) YM 7560 P

As per Police Report NO 7	20FF 1205	2120
---------------------------	-----------	------
