VEHICLE DAMAGE INSPECTION REPORT

Our File No: CS/MSG18002072/M1TD3E2

Claimant Vehicle No : SDS7191M

Make & Model: HYUNDAI HD AVANTE 1.6 A (BI-FUEL), 1.6 (A)

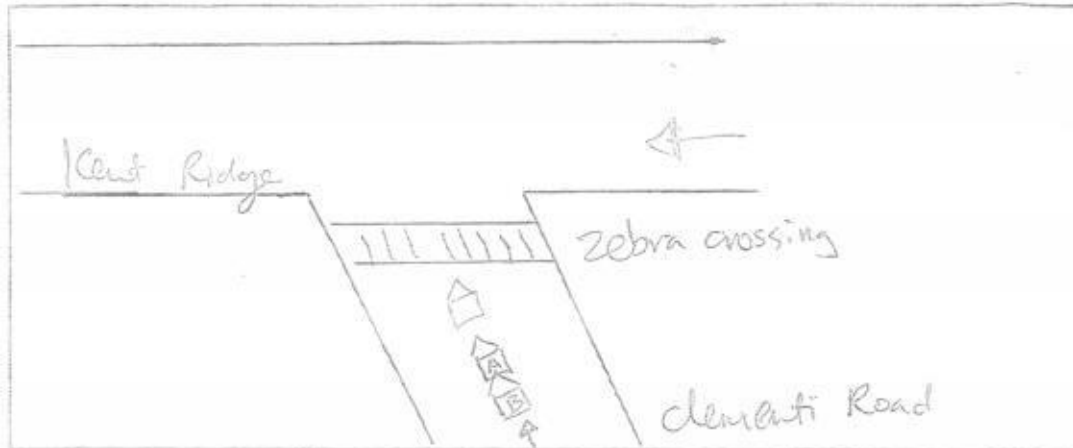
SKETCH PLAN

On the 30.1.18 at about 1235pm,
I was driving along Clementi Road.
I was waiting stationary on the slip Road
for oncoming traffic. Suddenly G7BB58424
came from behind and hit my vehicle
SDS7191M in the rear causing damages
to my car. There were no passengers
in my car at the time of the accident.
