To Inspect Vehicle No: **FBJ8711C**at Workshop m/s **RHH**

Veh No: **FBJ8711C** Yr Regn: **12/14**Type: M.Car / **M.Cycle** / Bus / Van / Lorry / Taxi / Prime Mover /

Left, N/S body
The U/C / Chassis frame / Body Structure affected due to collision.

VEHICLE DAMAGE INSPECTION REPORT

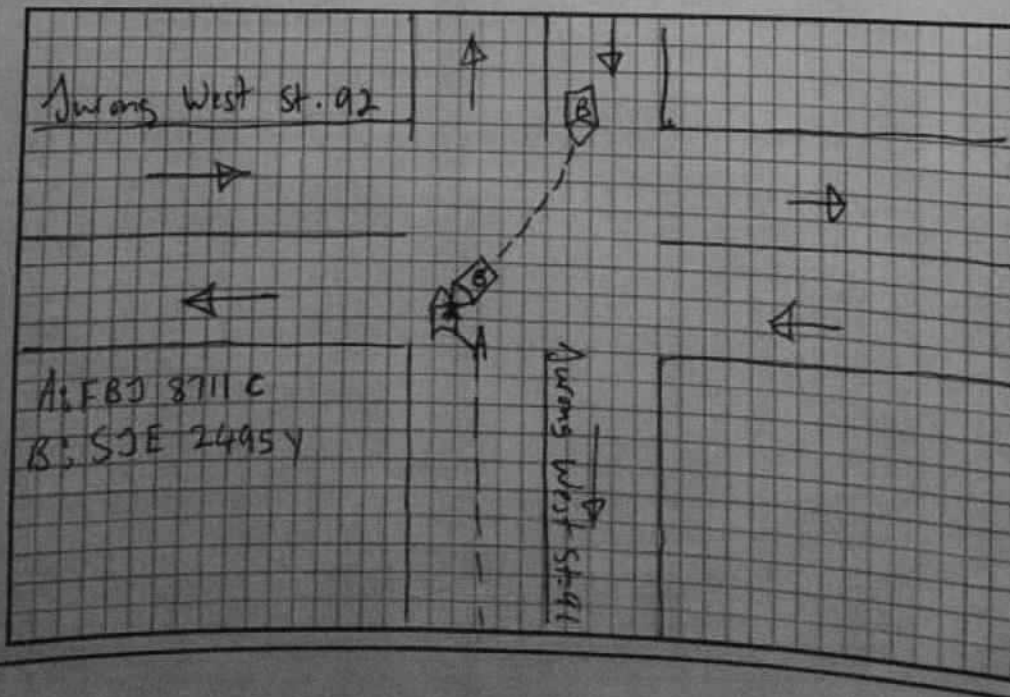
Sketch Plan

Date Of Report	30/01/2018 17:01
Date Of Accident	29/01/2018 21:40
Exact Location Of Accident	JURONG WEST ST 91 JUNCTION OF JURONG WEST ST 92
Country/State of Loss	SINGAPORE
