**ACCIDENT INVOLVING SLD1884X & SLT3369U ALONG ECP TOWARDS CHANGI
(BEFORE EXIT 1) AT ABOUT 0900 HOURS.**

VEHICLE DAMAGE INSPECTION REPORT

Our File No: CS/CT118002341/GRD3E2

Handling Insurer: China Taiping Insurance (Singapore) Pte. Ltd.	Policy No: DMPCSN3090071700	
Claimant Vehicle No: SLD1884X	Insured Vehicle No: SLT3369U	
Date of Loss: 02/02/2018	Nature of Claim: TP	Claim No: SNM18D00635C02

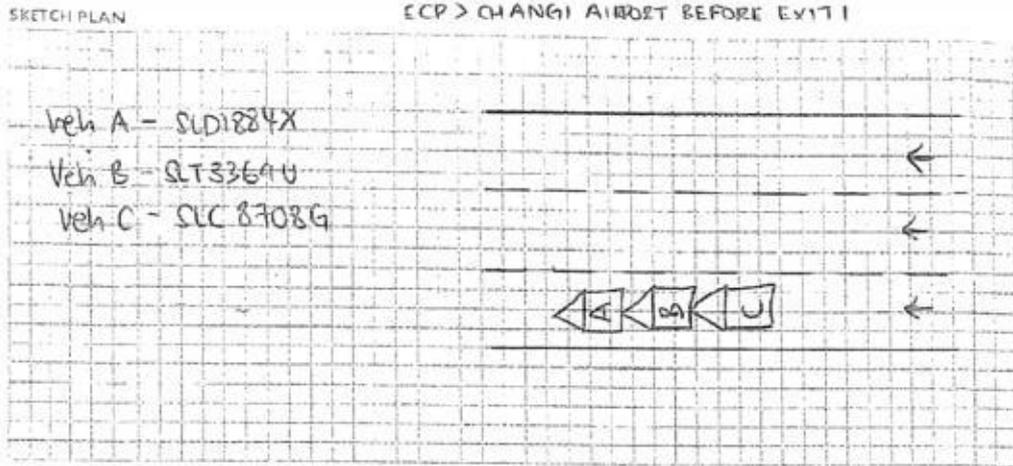
Sketch Plan #2 Pg. 1

DESCRIBE CIRCUMSTANCES OF THE ACCIDENT

On the stated date and time, I vehicle A was travelling along the stated venue. All vehicles in front were slowing down before the exit, I slow down as well. Suddenly I felt an impact and realize vehicle B has hit onto my rear portion. when I alight from my vehicle I then realize I was involve in a chain collision.
