REF: CS/MSG18002384/Ktd/302

SLL5110C

Make/Model: SUZUKI SWIFT 1.5 AT

VEHICLE DAMAGE INSPECTION REPORT**Our File No:** CS/MSG18002384/KTD3E2**Date:** 20/11/2018REFERENCE

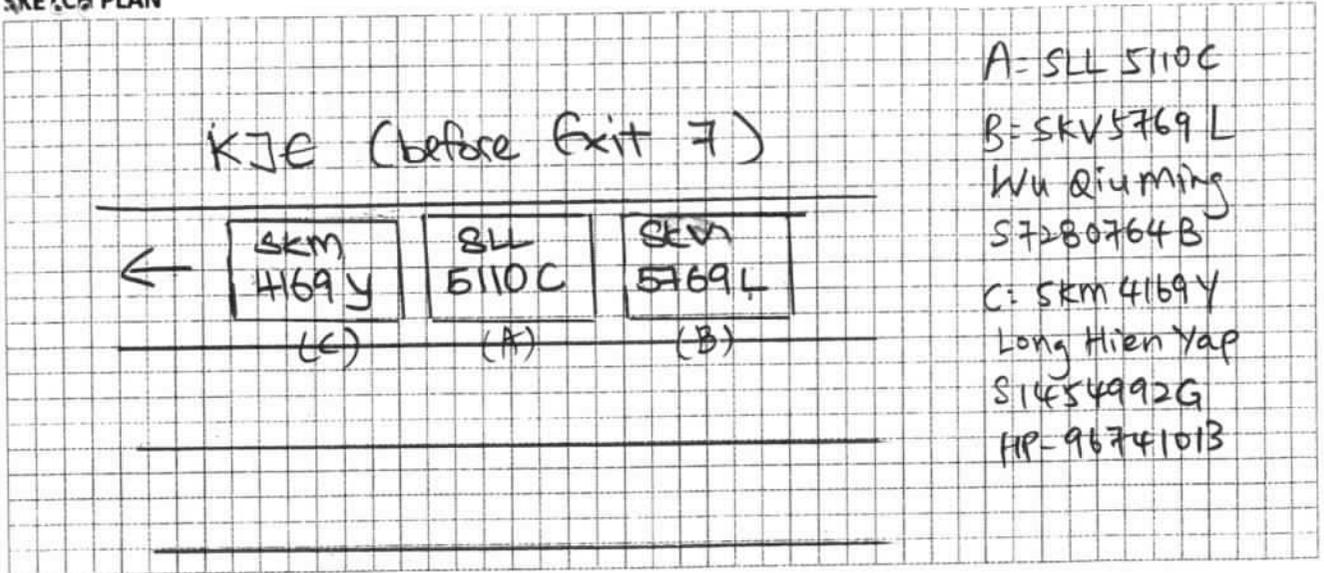
SKETCH PLAN

The actual scenario should be my car was hit
by m/car SKV5769L and the impact pushed my car forward
to hit the rear of m/car SKM4169Y.

Heavy Traffic along KJE, slowing moving traffic. My car ~~(SLL 5110C)~~ (SLL 5110C), was stopped due to slow moving traffic and suddenly SKM 4169Y hit into my car and cause my car to move forward & hit SKV 5769L, at 8.50am on 5 Feb 18.
