TRAFFIC ACCIDENT INVOLVING VEHICLE BEARING REGISTRATION NO : SGM9696G AND SJW779Y ALONG WOLSKEL ROAD ON 08 FEBRUARY 2018 AT ABOUT 1000 HRS.

1. Policy Particulars :- THIRD PARTY CLAIM				
Insured Veh.	SGM 9696G	Veh. Inspected	SJW 779Y	
Policy No.		Coverage (\$)	0.00	
Claim No.	CMTD1800645/THE	Excess (\$)	0.00	
Assign From	GRACE TEO	Assign Date	08/02/2018

4. Description of Damages				
THE VEHICLE SUSTAINED DAMAGES AT THE N/S BODY.				
DAMAGES SEE DETAILS.				
5. General Information				
Accident Date	08/02/2018	Inspection Date	09/02/2018	
Survey held at	TROPICAL SUCCESS AUTO CARE BLK 5032 ANG MO KIO AVENUE 3 #01-303 INDUSTRIAL PARK 2 SINGAPORE 569535.			
5a. Remarks

ADJUSTMENT ON REPAIR COST FOR VEHICLE NO. SJW 779Y

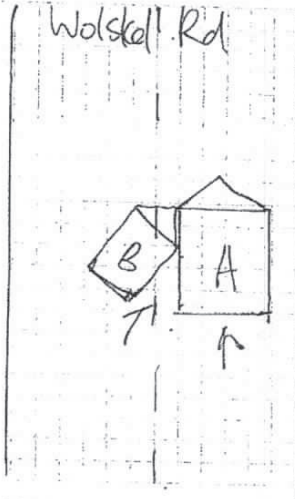
SKETCH PLAN

A: SJW 779Y
B: SQM 96969

I was driving along Wolstel Rd on 08 February 2018 at around 10:00 am. Suddenly a vehicle which was stationary on my lane in the lane on my left dashed into my lane and hit onto my car left side. My left doors were dented as a result. my video.
