# LKK Auto Consultants Pte Ltd

## 1. Policy Particulars :- THIRD PARTY CLAIM

**RE : ACCIDENT INVOLVING SLQ 8228 B & GBE 2486 T AT  
WOODLAND SECTOR 1 WOODLANDLANE SPECTRUM 1 CAR  
PARK ON 25/10/2017.**

## VEHICLE DAMAGE INSPECTION REPORT

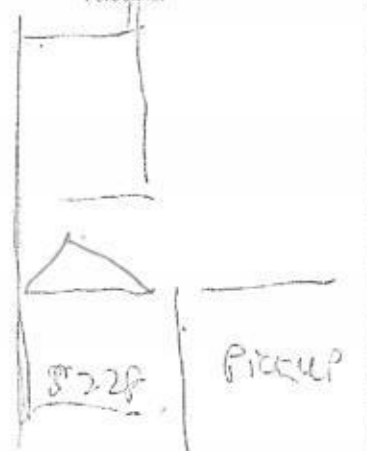
Sketch Plan

On 25 Oct 2017 9.45am, we receive a call from Mr Yong Chee Tyan (Yiho Glass Pte Ltd) 9272 1038 informing me that the my vehicle SLQ8228B has been damage by Mr Yong's Vehicle which was driven by his employee - The lorry GBE2486T has a metal frame that fell on My car and scratch/knock into the driver door and right side of bonnet. My vehicle was parked in the lot and I did not see the accident but was told by Mr Yong when he describe the accident at the Location of the car at the parking lot at Woodlands Sector 1 Woodlands spectrum 1.
