VEHICLE DAMAGE INSPECTION REPORT

Our File No: CS/MSG18002767/RD3Q2

Handling Insurer:	MSIG Insurance (Singapore) Pte. Ltd.	Policy No:	MSD/VCC/18-000002		
Claimant Vehicle No :	SKZ3087M	Insured Vehicle No :	XD5281S		
Date of Loss:	08/02/2018	Nature of Claim:	TP	Claim No:	MSC/V/18-000228

Reg No:	SKZ3087M	Engine No:	VQ25406993A
Make & Model:	NISSAN TEANA, 2.5 CVT ABS D/AB HID 2WD 4DR (A)	Chassis No:	JN1BBUJ32Z0001196
Reg. Date:	10/01/2009 (Man. Year: 2008)	Odometer:	150843 km
Colour:	Metallic Maroon		
Engine Capacity:	2496 cc		
Market Value/New Car Price:	N/A		
Sum Insured (\$\$):	Market Value/New Car Price

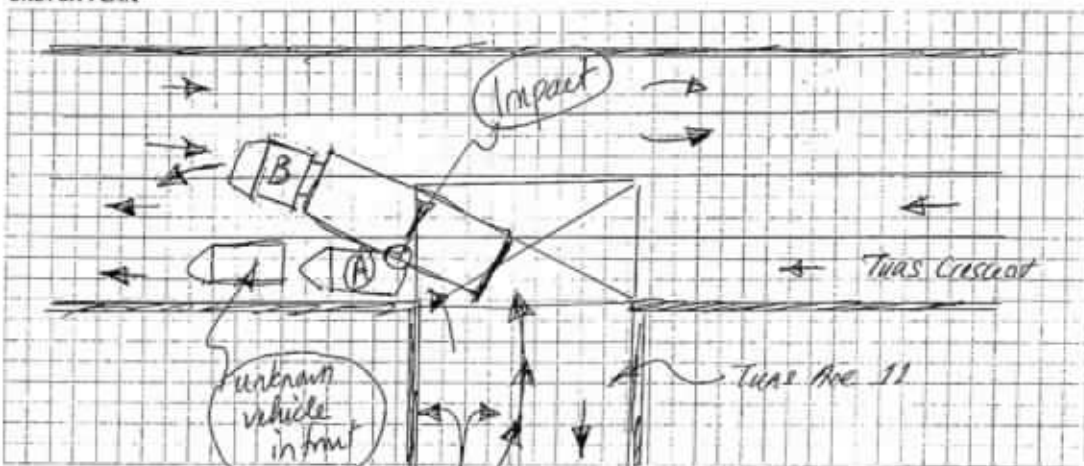
SKETCH PLAN

DESCRIBE CIRCUMSTANCES OF THE ACCIDENT

I stopped behind a unknown van while waiting for traffic light. the trailer turn ~~for~~ out from Twas Ave 11 on my right side and hit onto my vehicle right rear corner causing damage, no one has hurt and we exchange particulars.
