REF: CS3/LPC18002835/Rlvd3

To Inspect Vehicle No: SKA 2685T Insured: SGS 5015S

1. Policy Particulars :- (THIRD PARTY CLAIM)

ADJUSTMENT ON REPAIR COST FOR VEHICLE NO. SKA 3685T

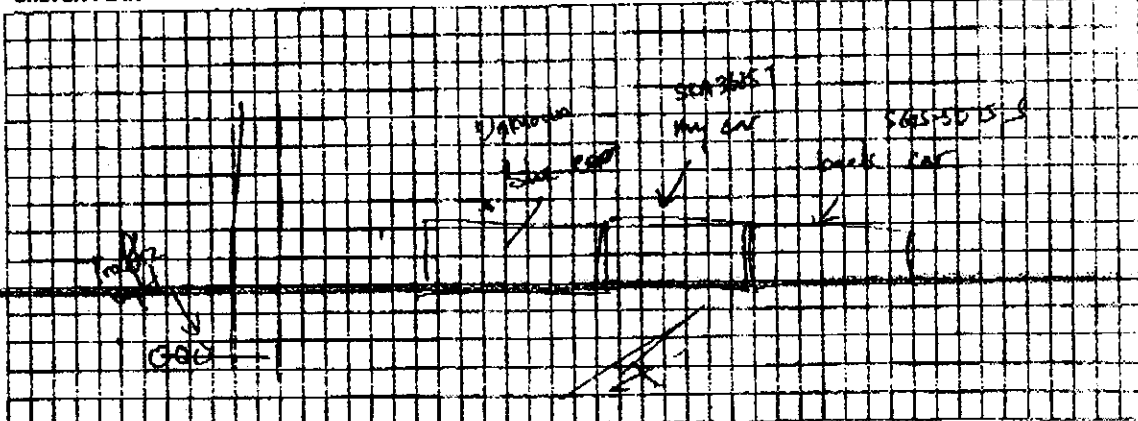
SKETCH PLAN

Vehicle is changing traffic light and am stop at that moment. But the back of the vehicle still moving forward my vehicle and the impact cause my car to move forward and touch the front car. But no damage can be seen on the front car.

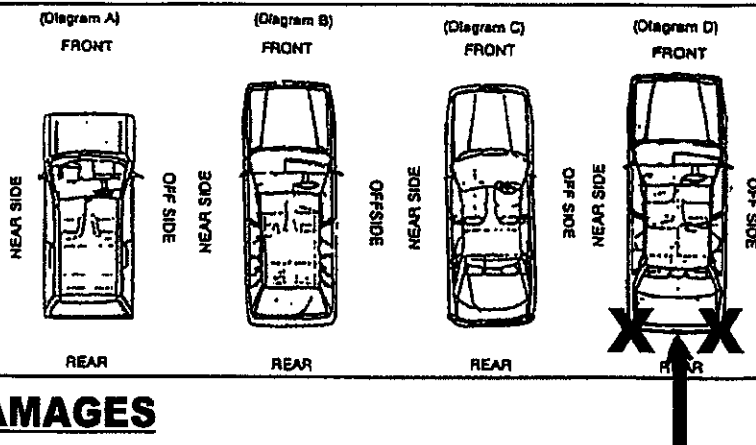
Direction of impact/damage marked (→) (X)

**The vehicle
sustained impact
on its Rear
Portion. (see
Diagram D)**

THE VEHICLE SUSTAINED DAMAGES AT THE REAR PORTION. DAMAGES SEE DETAILS.
