SKX 4515Z

Survey Report

**Preliminary Advice**

## VEHICLE DAMAGE INSPECTION REPORT

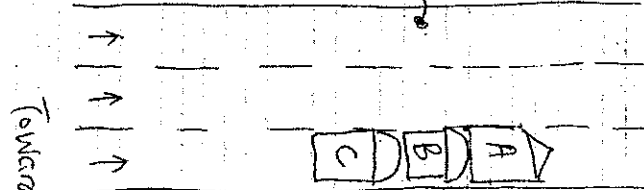
Sketch Plan

AYZ NEAR OZPOT ROAD.

I was driving on AYE towards # Tuas when the front car braked. I applied the brakes as well and stopped (SJV 1706G) before the front car. Subsequently, I was hit from behind by SKW 2851X, which caused me to hit SJV 1706G in front.
