JC NO 305118211

SHB 4154 H - ACCIDENT STATEMENT

**REPAIR ESTIMATE\***

## VEHICLE DAMAGE INSPECTION REPORT

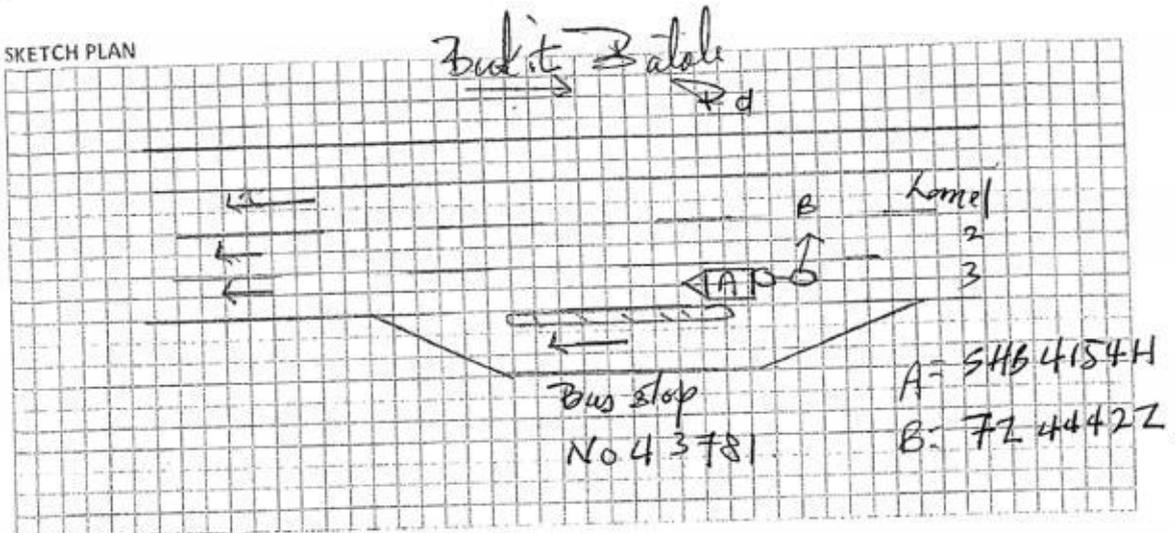
SKETCH PLAN

While I slowed down the speed in tandem with a private car which reduced speed near bus stop No 43781, I suddenly felt an impact after a rider on m/cycle B( FZ 4442Z) hit into the rear bumper of my taxi.

The impact inflicted damage to the rear right portion of my taxi.
