PRELIMINARY ADVICE OF VEHICLE NO. SHA 2143H

The vehicle sustained damages at the rear n/s portion.

ADJUSTMENT ON REPAIR COST FOR VEHICLE NO. SHA 2143H

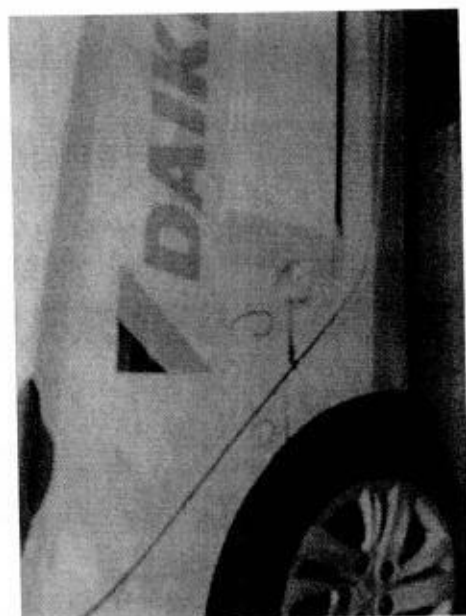
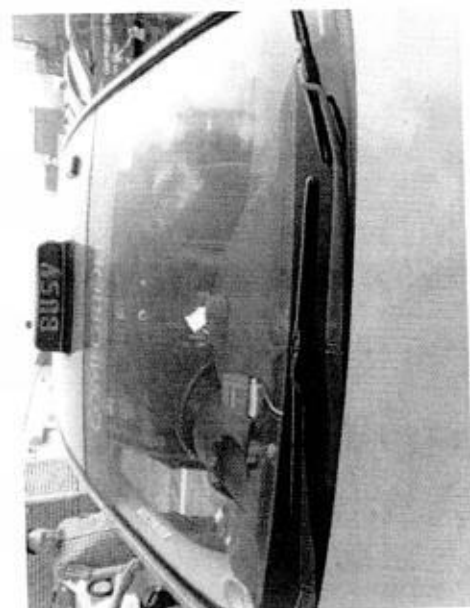
While I was driving, I suddenly felt an impact from the rear. I stopped my Taxi and discovered that a motorcycle hit the rear of my Taxi. The rider was walking around in pain. As such, I called for Ambulance. I made a check with my passenger and she was not injured at that point of time. Left side of the rear bumper and boot dented together with left rear lights broken.
