To: MSIG Insurance (Singapore) Pte. Ltd. 4 Shenton Way #21-01 SGX Centre 2 Singapore 068807	From: LKK Auto Consultants Pte Ltd 51 Ubi Ave 1 #01-25 Paya Ubi Industrial Park Singapore 408933
Attn: Lionel Tan Tian Pei	Date: 27 Feb 2018
<u>Preliminary Advice</u>

Point of Impact / General Description of Damages

YOU ARE LICENSED TO DRIVE VEHICLES IN THE FOLLOWING CLASS(ES)

ESTIMATE FOR SKM79A

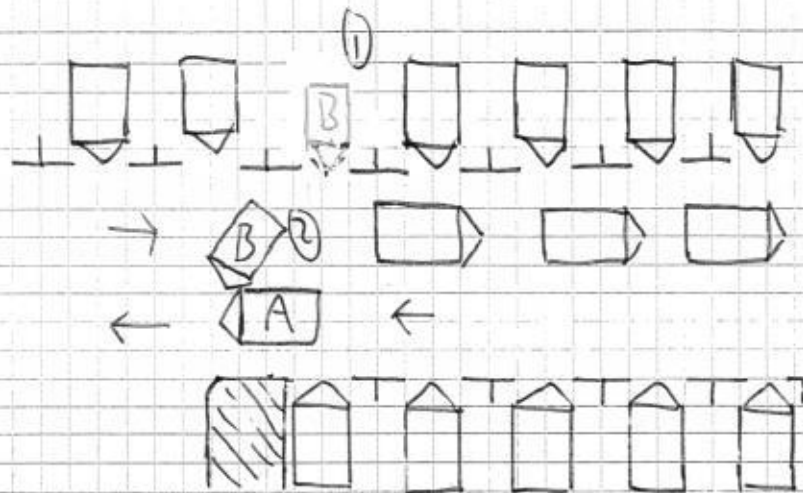
SKETCH PLAN

- ① 'A' vehicle driving straight
- ② 'B' vehicle exit parking lot fail to look out ongoing car and collided my front right side.
- ③ The impact cause my front right tyre damage too.
- ④ No one was injure and we exchange particular.
- ⑤ I arrange to tow in my car.
