Insured Vehicle No	: SJN3393D	Accident Date	: 21/02/2018
TP Vehicle No	: XB8506K	Assignment Date	: 22/02/2018
Make	: VOLVO FMX37064R	Est. Duration of Repair	: 2.00
Date of Inspection	: 26/02/2018		
Inspection At	: VFIX AUTO SERVICE PTE LTD (HQ) 60 KAKI BUKIT AVE 6, ARK@KB SINGAPORE 417892

**Attention: Motor Claim Department**  
**RE : VEHICLE NO XB8506K VOLVO FMX370**

## VEHICLE DAMAGE INSPECTION REPORT

Our File No: CS/MSG18003464/UQBN2

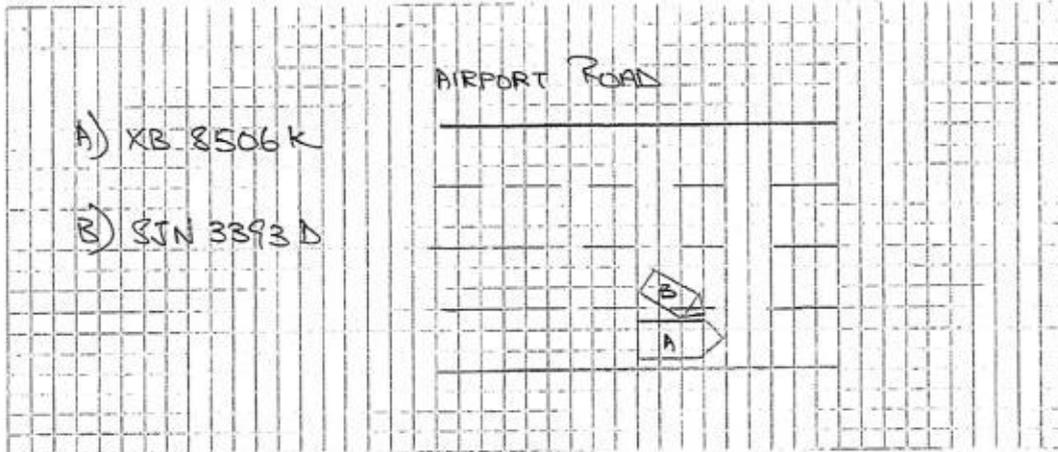
SKETCH PLAN

DESCRIBE CIRCUMSTANCES OF THE ACCIDENT

On 21/02/2018 at about 0835am, I was driving along Airport Road. While I was travelling on my lane, vehicle B (SJN 3393D) suddenly cut into my lane and collided on to my truck.
