AUTOMOTIVE ENGINEERING & MGT DIVISION Ref : CS/SPF18003599/Kqb

ACCIDENT ON 22 FEBRUARY 2018 INVOLVING GOVT VEHICLE GZ3371P AND OTHER VEHICLE SLR9963A

THE VEHICLE SUSTAINED DAMAGES AT THE FRONT O/S PORTION.
DAMAGES SEE DETAILS.

ADJUSTMENT ON REPAIR COST FOR VEHICLE NO. SLR 9963A

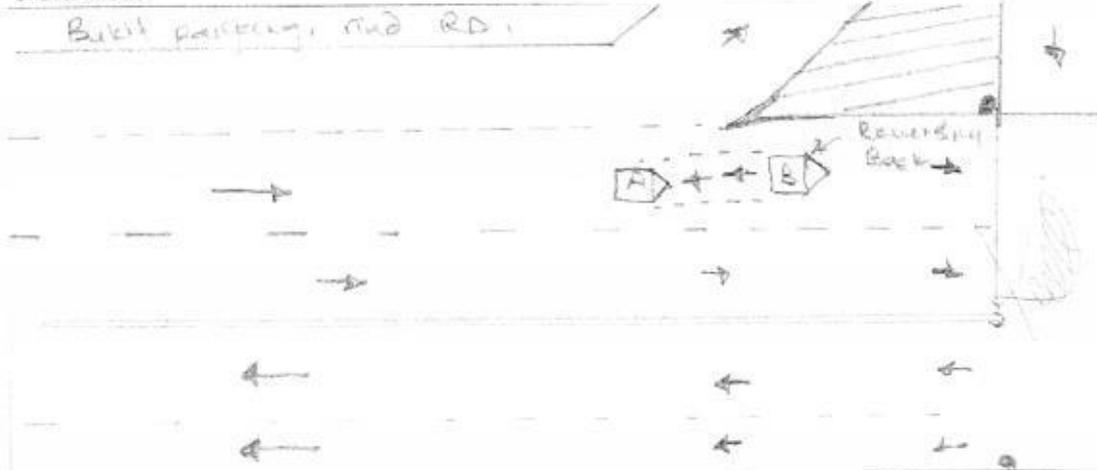
SKETCH PLAN

At approx 1230pm, 23 Feb 2017, I, driver of SLR4963A came to a stop behind a police car, G23371P at a red light traffic junction

We are about 1/3 car length away from G23371P

The police car started reversing slowly. I honk at the police vehicle when the distance became too close but it was too late and the front vehicle had hit my car

I could not reverse as there were vehicles behind me as well.
