ACCIDENT ON 31 JANUARY 2018 INVOLVING POLICE VEHICLE QX61X AND OTHER VEHICLE SLF2798U

DAMAGE ASSESSMENT REPORT

THE VEHICLE SUSTAINED DAMAGES AT THE REAR PORTION.
DAMAGES SEE DETAILS.

OPINION ON REPAIR COST FOR VEHICLE NO. SLF 2798U

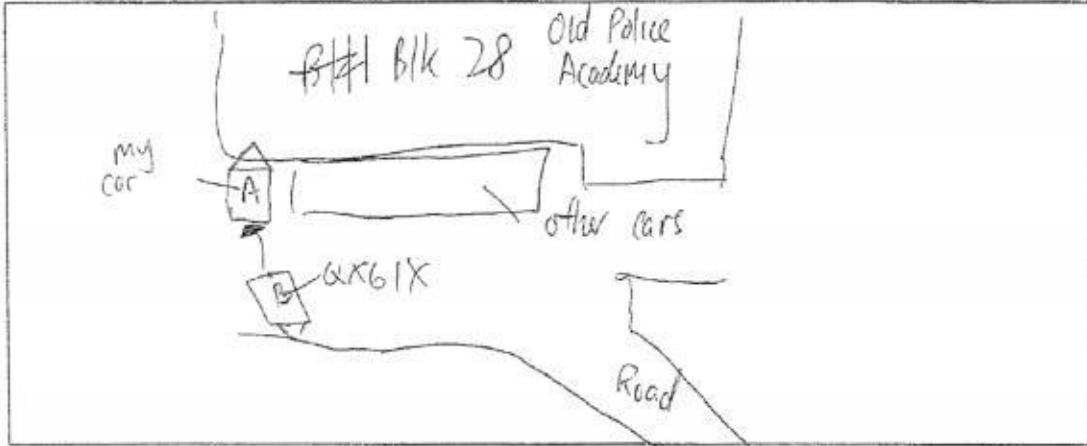
SKETCH PLAN

Date of accident: 31/1/18 Time: 1510hrs Location: Blk 28 Old Police Academy
 My Vehicle A: SLF2798U Vehicle B: QX61X Vehicle C: -

My car was parked stationary at 1330hrs on 31/1/18 with hand brake on.

At around 1530hrs I was informed a police car has hit my stationary vehicle. Thereafter, I exchange particulars with the driver of QX61X. Please see detail in Police Report.
