National Assessment Centre Services

1. Policy Particulars :- THIRD PARTY CLAIM

Insured Veh.	SJL 7579U	Veh. Inspected	SHA 3341X
Policy No.	5085536246-01	Coverage (\$)	0.00
Claim No.		Excess (\$)	0.00
Assign From		Assign Date	27/02/2018

ADJUSTMENT ON REPAIR COST FOR VEHICLE NO. SHA 3341X

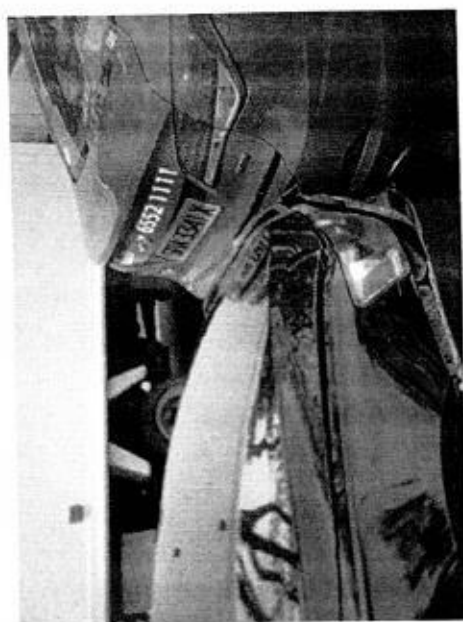
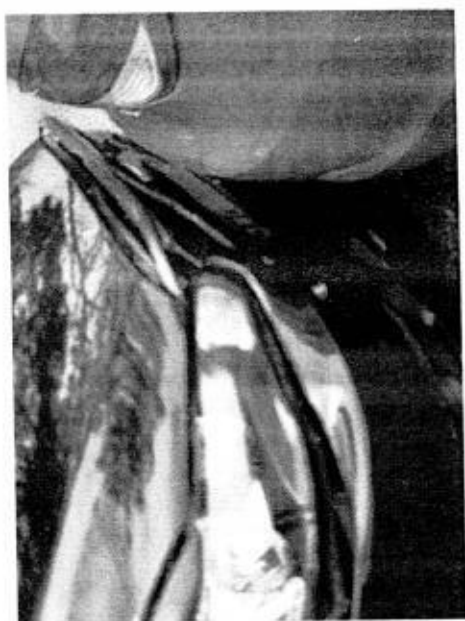
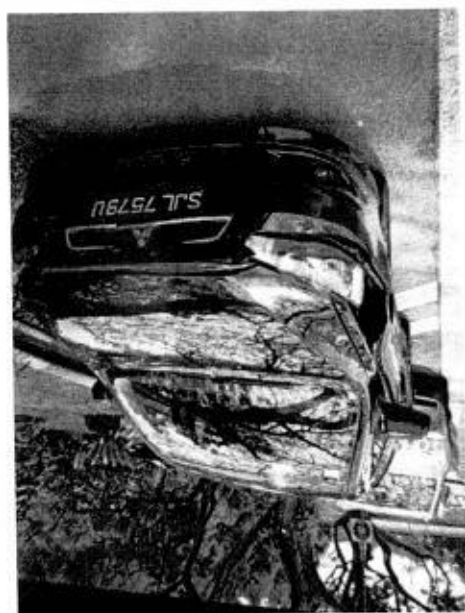
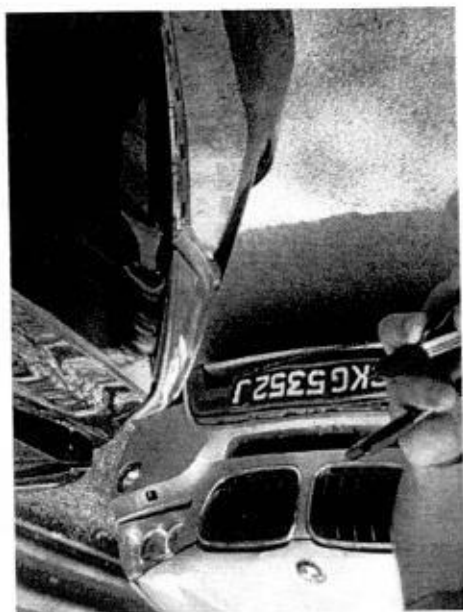
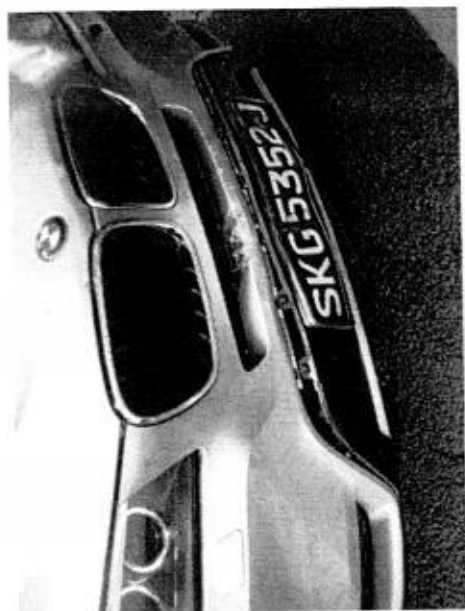
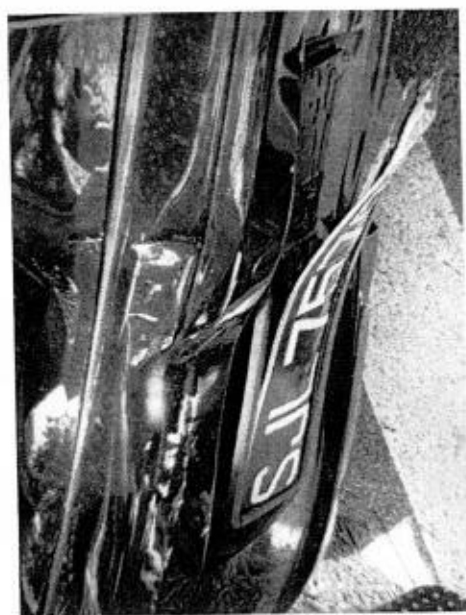
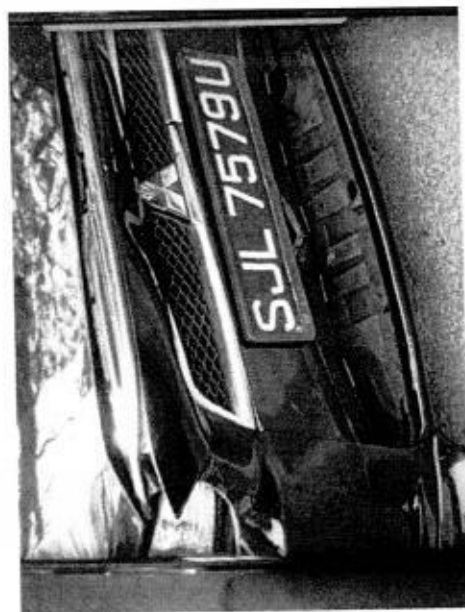
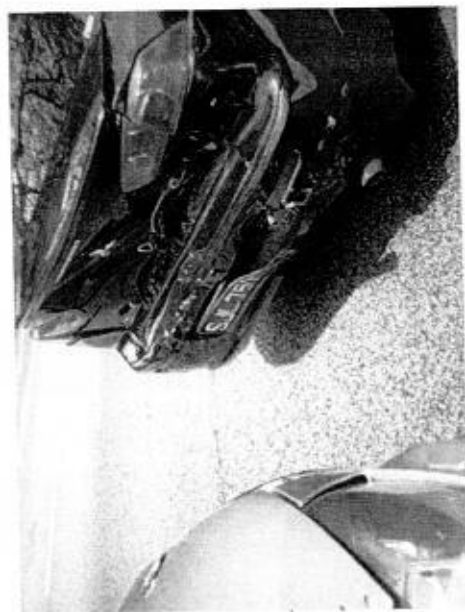
THE VEHICLE SUSTAINED DAMAGES AT THE REAR PORTION. DAMAGES SEE DETAILS.
--

Qty	Description of Parts	Condition	Estimate By Workshop (\$)	Our Adjusted (\$)
<u>REPLACEMENT OF PARTS</u>				
1	BOOT LID	TO REPAIR	1,681.40	-
1	BOOT LID RUBBER	SERVICEABLE	115.80	-
1	BOOT LID LOCK UPPER	SERVICEABLE	137.90	-
1	BOOT LID LOCK LOWER	SERVICEABLE	31.70	-
1	BOOT LID "H" EMBLEM	NECESSARY	27.20	27.20
1	BOOT LID CRDI PLATE	NECESSARY	41.00	41.00
1	BOOTLID MOULDING	SERVICEABLE	85.00	-
1	BOOTLID I40 EMBLEM	NOT NECESSARY	41.00	-
1	BOOTLID LOWER GARNISH	TO REPAIR	398.00	-
1	REAR BUMPER	DEFORMED	603.60	603.60
1	REAR BUMPER REINFORCEMENT	SERVICEABLE	504.35	-
2	REAR BUMPER REINFORCEMENT BRACKET (LH/RH) @\$180.00	SERVICEABLE	360.00	-
2	REAR BUMPER SIDE BRACKET @\$49.00	SERVICEABLE	98.00	-
10	REAR BUMPER CLIPS	NECESSARY	22.00	22.00
1	REAR BUMPER SPONGE	SERVICEABLE	143.40	-
1	REAR BUMPER UNDER COVER	SERVICEABLE	225.00	-
1	REAR PANEL	SERVICEABLE	592.30	-
1	REAR PANEL GARNISH	SERVICEABLE	57.70	-
1	REAR PANEL LOWER PANEL	SERVICEABLE	495.50	-

Qty	Description of Parts	Condition	Estimate By Workshop (\$)	Our Adjusted (\$)
	THATCHAM TTS STANDARD SPRAY PAINTING COST AND LABOUR.		650.00	360.00
			1,670.00	780.00
GRAND TOTAL			6,414.38	1,550.74
RECOMMENDED COST OF LUMP SUM REPAIRS (TO ITS PRE-ACCIDENT CONDITION) (CONFIRMED)				1,200.00
