# Survey Department Check List (Case Handler)

To: MSIG Insurance (Singapore) Pte. Ltd. 4 Shenton Way #21-01 SGX Centre 2 Singapore 068807	From: LKK Auto Consultants Pte Ltd 51 Ubi Ave 1 #01-25 Paya Ubi Industrial Park Singapore 408933
Attn: Irene Tan Gek Ing	Date: 08 Mar 2018
<b><u>Preliminary Advice</u></b>

## VEHICLE DAMAGE INSPECTION REPORT

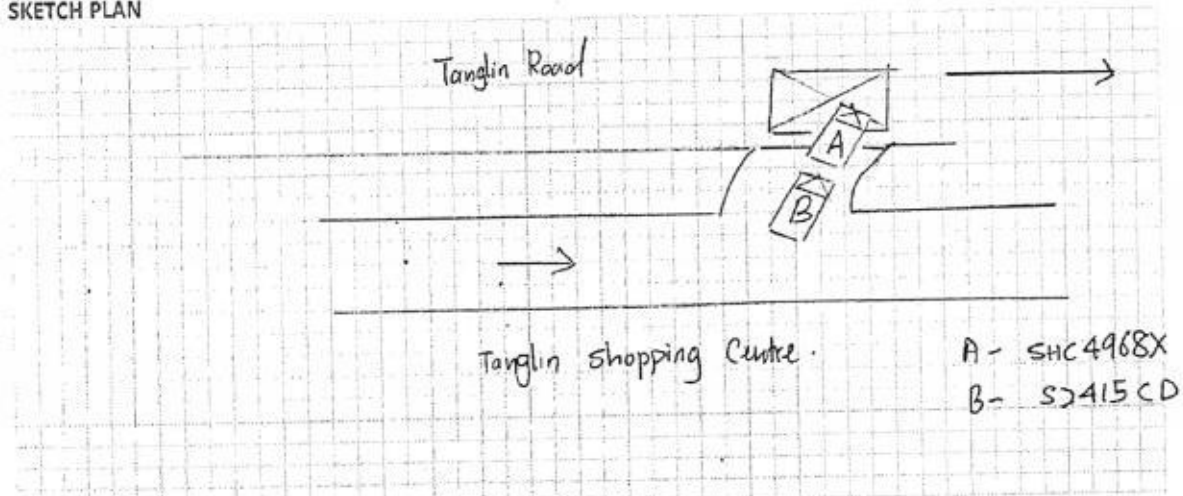
### SKETCH PLAN

I WAS DRIVING ALONG TANGLIN SHOPPING CENTRE DRIVEWAY TOWARDS TANGLIN ROAD. I STOPPED TO LOOK OUT FOR THE ONCOMING TRAFFIC. SUDDENLY I FELT AN IMPACT AT THE REAR OF MY TAXI. A VEHICLE S2415CD HAD COLLIDED ONTO THE REAR OF MY TAXI.
