Code : MSG			
<b>1. Policy Particulars :- THIRD PARTY CLAIM</b>			
Insured Veh.	SLV 3723U	Veh. Inspected	AIRSHOW318
Policy No.	29040254MCY	Coverage (\$)	0.00
Claim No.	550539	Excess (\$)	0.00
Assign From	MERIMEN (KATHERINE WONG)	Assign Date	26/02/2018
<b>2. Vehicle Particulars &amp; Condition</b>			
Make & Model		c.c	0
Engine No.	HIDDEN	Year of Reg.	
Chassis No.		Colour	
Odometer	-	Steering	
Brakes		Modification	
General			
<b>3. Conditions of Tyres</b>			
	Size	Make	Balance
R/H Front Tyre			mm
L/H Front Tyre			mm
R/H Rear Tyre			mm
L/H Rear Tyre			mm
<b>4. Description of Damages</b>			
<b>5. General Information</b>			
Accident Date	08/02/2018	Inspection Date	28/02/2018
Survey held at	PERFORMANCE MOTORS LTD 303 ALEXANDRA ROAD SINGAPORE 159941

**Preliminary Advice**

## VEHICLE DAMAGE INSPECTION REPORT

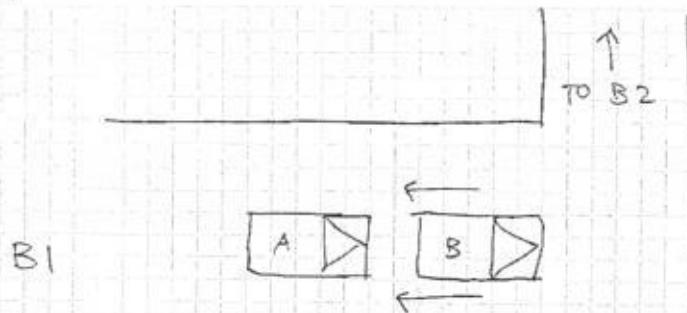
## SKETCH PLAN

Type Of Accident	COLLISION - HEAD TO REAR
Weather Conditions	CLEAR
Road Surface	DRY

A - AIRSTOW 318 / WC08833  
B - SLV3723U / NU81687
