## Preliminary Advice

Insured Vehicle No: SKK2441J

: SLF1564J

## VEHICLE DAMAGE INSPECTION REPORT

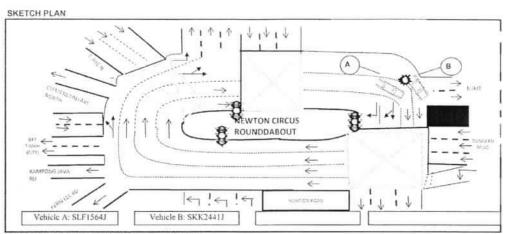
#### SKETCH PLAN

I WAS TRAVELLING ALONG THE CENTRE LANE OF DUNEARN RD INTO NEWTON CIRCUS ROUNDABOUT. I WAS INTENDING TO ENTER INTO BUKIT TIMAH EXIT. AS I WAS ABOUT TO TURN LEFT INTO THE EXIT, VEHICLE B FROM MY REAR (COMING IN FROM C.AVE NORTH) TRAVELLING ON THE LEFT LANE, SPEED FORWARD AND HIT ONTO MY FRONT LEFT PORTION. I HAD AN IN-CAR CAMERA WHICH RECORDED THE INCIDENT. NO ONE WAS INJURED.
