REF: NS/INC18003937 / Klvb02

#05-01 NTUC TRADE UNION HOUSESINGAPORE 189556			
		Date: 07-03-2018	
		Code: INC4	
<b>1. Policy Particulars :- THIRD PARTY CLAIM</b>			
Insured Veh.	SGF 2628L	Veh. Inspected	SHD 3779B
Policy No.	5092378003	Coverage (\$)	0.00
Claim No.	MT/0983987-002	Excess (\$)	0.00
Assign From		Assign Date	28/02/2018
<b>2. Vehicle Particulars &amp; Condition</b>			
Make & Model	HYUNDAI I40	c.c	1685
Engine No.	HIDDEN	Year of Reg.	2017
Chassis No.	KMHLB41UMHU098816	Colour	BLUE
Odometer	35849	Steering	IN ORDER
Brakes	IN ORDER	Modification	STANDARD ALLOY RIM
General	FAIR		
<b>3. Conditions of Tyres</b>			
	Size	Make	Balance
R/H Front Tyre	205/60 R16	HANKOOK	7 mm
L/H Front Tyre	205/60 R16	HANKOOK	7 mm
R/H Rear Tyre	205/60 R16	HANKOOK	7 mm
L/H Rear Tyre	205/60 R16	HANKOOK	7 mm
<b>4. Description of Damages</b>			
THE VEHICLE SUSTAINED DAMAGES AT THE O/S BODY.

**ADJUSTMENT ON REPAIR COST FOR VEHICLE NO. SHD 3779B**

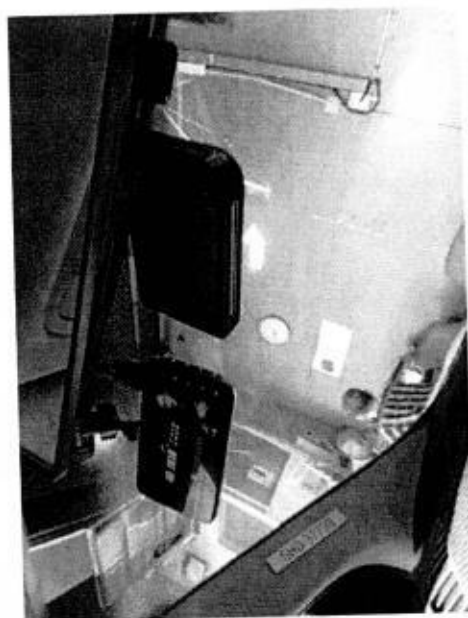
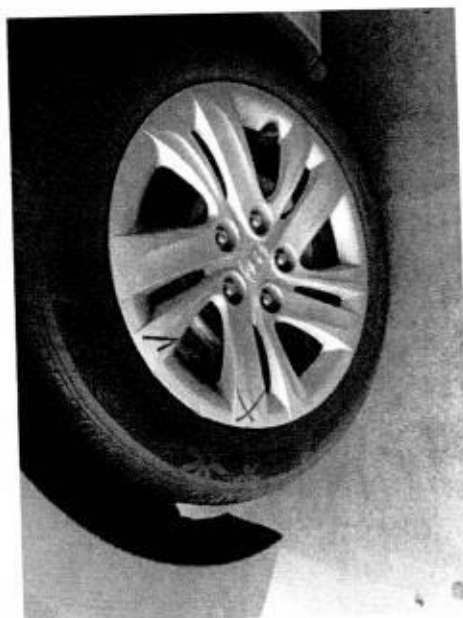
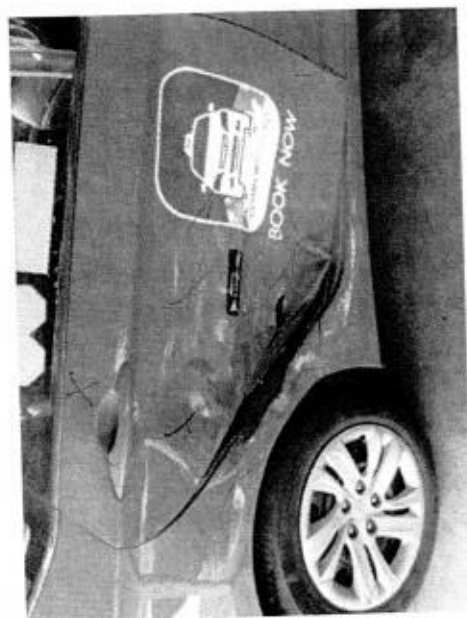
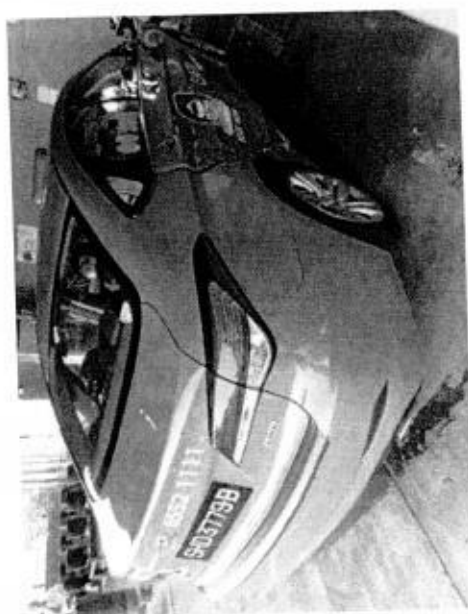
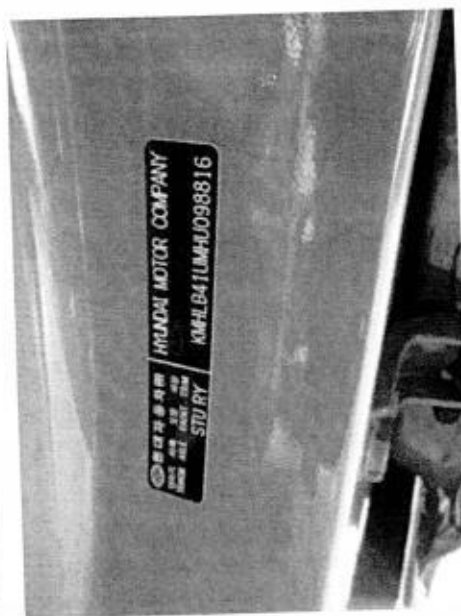
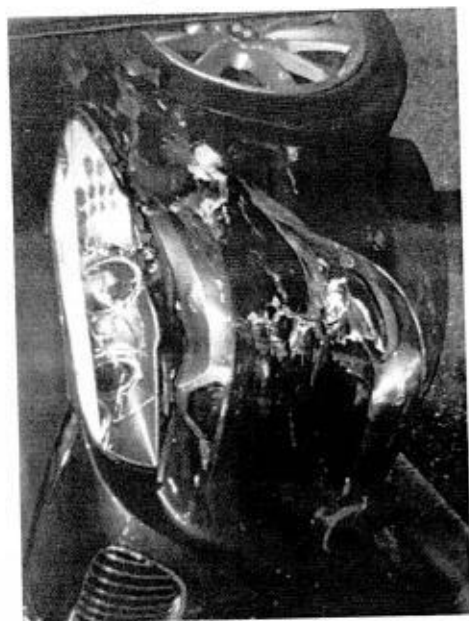
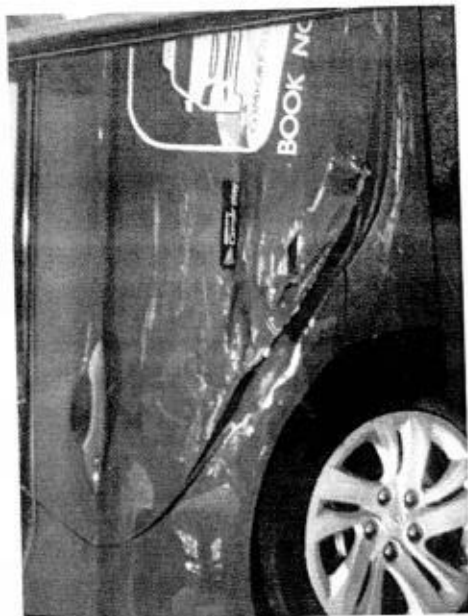
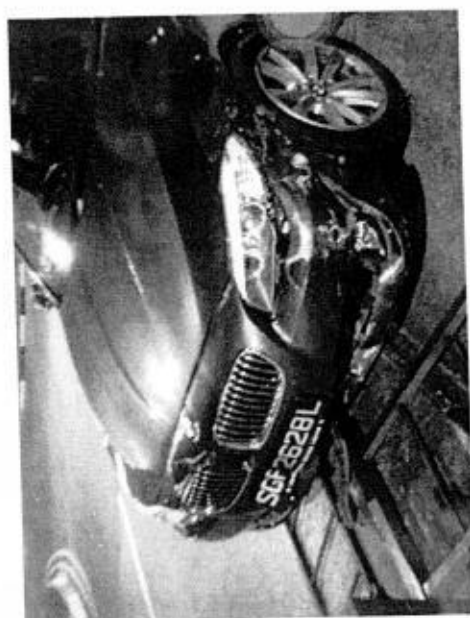
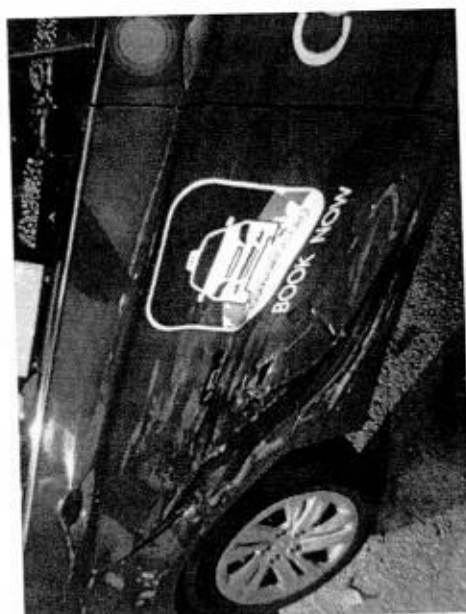
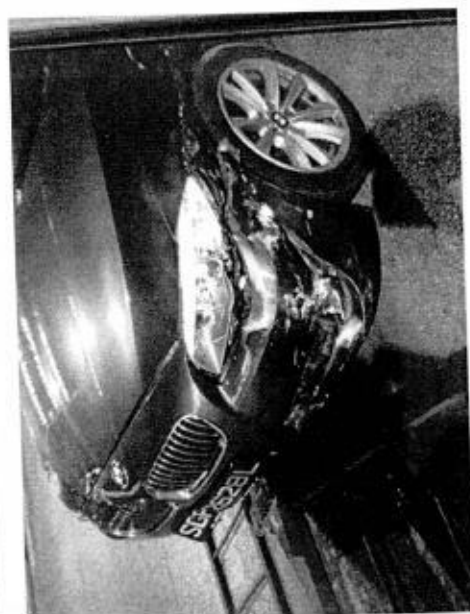
Qty	Description of Parts	Condition	Estimate By Workshop (\$)	Our Adjusted (\$)
<b><u>REPLACEMENT OF PARTS</u></b>				
1	REAR FENDER (RH)	DENTED	2,020.10	2,020.10
1	REAR FENDER INNER LINING (RH)	SERVICEABLE	164.40	-
1	REAR WINDSCREEN MOULDING	NOT NECESSARY	60.00	-
1	REAR DOOR (RH)	DENTED	1,351.10	1,351.10
1	REAR DOOR RUBBER (RH)	SERVICEABLE	280.50	-
1	REAR DOOR GEAR/REGULATOR (LRH)	SERVICEABLE	785.00	-
1	REAR DOOR POWER MOTOR (RH)	SERVICEABLE	530.50	-
1	REAR DOOR LOCK ASSY	SERVICEABLE	321.85	-
1	ROCKER PANEL OUTER GARNISH (RH)	CRACKED	483.60	483.60
1	ROCKER PANEL STEP GARNISH (REAR)(RH)	SERVICEABLE	31.70	-
1	REAR WHEEL HUP-CAP (RH)	GRAZED	150.70	150.70
	LESS 20% DISCOUNT		-1,235.89	-801.10
			4,943.56	3,204.40
<b><u>NETT ITEMS</u></b>				
1	REAR WINDSCREEN SEALANT (N)	NECESSARY	46.00	46.00
1	REAR DOOR COMFORTDELGRO & APPS STICKER (RH) (N)	NECESSARY	80.00	80.00
1	FRONT DOOR COLOURED COMFORT LOGO (RH)(N)	NECESSARY	75.00	75.00

LESS 10% DISCOUNT		-	-20.10
			201.00	180.90
<b><u>LABOUR</u></b>				
	THATCHAM STANDARD REPAIR TIME ON BODY WORKS.		1,720.00	1,020.00
	THATCHAM TTS STANDARD SPRAY PAINTING COST AND LABOUR.		900.00	740.00

RECOMMENDED COST OF REPAIRS (CONFIRMED)			5,145.30
---	--	--	----------
