Job No: K51111 REF: NS/INC18008939/Kltbn2

189556		Code: INC4	
<b>1. Policy Particulars :- THIRD PARTY CLAIM</b>			
Insured Veh.	SGJ 7987X	Veh. Inspected	SH 7081C
Policy No.	5029197229-09	Coverage (\$)	0.00
Claim No.	MT/0983862-002	Excess (\$)	0.00
Assign From		Assign Date	28/02/2018
<b>2. Vehicle Particulars &amp; Condition</b>			
Make & Model	HYUNDAI I40	c.c	1685
Engine No.	HIDDEN	Year of Reg.	2016
Chassis No.	KMHLB41UMHU097228	Colour	BLUE
Odometer	173169	Steering	IN ORDER
Brakes	IN ORDER	Modification	STANDARD ALLOY RIM
General	FAIR		
<b>3. Conditions of Tyres</b>			
	Size	Make	Balance
R/H Front Tyre	205/60 R16	WEST LAKE	7 mm
L/H Front Tyre	205/60 R16	WEST LAKE	7 mm
R/H Rear Tyre	205/60 R16	WEST LAKE	7 mm
L/H Rear Tyre	205/60 R16	WEST LAKE	7 mm
<b>4. Description of Damages</b>			
THE VEHICLE SUSTAINED DAMAGES AT THE REAR N/S PORTION.

**ADJUSTMENT ON REPAIR COST FOR VEHICLE NO. SH 7081C**

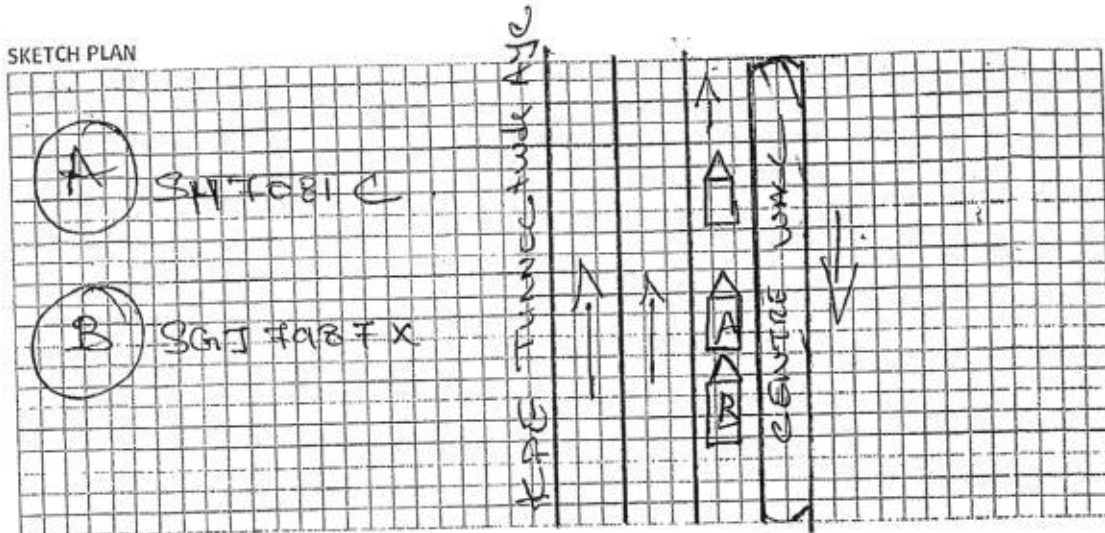
## SKETCH PLAN

## DESCRIBE CIRCUMSTANCES OF THE ACCIDENT

ON 27 FEB 2018 @ 1010hrs. I

VEH A was driving along KPE tube

AYE along the way in the tunnel I veh

A was on 1st lane. Suddenly veh in lat

vehicle slow down I veh A also

slow down Suddenly veh B from rear

hit veh A Rear. at the point of accident

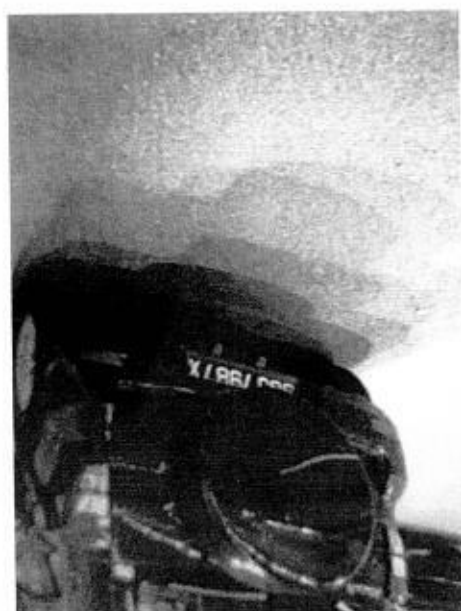
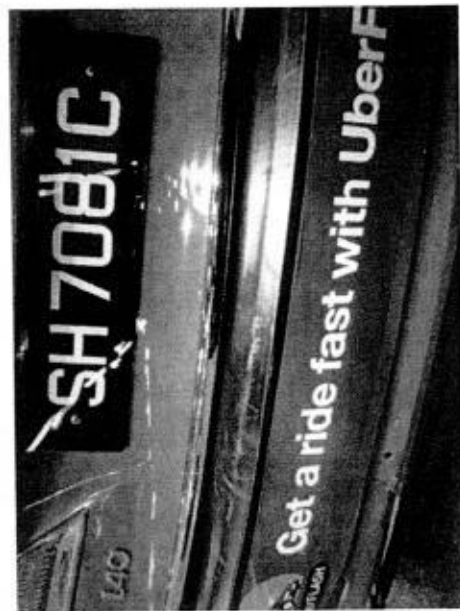
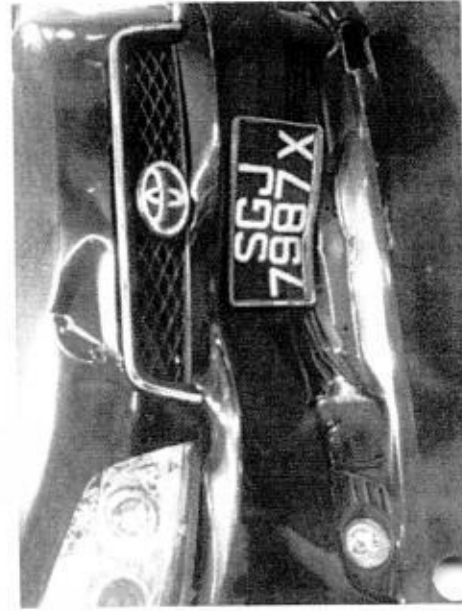
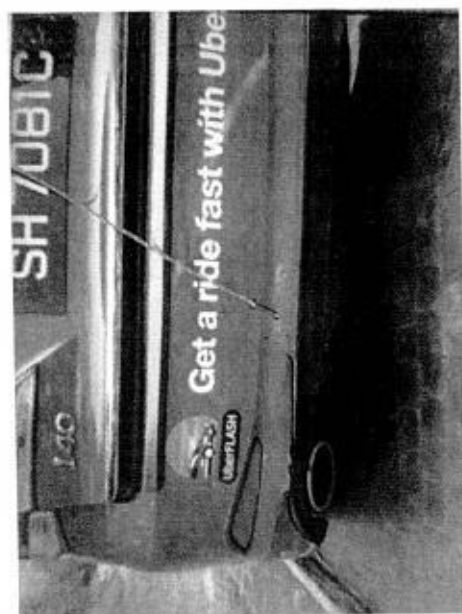
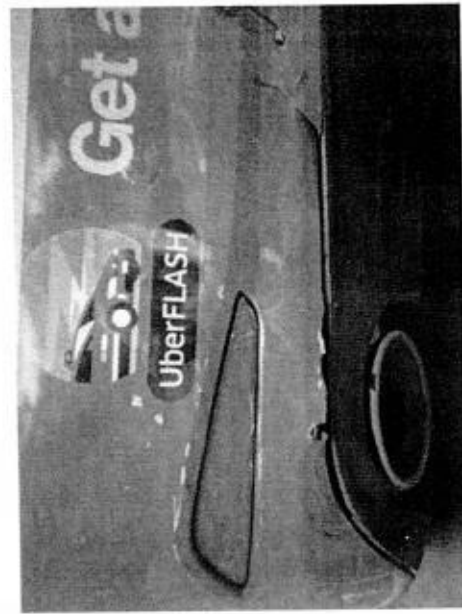
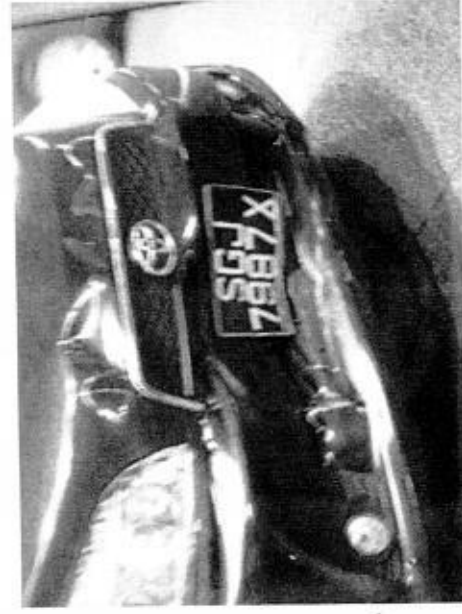
DAMAGES SEE DETAILS.			
<b>5. General Information</b>			
Accident Date	27/02/2018	Inspection Date	28/02/2018
Survey held at	COMFORTDELGRO ENGINEERING PTE LTD 59 LOYANG DRIVE SINGAPORE 508969		
<b>5a. Remarks</b>			
A)THE INSPECTION WAS CONDUCTED ON A"WITHOUT PREJUDICE" BASIS. B)IN ACCORDANCE TO YOUR INSTRUCTIONS, WE HAVE NOT AUTHORISED REPAIRS.			
<b>5b. Estimate Days of Repair</b>			
ESTIMATED NORMAL PERIOD FOR REPAIR:		3 Working Days

Qty	Description of Parts	Condition	Estimate By Workshop (\$)	Our Adjusted (\$)
<b>REPLACEMENT OF PARTS</b>				
1	BOOT LID	DENTED	1,681.40	1,681.40
1	BOOT LID RUBBER	SERVICEABLE	115.80	-
1	BOOT LID LOCK UPPER	SERVICEABLE	137.90	-
1	BOOT LID LOCK LOWER	SERVICEABLE	31.70	-
1	BOOT LID "H" EMBLEM	NECESSARY	27.20	27.20
1	BOOT LID CRDI PLATE	NECESSARY	41.00	41.00
1	BOOT LID LAMP (LH)	CRACKED	556.80	556.80
1	BOOT LID TRIMBOARD	SERVICEABLE	172.70	-
11	BOOT LID TRIMBOARD CLIPS	NOT NECESSARY	11.00	-
1	BOOTLID MOULDING	SERVICEABLE	85.00	-
1	BOOTLID I40 EMBLEM	NECESSARY	41.00	41.00
1	BOOTLID LOWER GARNISH	CRACKED	398.00	398.00
1	REAR BUMPER	DEFORMED	603.60	603.60
1	REAR BUMPER REINFORCEMENT	SERVICEABLE	504.35	-
2	REAR BUMPER REINFORCEMENT BRACKET (LH/RH) @\$180.00	N/S BENT / O/S SERVICEABLE	360.00	180.00
2	REAR BUMPER SIDE BRACKET @\$49.00	SERVICEABLE	98.00	-
10	REAR BUMPER CLIPS	NECESSARY	22.00	22.00
1	REAR BUMPER SPONGE	TORN	143.40	143.40

1	REAR BUMPER UNDER COVER	CUT	225.00	225.00
1	REAR BUMPER REFLECTLR LAMP (LH)	CRACKED	32.00	32.00
1	REAR END PANEL (NPA)	TO REPAIR	-	-
1	EXHAUST LH	BENT	953.00	953.00
1	EXHAUST CENTER	BENT	1,130.50	1,130.50
	LESS 20% DISCOUNT		-1,474.27	-1,206.98
			5,897.08	4,827.92
<b>NETT ITEMS</b>				
1	BOOT LID COMFORT LOGO & TEL NO STICKER (N)	NECESSARY	30.00	30.00
1	REAR BUMPER REVERSE SENSOR (N)	SHORTED	135.70	135.70

Qty	Description of Parts	Condition	Estimate By Workshop (\$)	Our Adjusted (\$)
	LESS 10% DISCOUNT		-	-16.57
			165.70	149.13
	<b>SPECIAL NETT ITEMS</b>			
1	REAR BUMPER RUBBER MAT (SN)	NECESSARY	50.00	50.00
2	REAR FENDER ADVERTISEMENT LOGO (LH/RH) @ \$100.00 (SN)	NOT NECESSARY	200.00	-
			250.00	50.00
	<b>LABOUR</b>			
	THATCHAM STANDARD REPAIR TIME ON BODY WORKS.		1,020.00	440.00
	THATCHAM TTS STANDARD SPRAY PAINTING COST AND LABOUR.		650.00	560.00
			1,670.00	1,000.00
	<b>GRAND TOTAL</b>		<b>7,982.78</b>	<b>6,027.05</b>
<b>RECOMMENDED COST OF REPAIRS (CONFIRMED)</b>				<b>6,027.05</b>
