## Preliminary Advice

Vehicle No	: PC2124H	Accident Date	: 25/02/2018
Make	: YUTONG ZK6930H	Policy No.	: DMB1SN1748311700
Assignment Date	: 01/03/2018	Excess	: S\$2,000.00
Date of Inspection	: 01/03/2018	Est. Duration of Repair	: 12.00
Inspection At	: UCB ENGINEERING PTE LTD (HQ) 2C JALAN PESAWAT SINGAPORE 619359

## SINGAPORE ACCIDENT STATEMENT

## VEHICLE DAMAGE INSPECTION REPORT

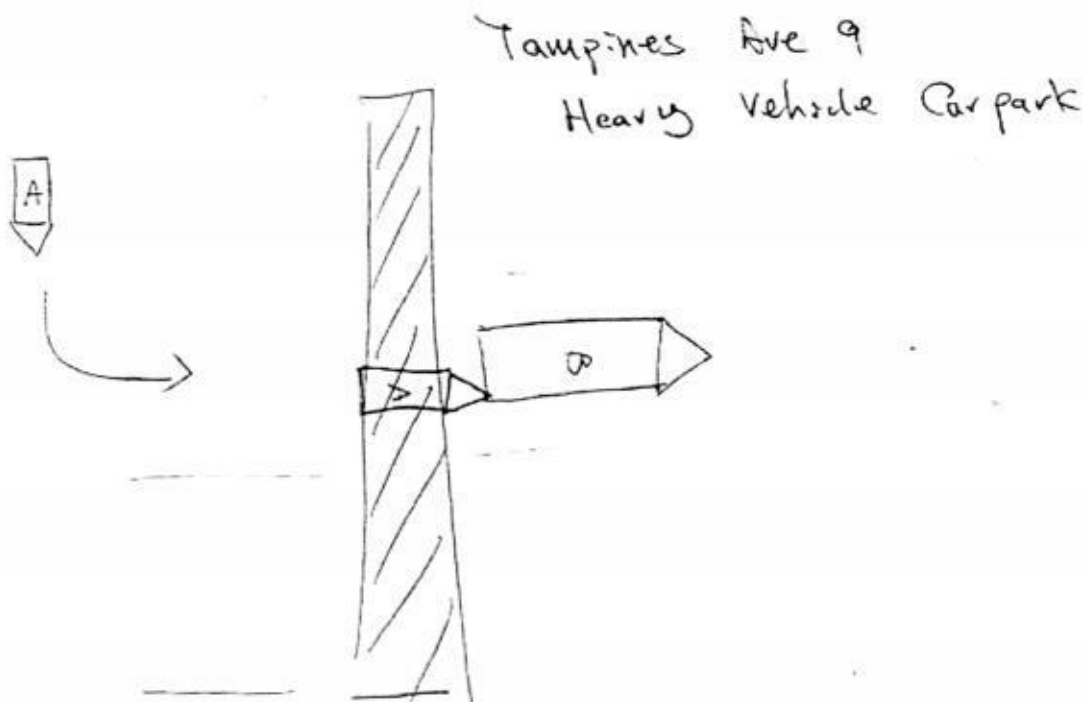
Sketch Plan #3

At 2330 hrs, I was returning to the carpark.

As I was ~~turning~~<sup>slowly</sup> turning into the carpark lot,

I accidentally stepped on the accelerator instead of the brake, and hit onto the stationary vehicle
